City of Conover

ADA Transition Plan

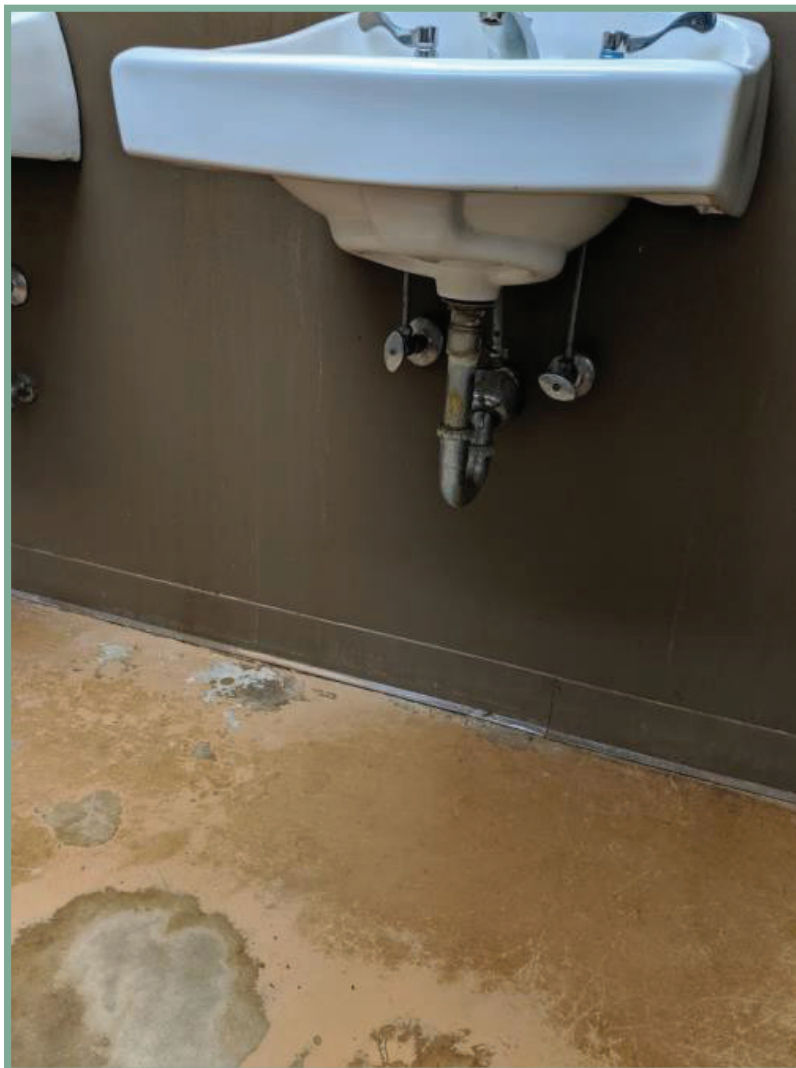
- » 2010 ADA Standards require a 12" clearance between the grab bar and protruding objects above. There are 7.5" between the side bar and the toilet paper dispenser above the side bar. If the facility was built prior to 2012, there are no space requirements above or below bars.
- » Door pulls on stalls (both sides) are recommended but not required if the facility was constructed prior to 3/15/12.

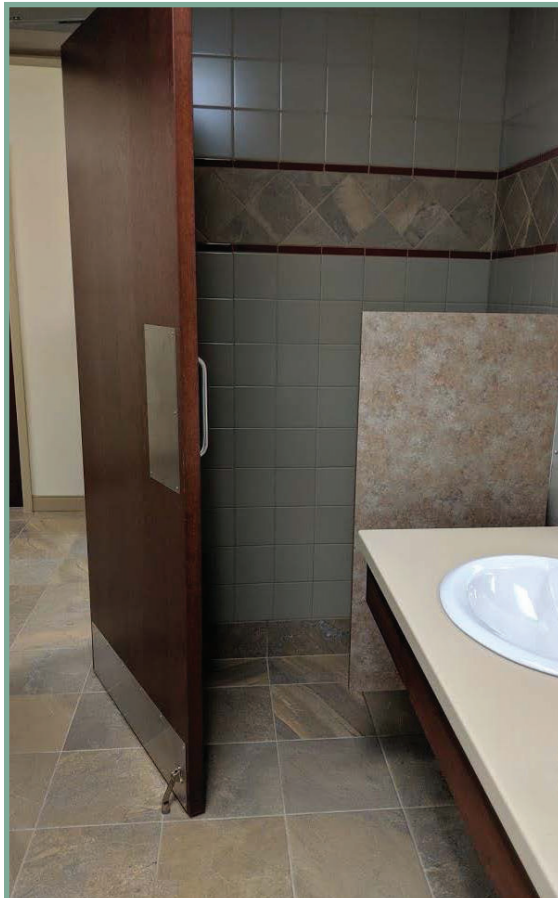
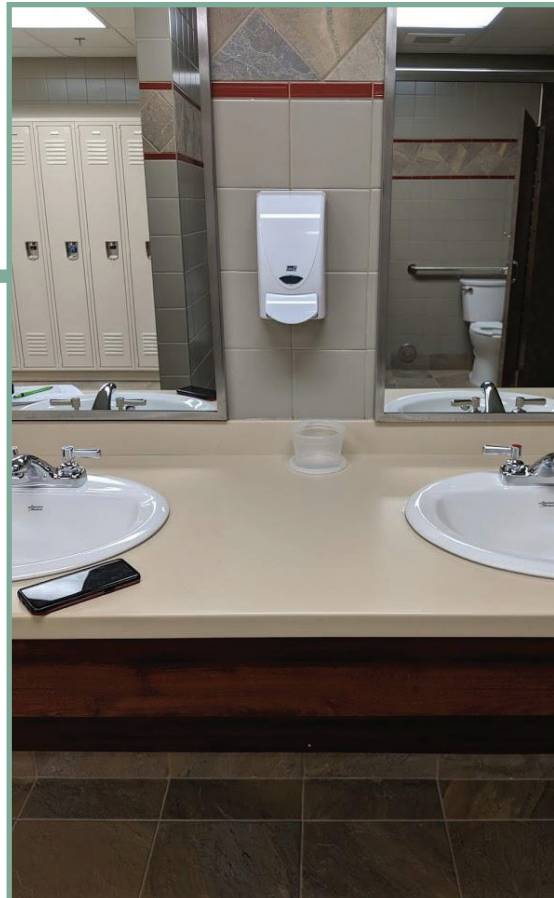
- » The highest grab bar is located 6" above the side grab bar. ADA Standards require a 12" clearance between the grab bar and protruding objects above. If the facility was built prior to March 15, 2012, there are no space requirements above or below bars.

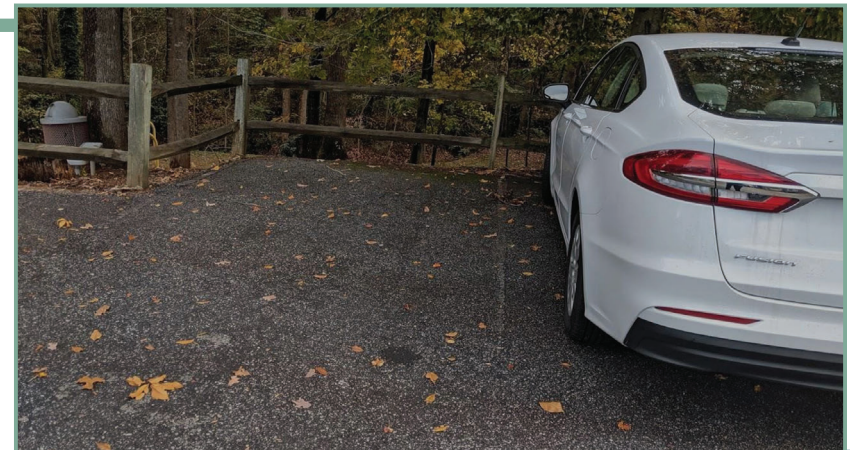
- » There is no designated accessible space at the bottom access to the park (next to the City Park sign)
- » The space to the left of the sign meets the proper size dimensions and slope requirements of a van or standard accessible space – signage should be added

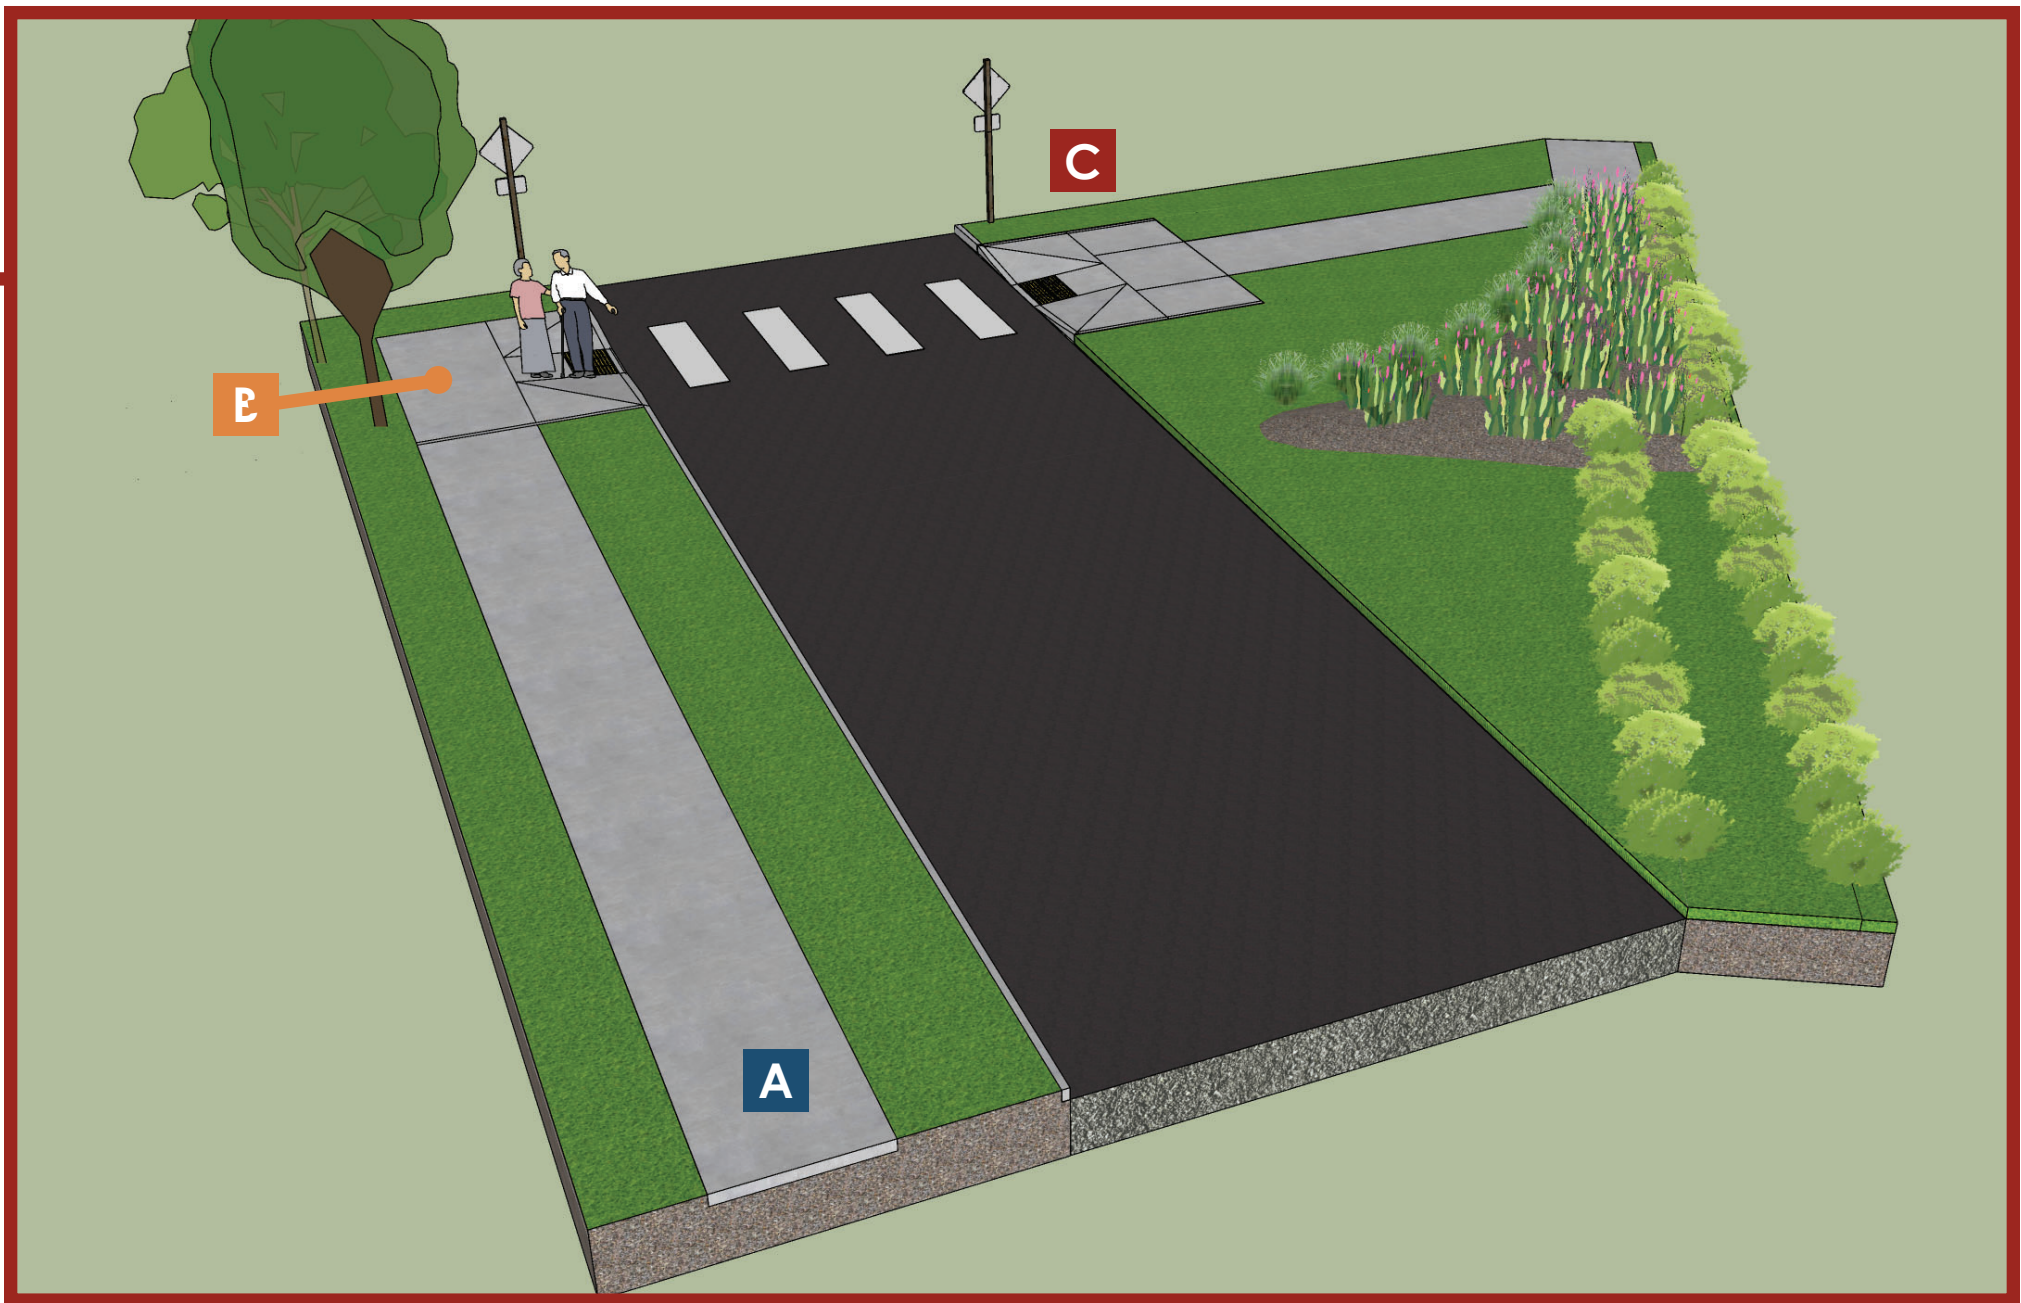
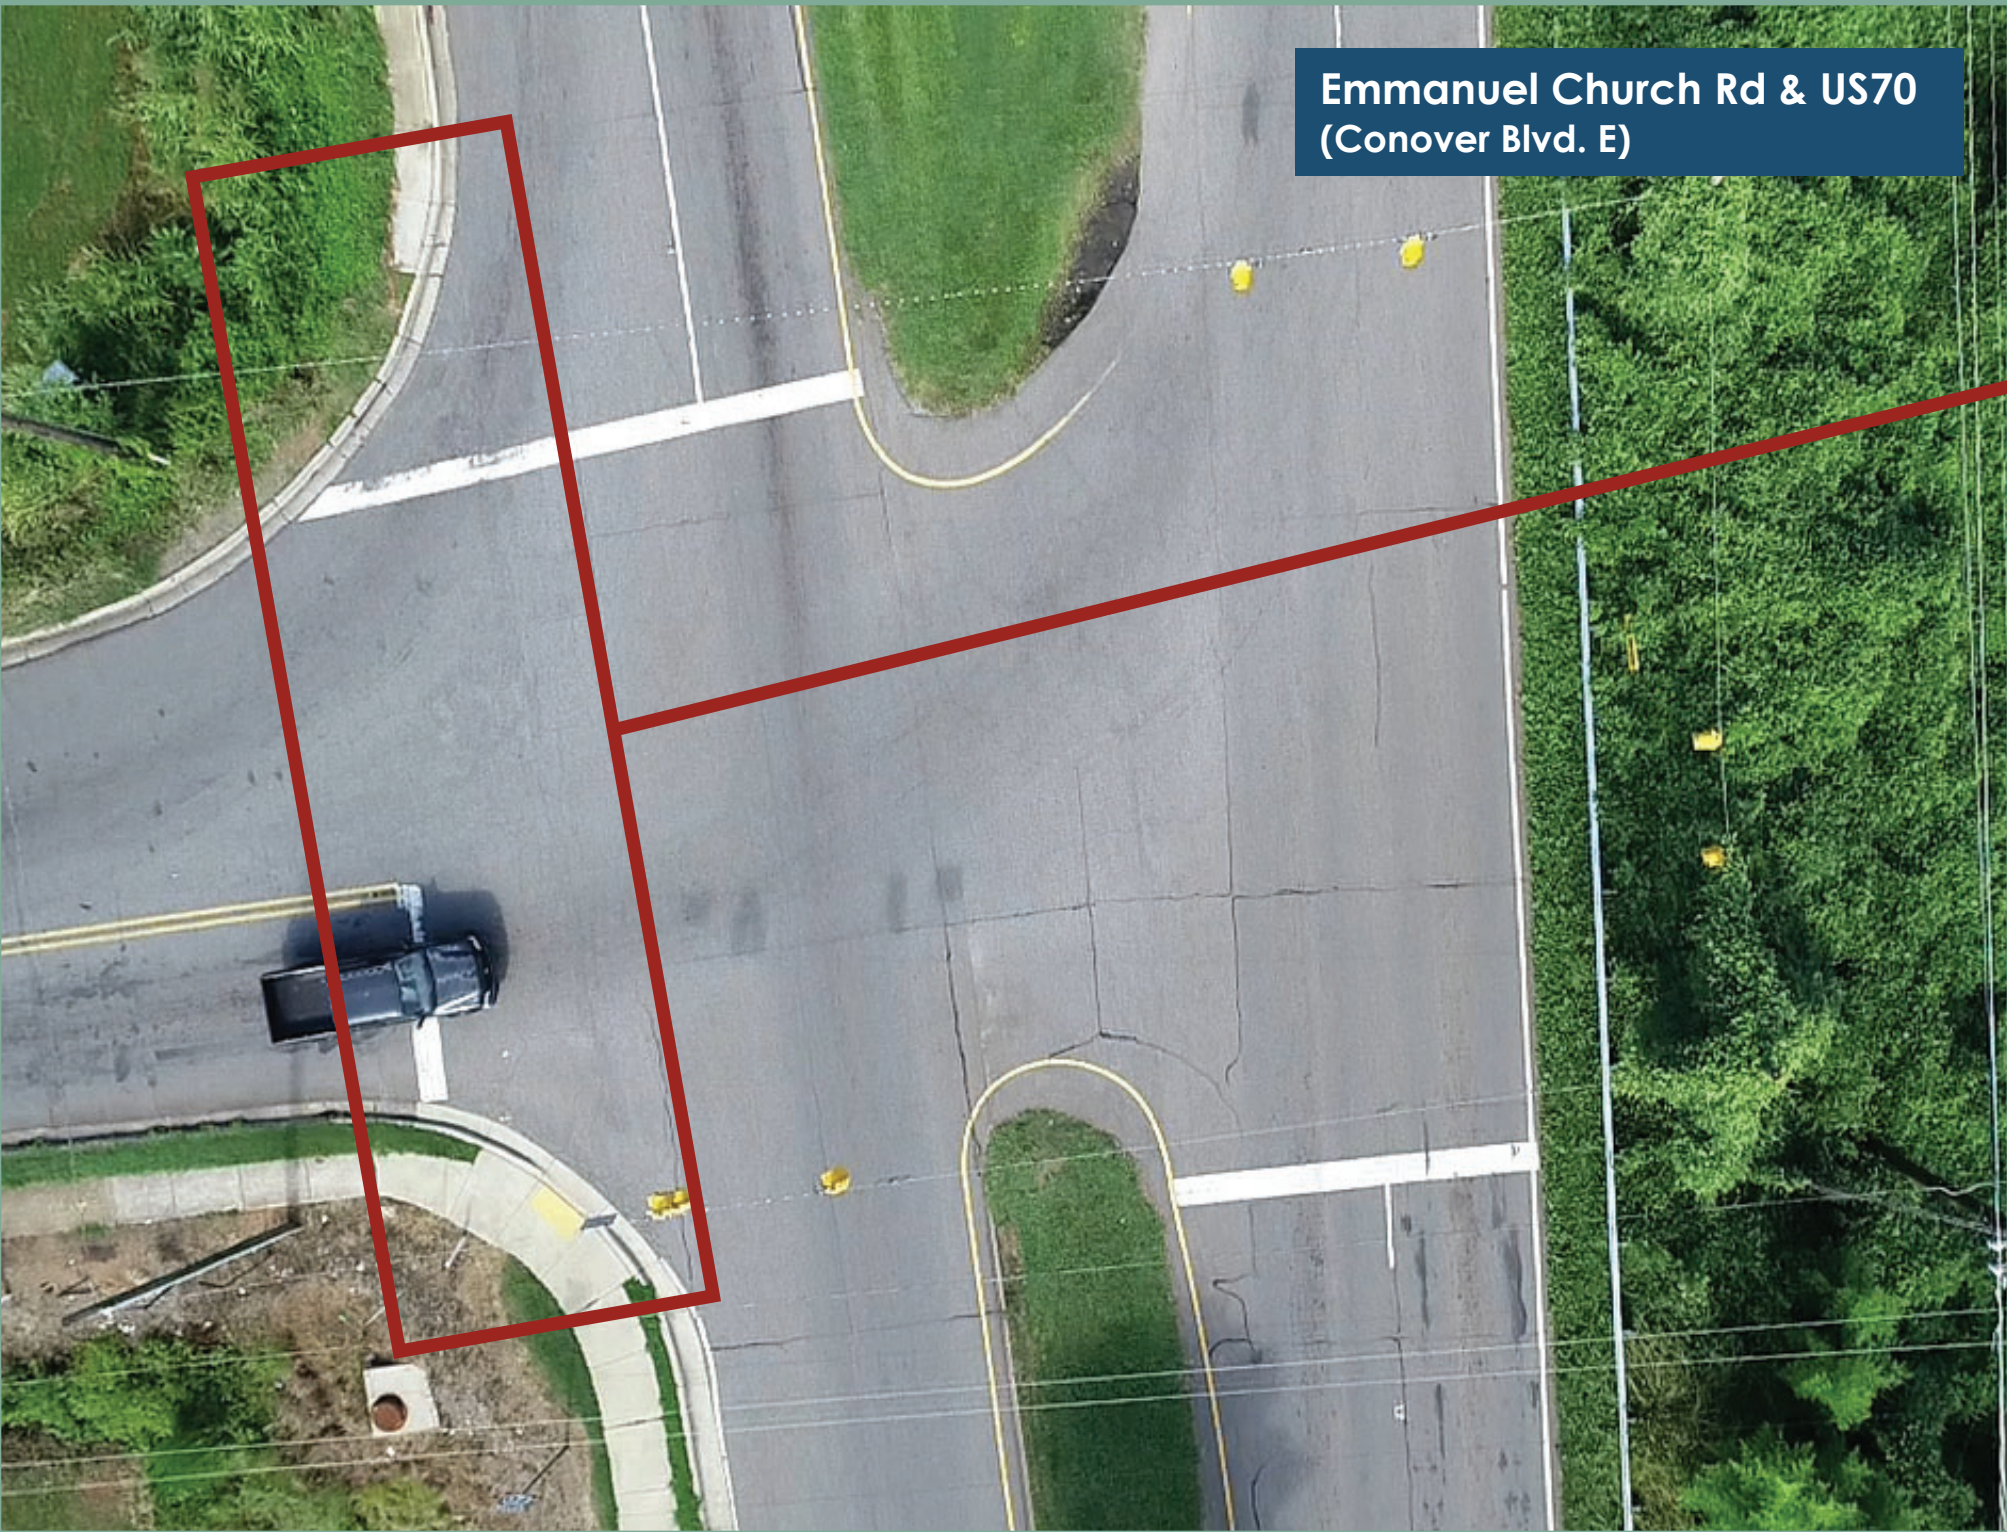
**Emmanuel Church Rd & US70
(Conover Blvd. E)**

- » Advanced crosswalk signage and rapid flash beacon recommended for this location
- » Sidewalk width is 4-5 feet wide

- » Improved, high visual pedestrian crossing
- » Sidewalk that is hidden by the trees extended up to align with visible sidewalk on the other side of the road
- » Detectable warnings on either side of crossing and flat resting areas for pedestrians

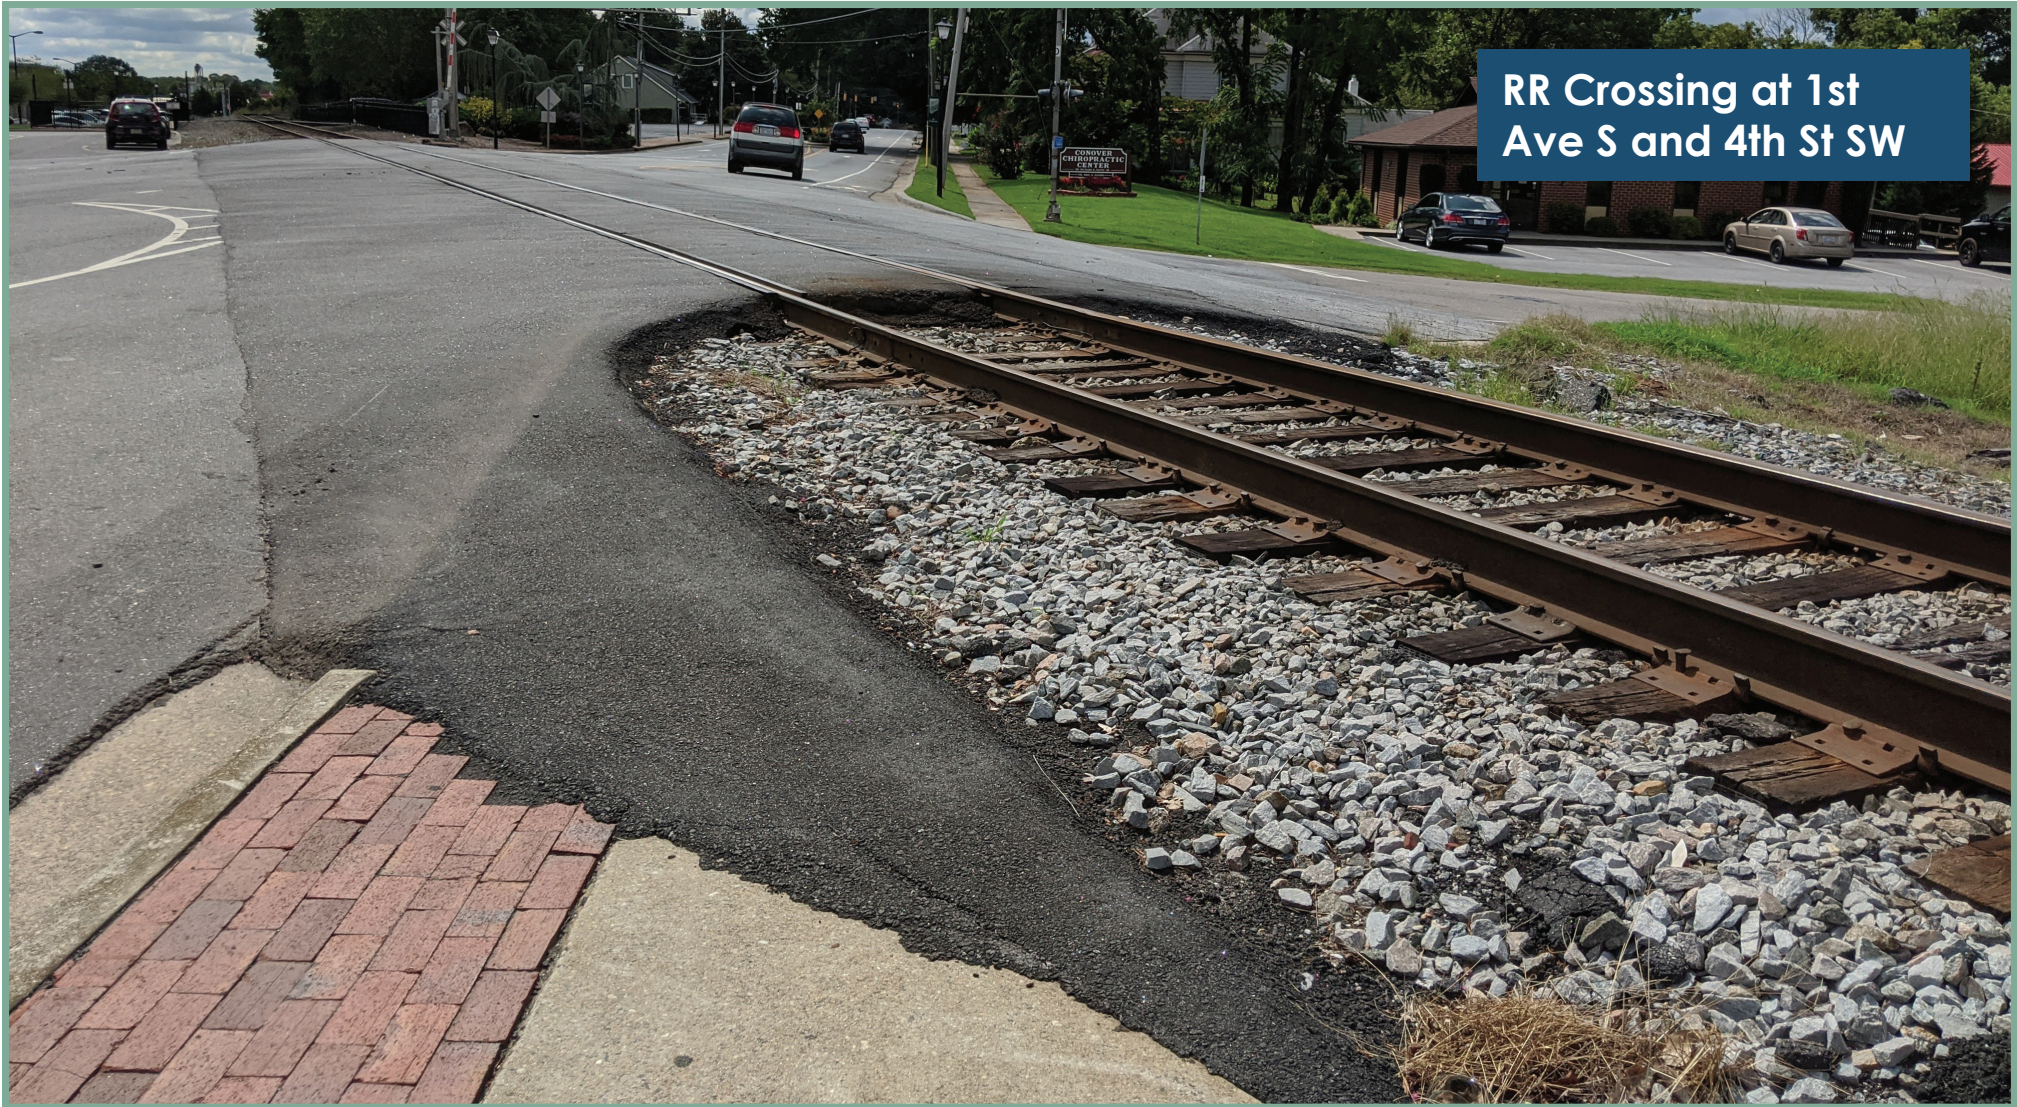
- » This is a very unsafe railroad crossing for all pedestrians. Engineer guidance is warranted for best safety solutions. Sidewalk is present on either side of the railroad on 1st Ave South as well as on 4th St Southwest. This creates legal crossings for pedestrians that are required to be compliant. The sidewalk ends before the railroad track, leaving large, impassible gaps for most users. Motorists turning from 1st Ave South onto 4th St Southwest cannot see pedestrians crossing from 4th St Southwest to the continuing sidewalk on 1st Ave South. This is due to the grade change at that intersection. The cross slope is too steep for persons in wheelchairs to cross at the intersection of 4th St Southwest and 1st Ave South.

- » There is currently a compliant railroad crossing at Conover Station Southeast. Until this issue can be resolved, advanced directional signage on 1st Ave South and 4th St Southwest showing accessible street and railroad crossings is highly recommended.
