City of Conover

ADA Transition Plan

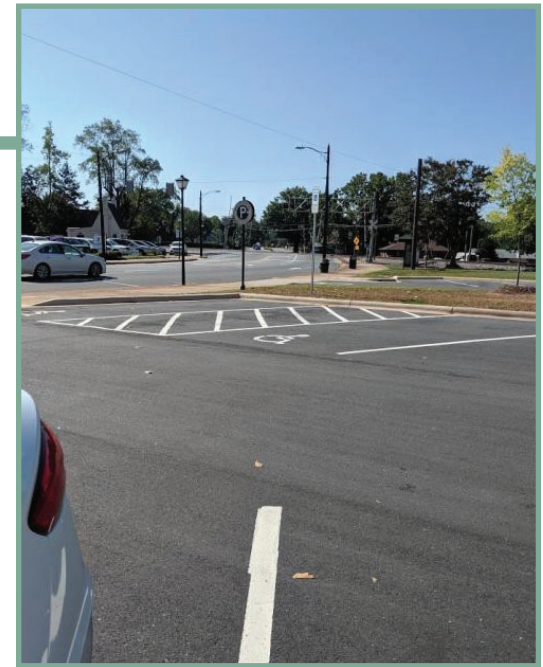
Post Office Parking Lot

High Priority	No Moderate Priority	Low Priority	Low Recommendation
<ul style="list-style-type: none"> » The running slope of the walkway leading out of the parking lot and to the cross walk measures 10.6%. Sidewalks not running parallel to a roadway cannot exceed a running slope of 5%. 		<ul style="list-style-type: none"> » The accessible pathway leading down the middle of the parking lot: The curb ramp (leading into the parking lot) closest to City Hall has a running slope of 9.4%. Curb ramps cannot exceed a running slope of 8.33%. 	<ul style="list-style-type: none"> » Recommend smoother transitions of curb ramps along the accessible pathway throughout the parking lot.

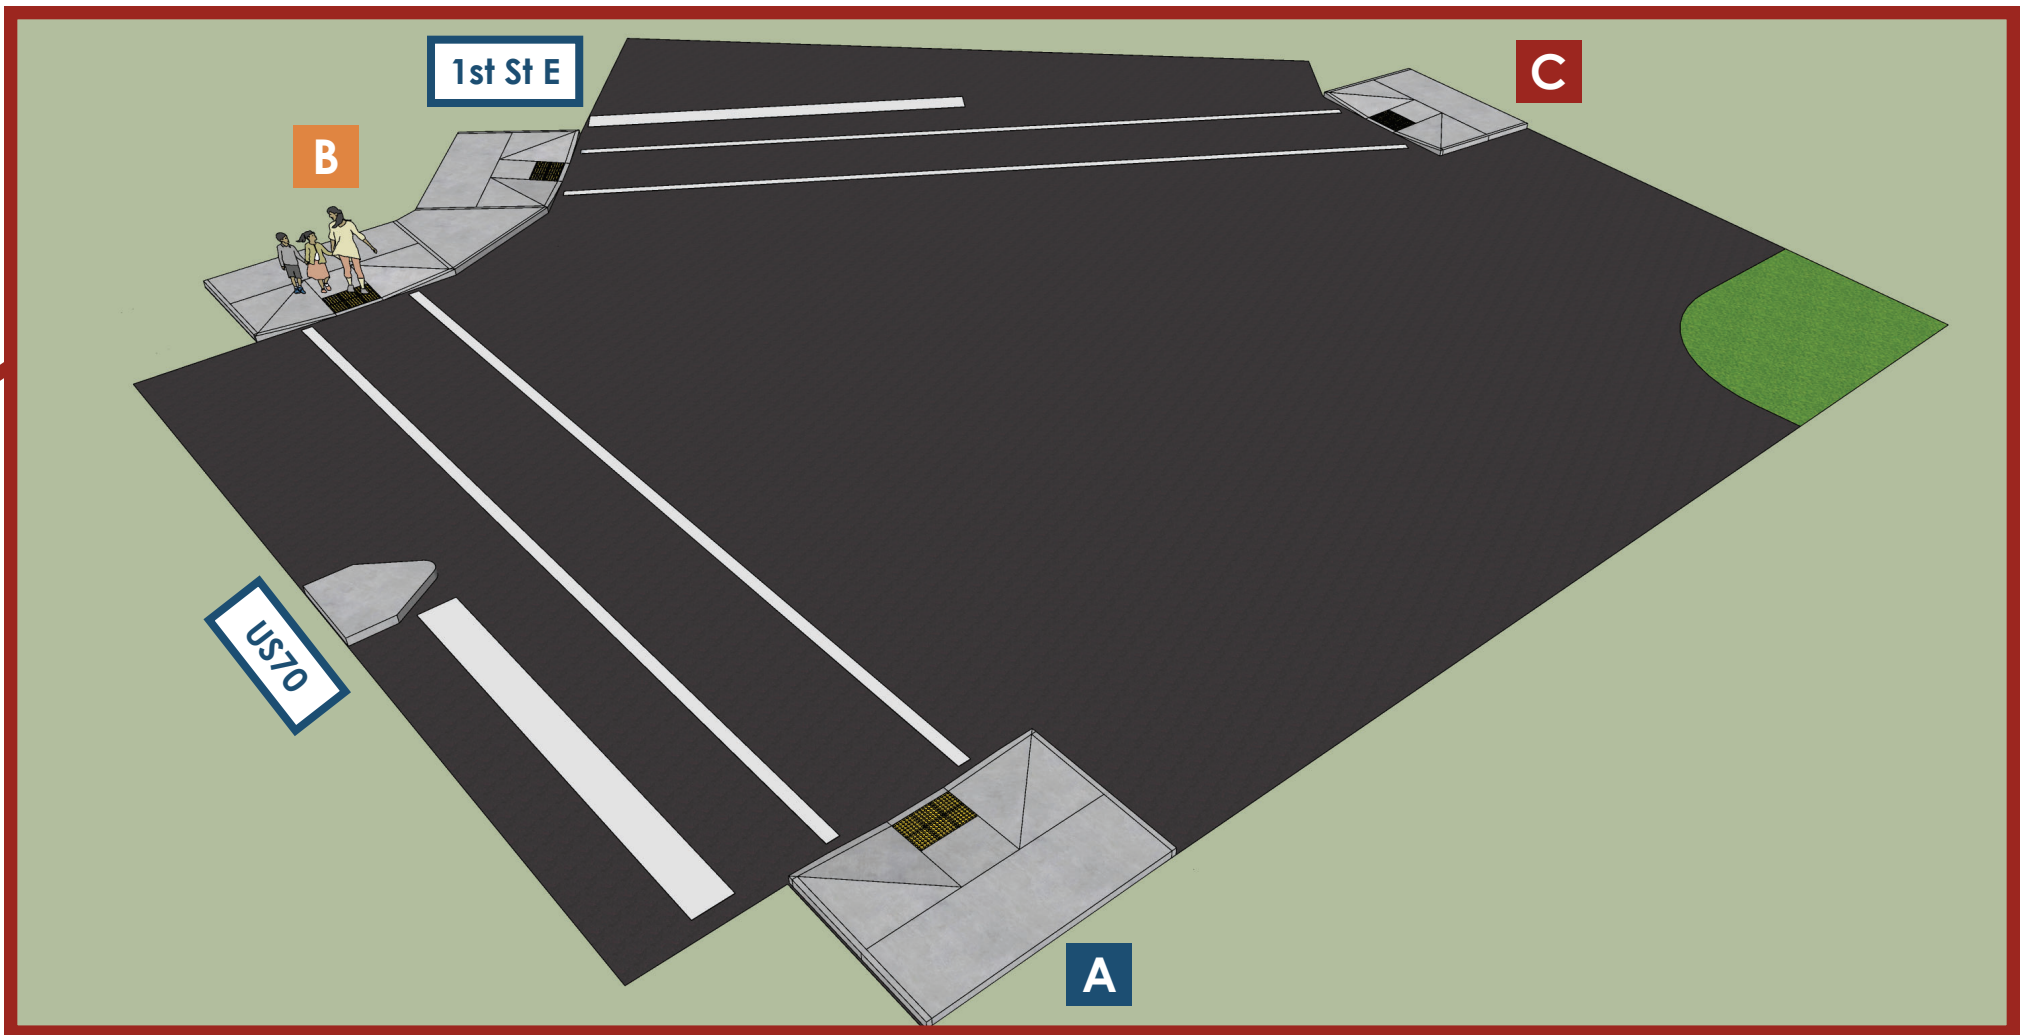
Conover Blvd. Merging on to US70

- » NW quadrant extend sidewalk up to intersection
- » Stop bar moved back 4 feet behind the designated crossing
- » NW quadrant curb ramp has detectable warning at the curb ramp
- » NW quadrant curb ramp aligns with curb ramp on NE quadrant
- » NW quadrant has additional curb ramp to align with curb ramp in SW quadrant – additional curb ramp should also have a detectable warning
- » Recommend marking crosswalks – crosswalks are needed where sidewalk is on either side of road/intersection. If crosswalks are marked at signalized intersections, NCDOT requests pedestrian signals.

- » NE quadrant curb ramp aligns with NW quad curb ramp and has detectable warning (only need one curb ramp here since sidewalk is only on NW side)
- » SW quadrant has curb ramp with detectable warning
- » SW and NW quadrant ramps align with 4 feet of space between vehicle stop bar and crosswalk
- » If feasible, a pedestrian refuge island is recommended where the traffic median is currently. Refuge islands wider than 6 feet need detectable warnings on either side of the crossing. If an island is not feasible, the current median and stop bar should be reduced to allow for proper pedestrian crossing. Evaluate green times for traffic signals to ensure all pedestrians have sufficient crossing time

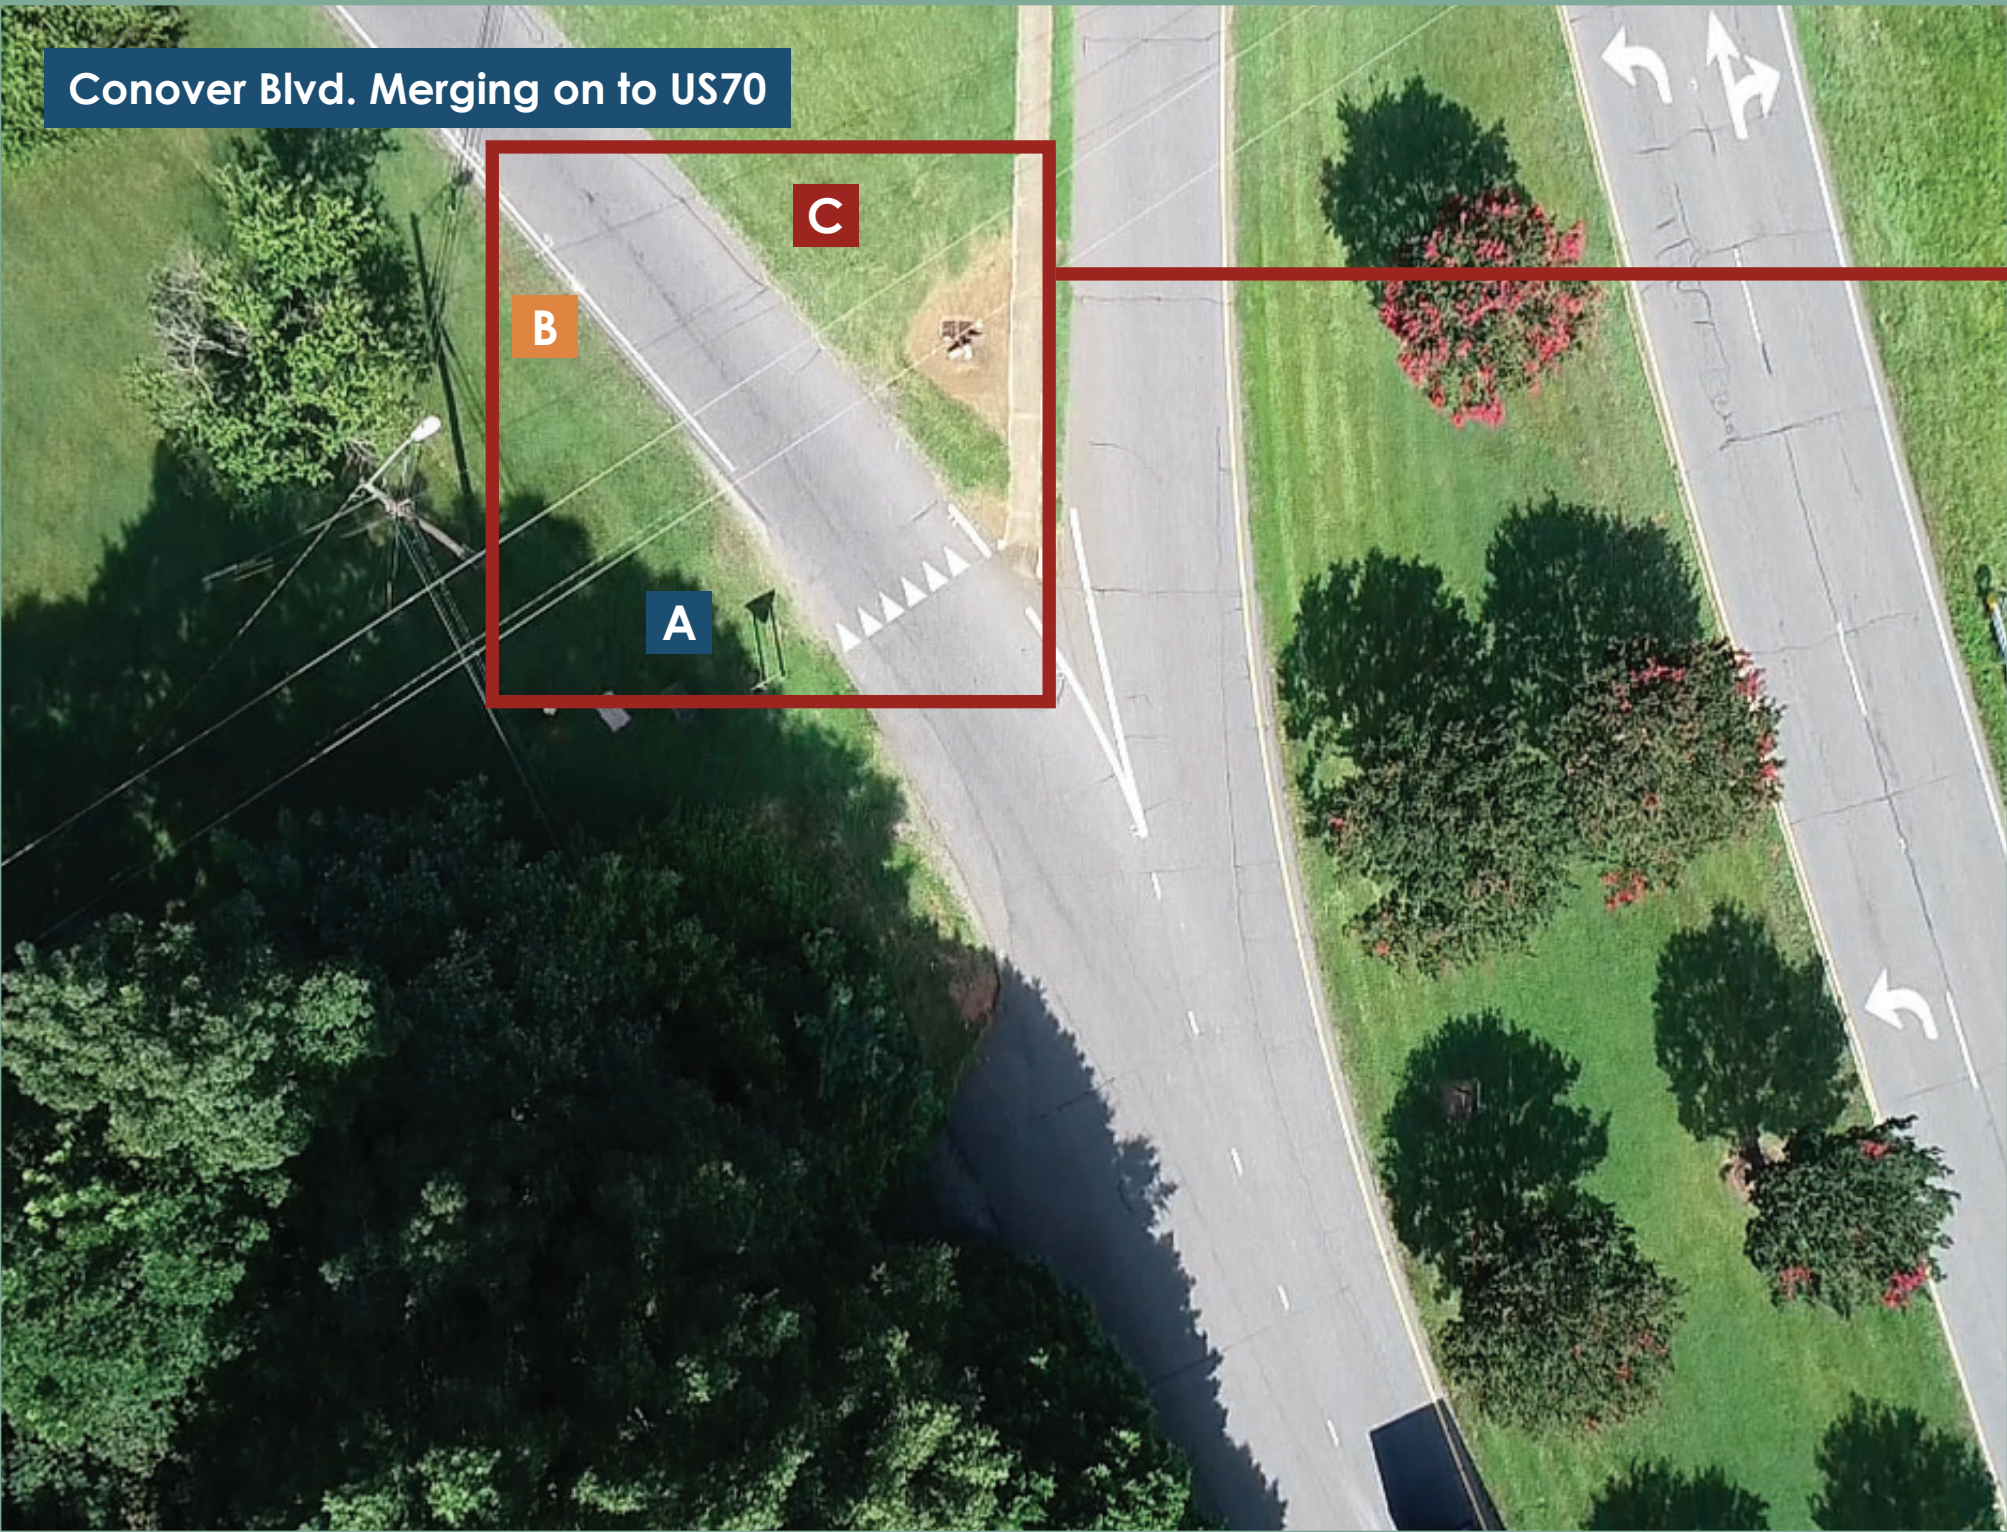
**Emmanuel Church Rd & US70
(Conover Blvd. E)**

- » Improved, high visual pedestrian crossing
- » Sidewalk that is hidden by the trees extended up to align with visible sidewalk on the other side of the road
- » Detectable warnings on either side of crossing and flat resting areas for pedestrians

- » Advanced crosswalk signage and rapid flash beacon recommended for this location
- » Sidewalk width is 4-5 feet wide

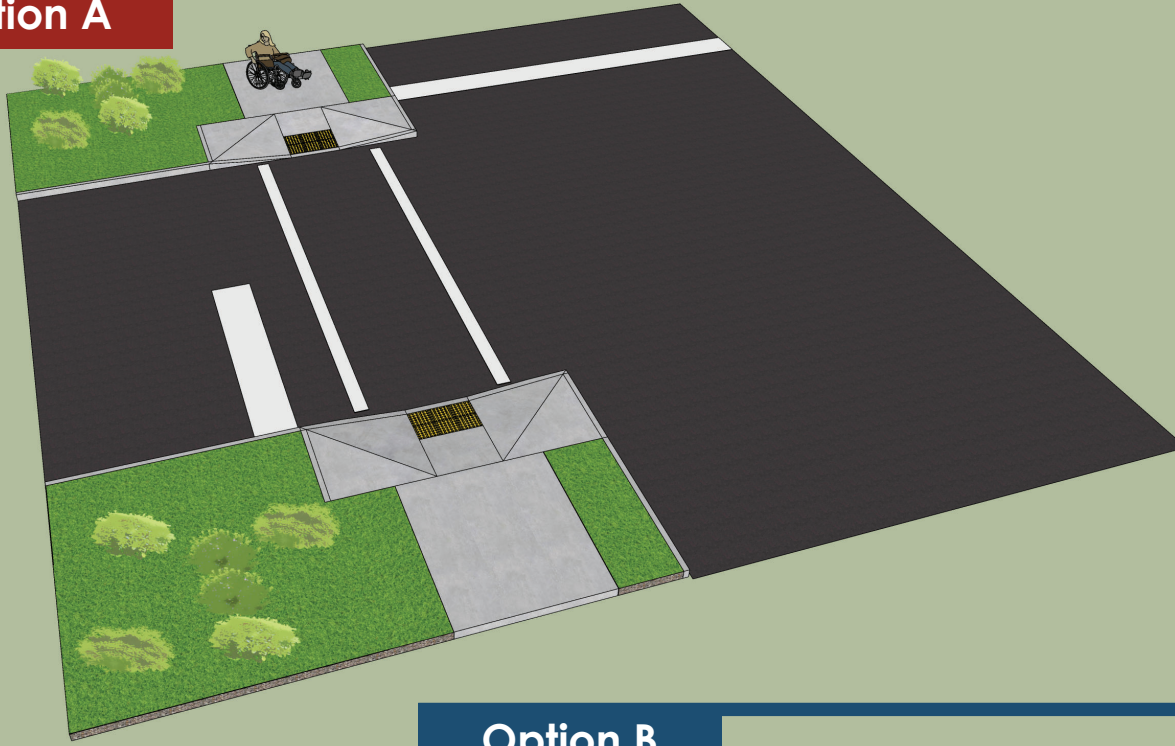
Option A

- » NW quadrant sidewalk extended all the way to squared intersection beyond stop bar
- » NW quadrant sidewalk ends in curb ramp with detectable warning
- » Stop bar 4 feet behind new curb ramp in NW quadrant
- » Wider sidewalk in the NW quadrant (at least 4 feet wide, however, 5 feet recommended)
- » SW curb ramp realigned to align with sidewalk across the road
- » SW curb ramp 4 feet ahead of stop bar

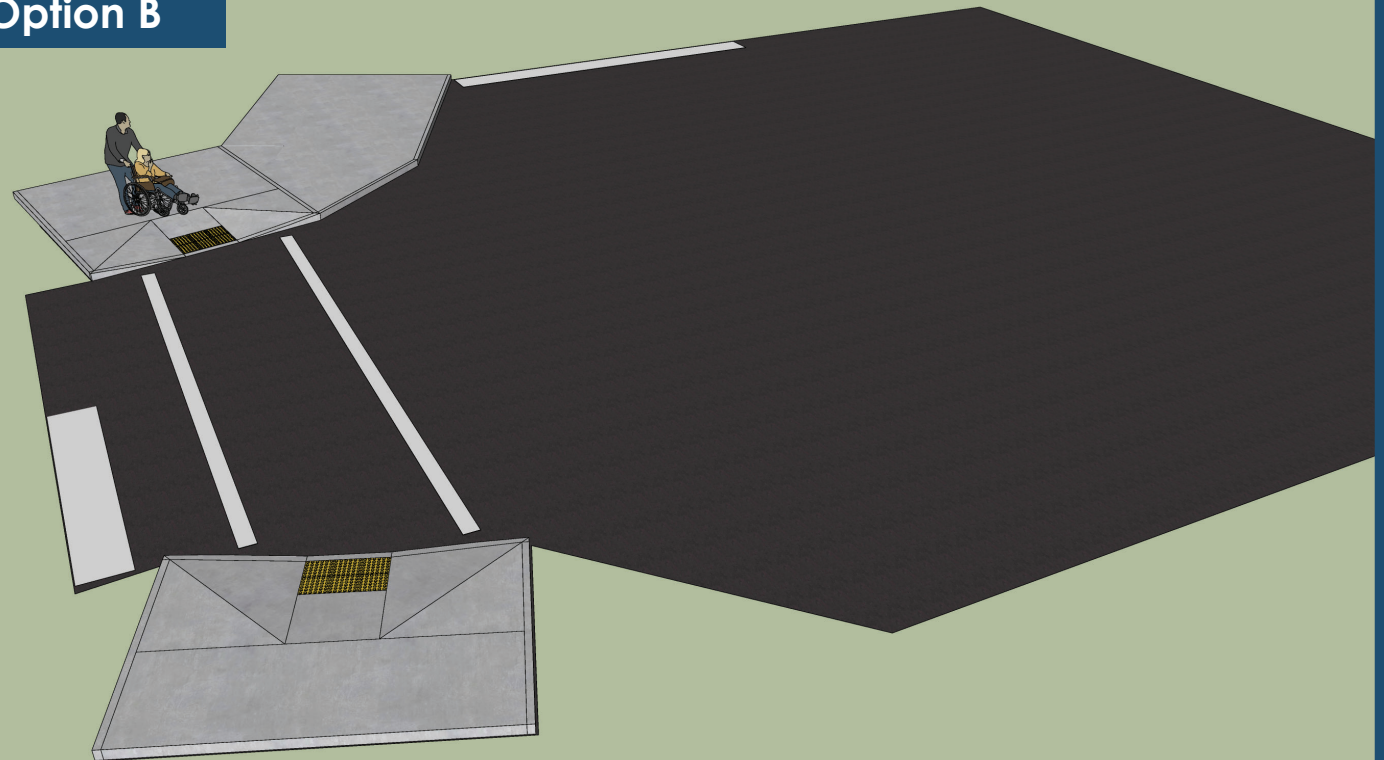
Option B

- » marked crosswalk at curb ramps (crosswalks must be 6-10 feet wide)
- » Pedestrian signals are advised at marked crosswalks
- » Evaluate green times for traffic signals to ensure all pedestrians have sufficient crossing time

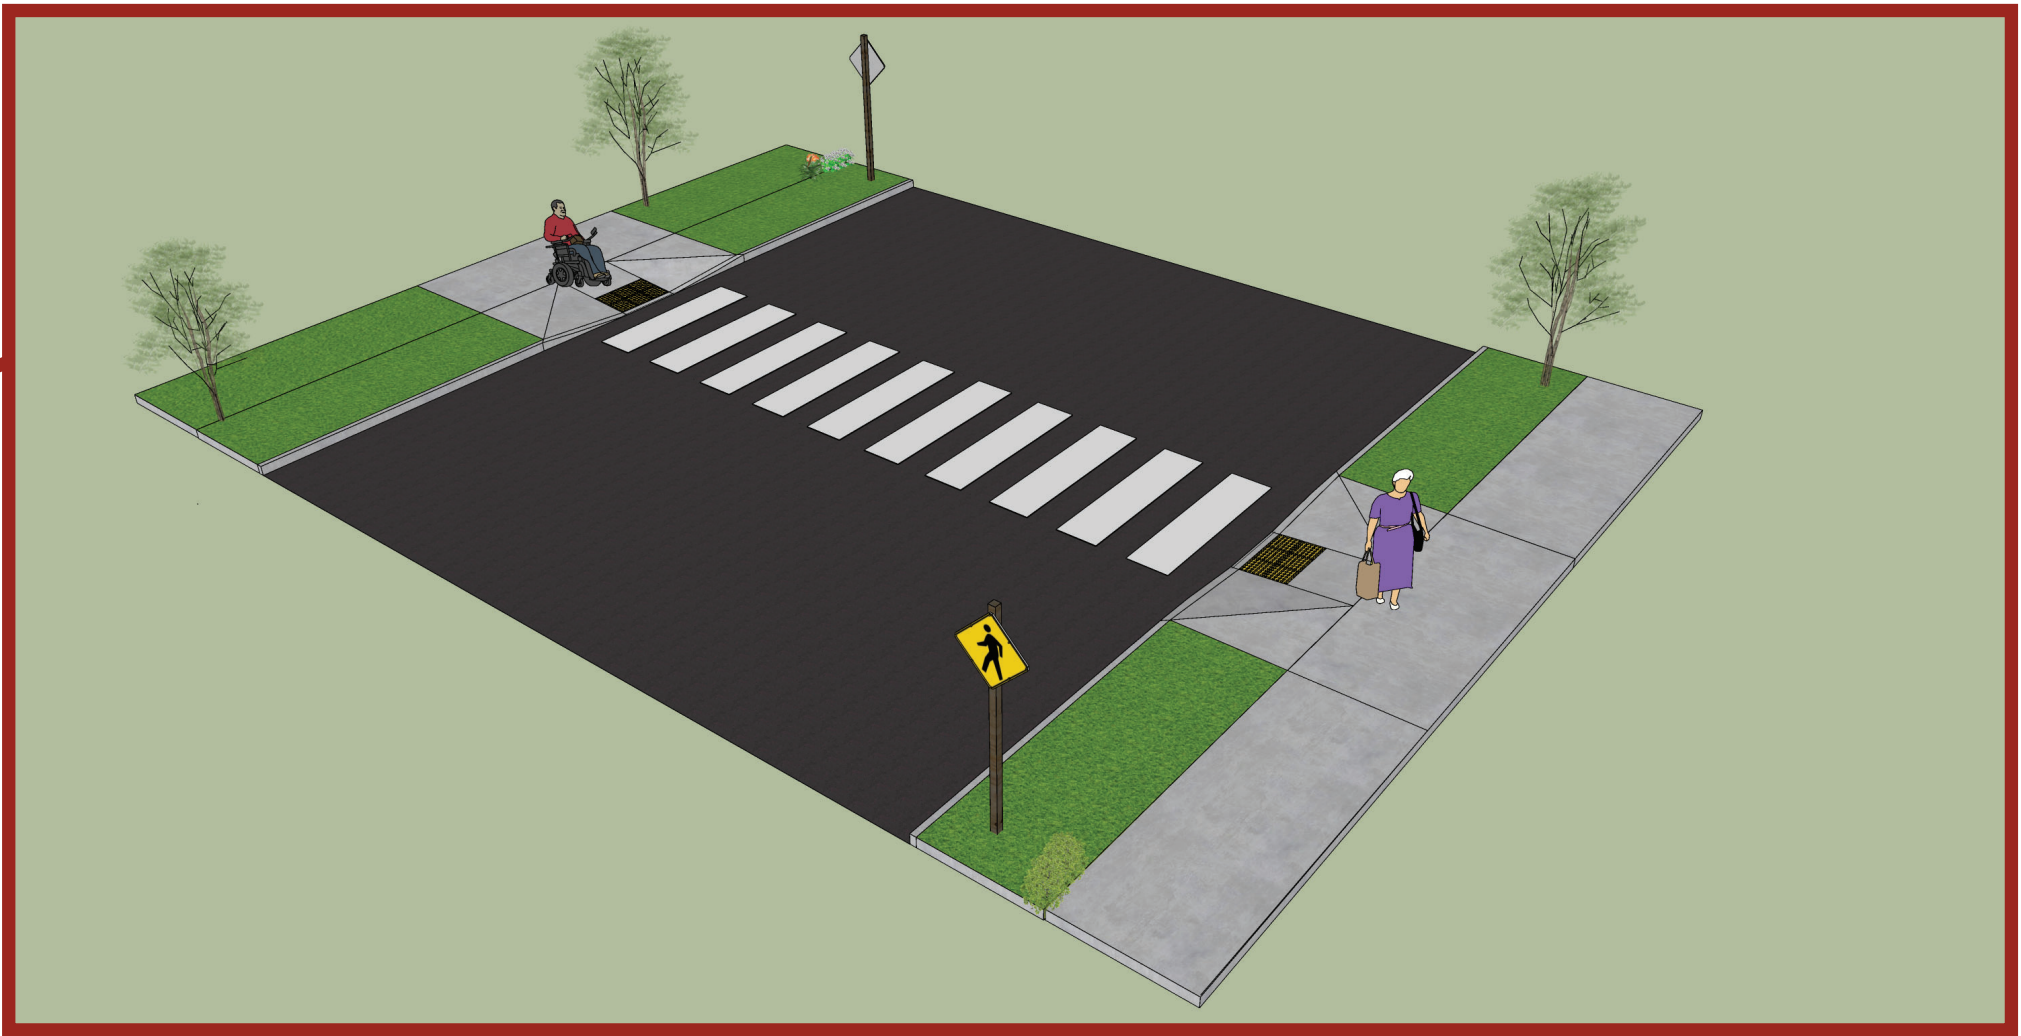
**Mid-Block Crossing
at 7th Street Place SW**

Pedestrian Crossing Signage needed at the intersection of US70 and 7th Street to warn motorists of mid-block crossing.

- » Detectable warnings present on either side of crosswalk
- » Extend curb ramps out to inside edge of the bike lanes to shorten the walking distance for pedestrians
- » High visual crosswalk to improve visibility
- » Advanced signage at intersection of US 70 warning motorists of midblock crossing
- » Rapid flashing beacon recommended

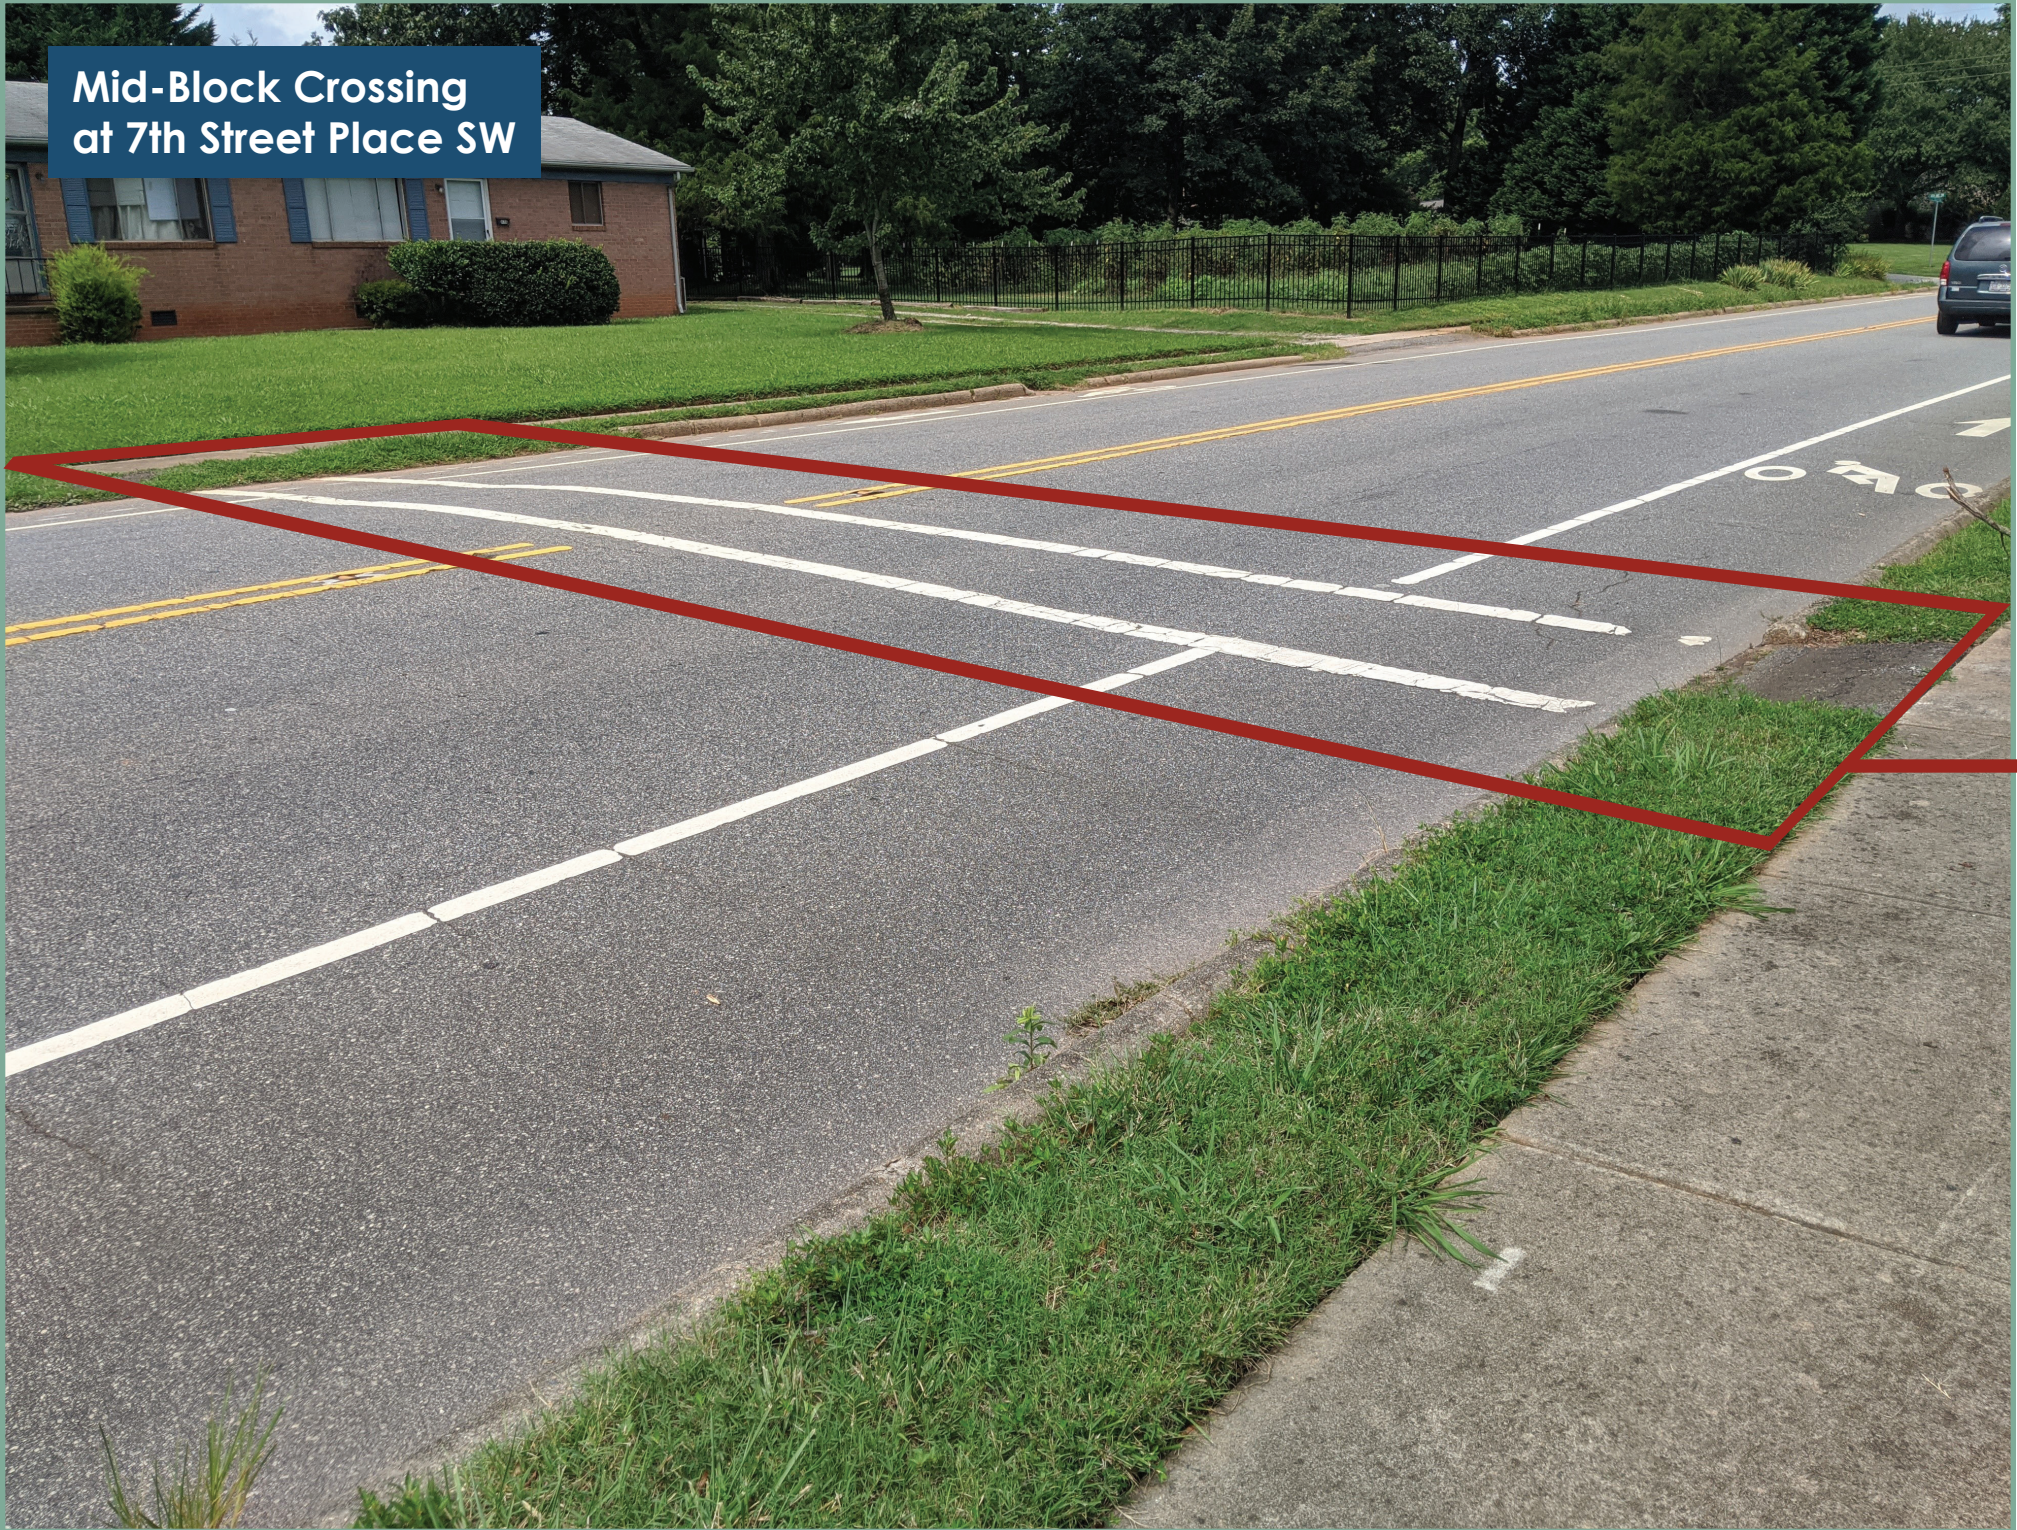
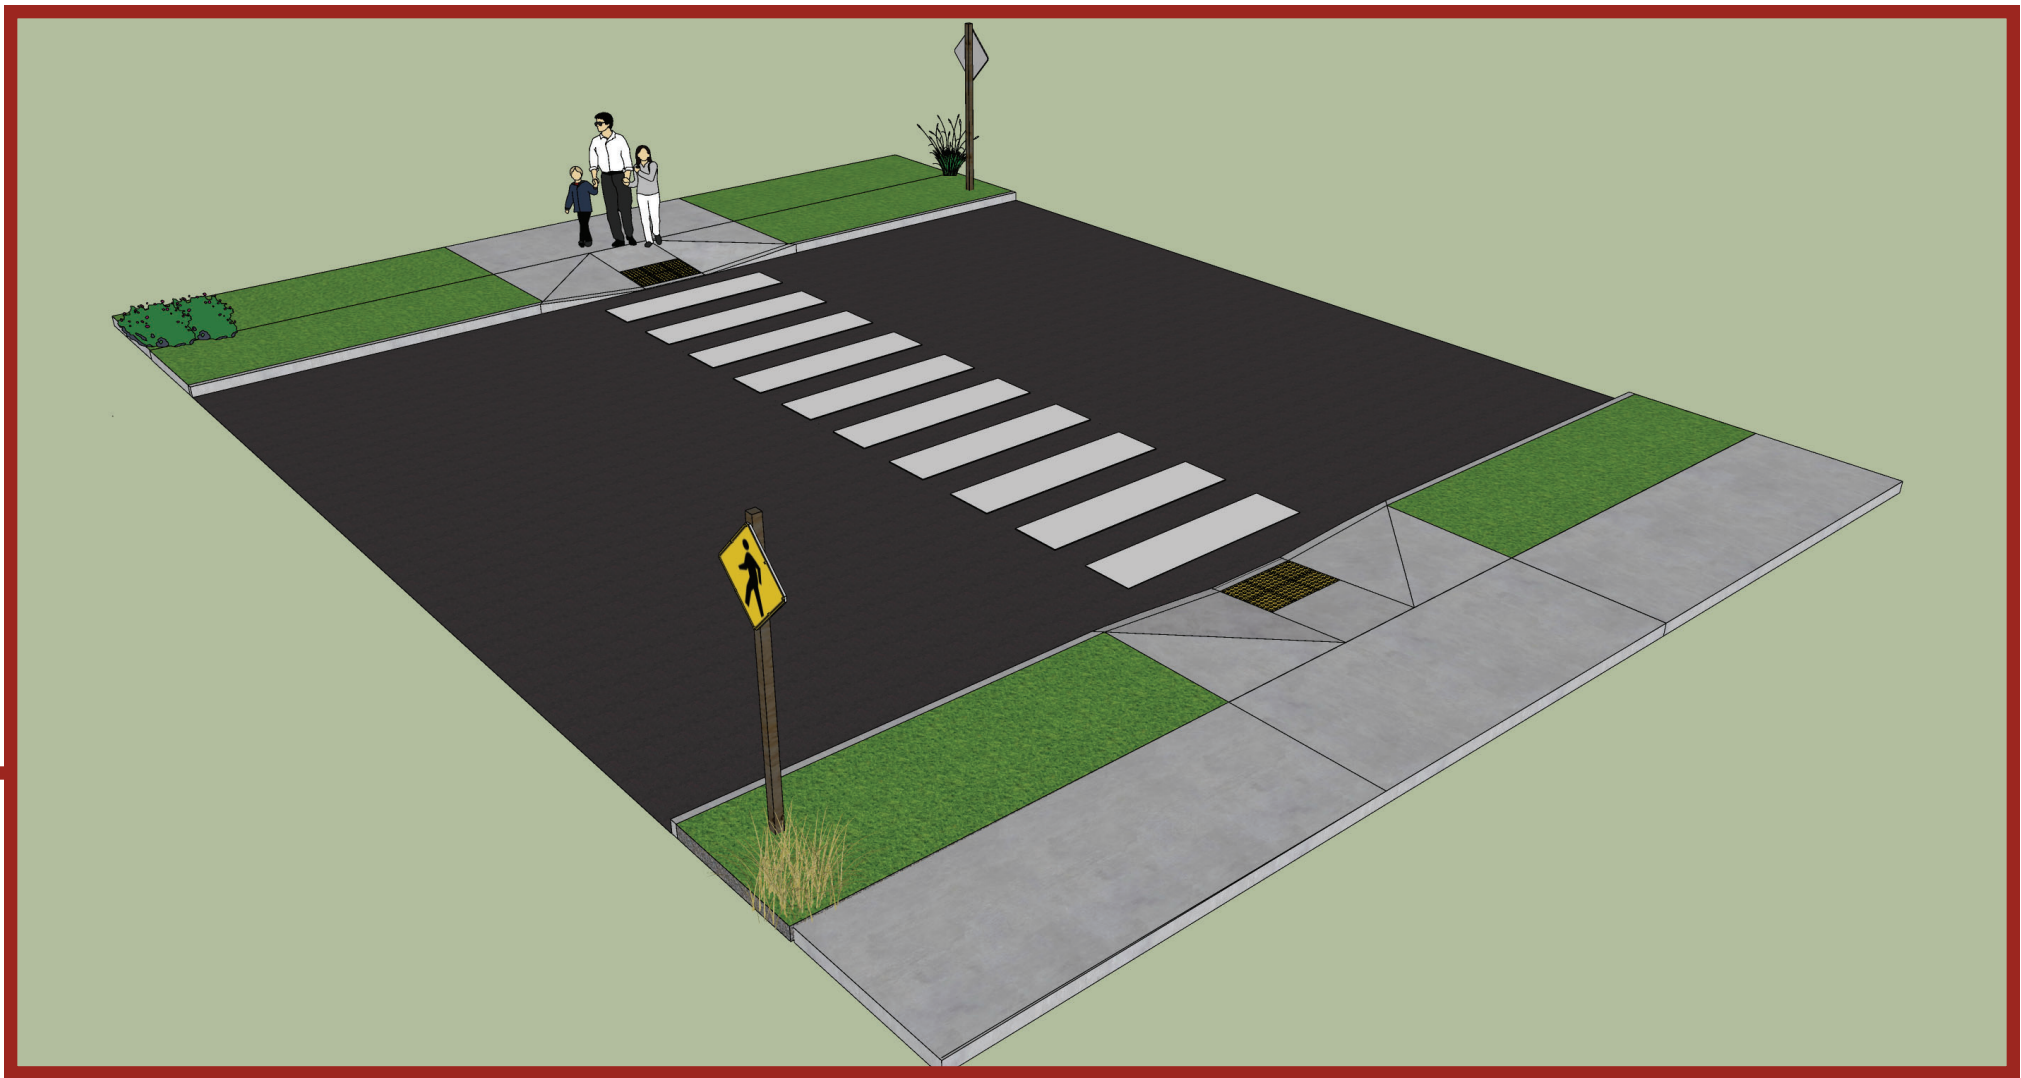
- » **Compliant curb ramps extend to the edge of the grassy area**
- » **Each curb ramp has a detectable warning**
- » **Crosswalk is high visual – must be 6-10 feet wide**
- » **Pedestrian signage**
- » **Rapid flashing beacon recommended but not required**

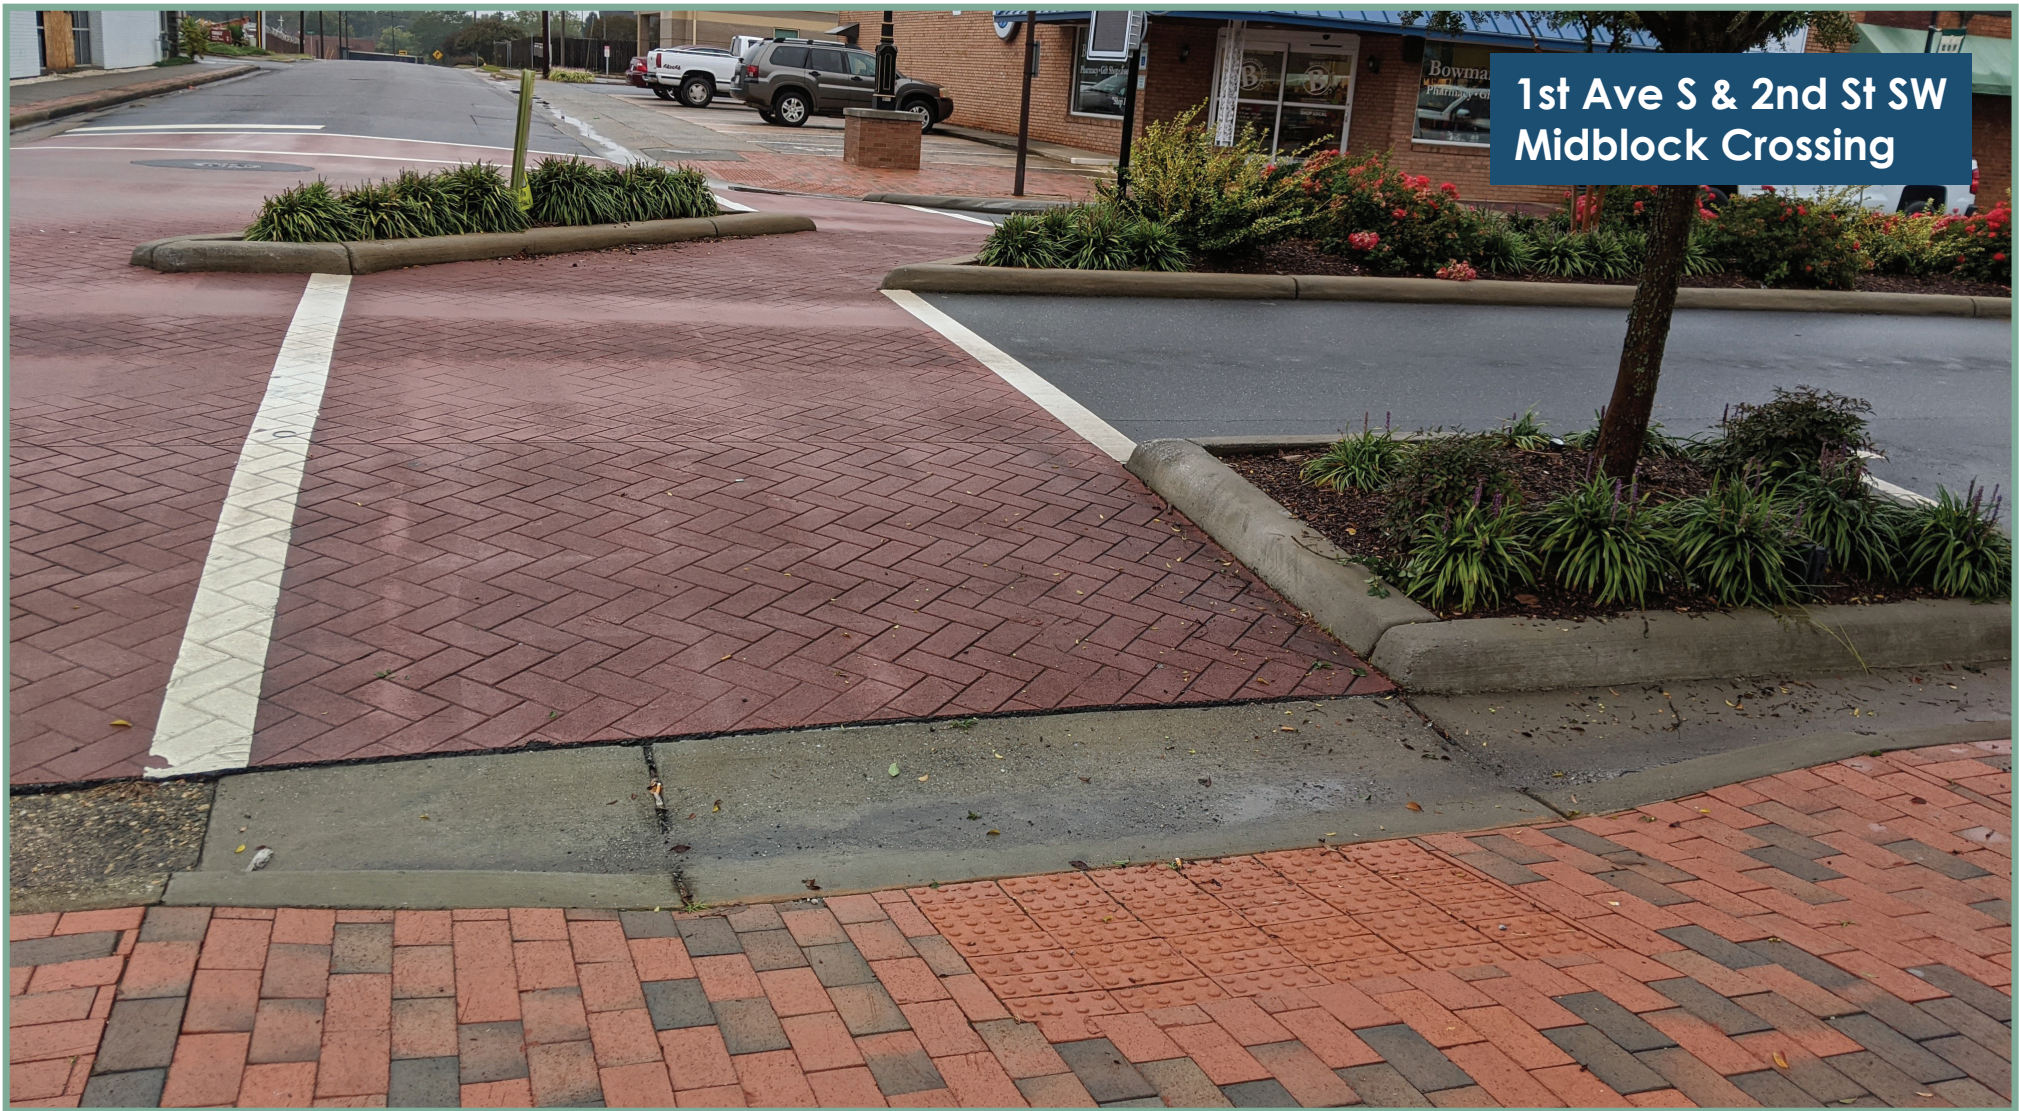
1st Ave S & 2nd St SW
Midblock Crossing

- » Needs visually contrasting detectable warnings on either side
- » Detectable warnings should cover the entire depressed section of curb
- » Compliant curb ramps provide a level resting pad
- » Strongly recommend rapid flashing beacon that alerts motorists when pedestrians are utilizing the crosswalk
- » The crosswalk should visually contrast from the surrounding pavement – the imprinted brick should only be present in the crosswalk
- » On street parking is too close to the crosswalk and blocking pedestrian visibility – see the Manual on Uniform Traffic Control Devices (MUTCD) 2009 Edition for proper distance
