City of Conover

ADA Transition Plan

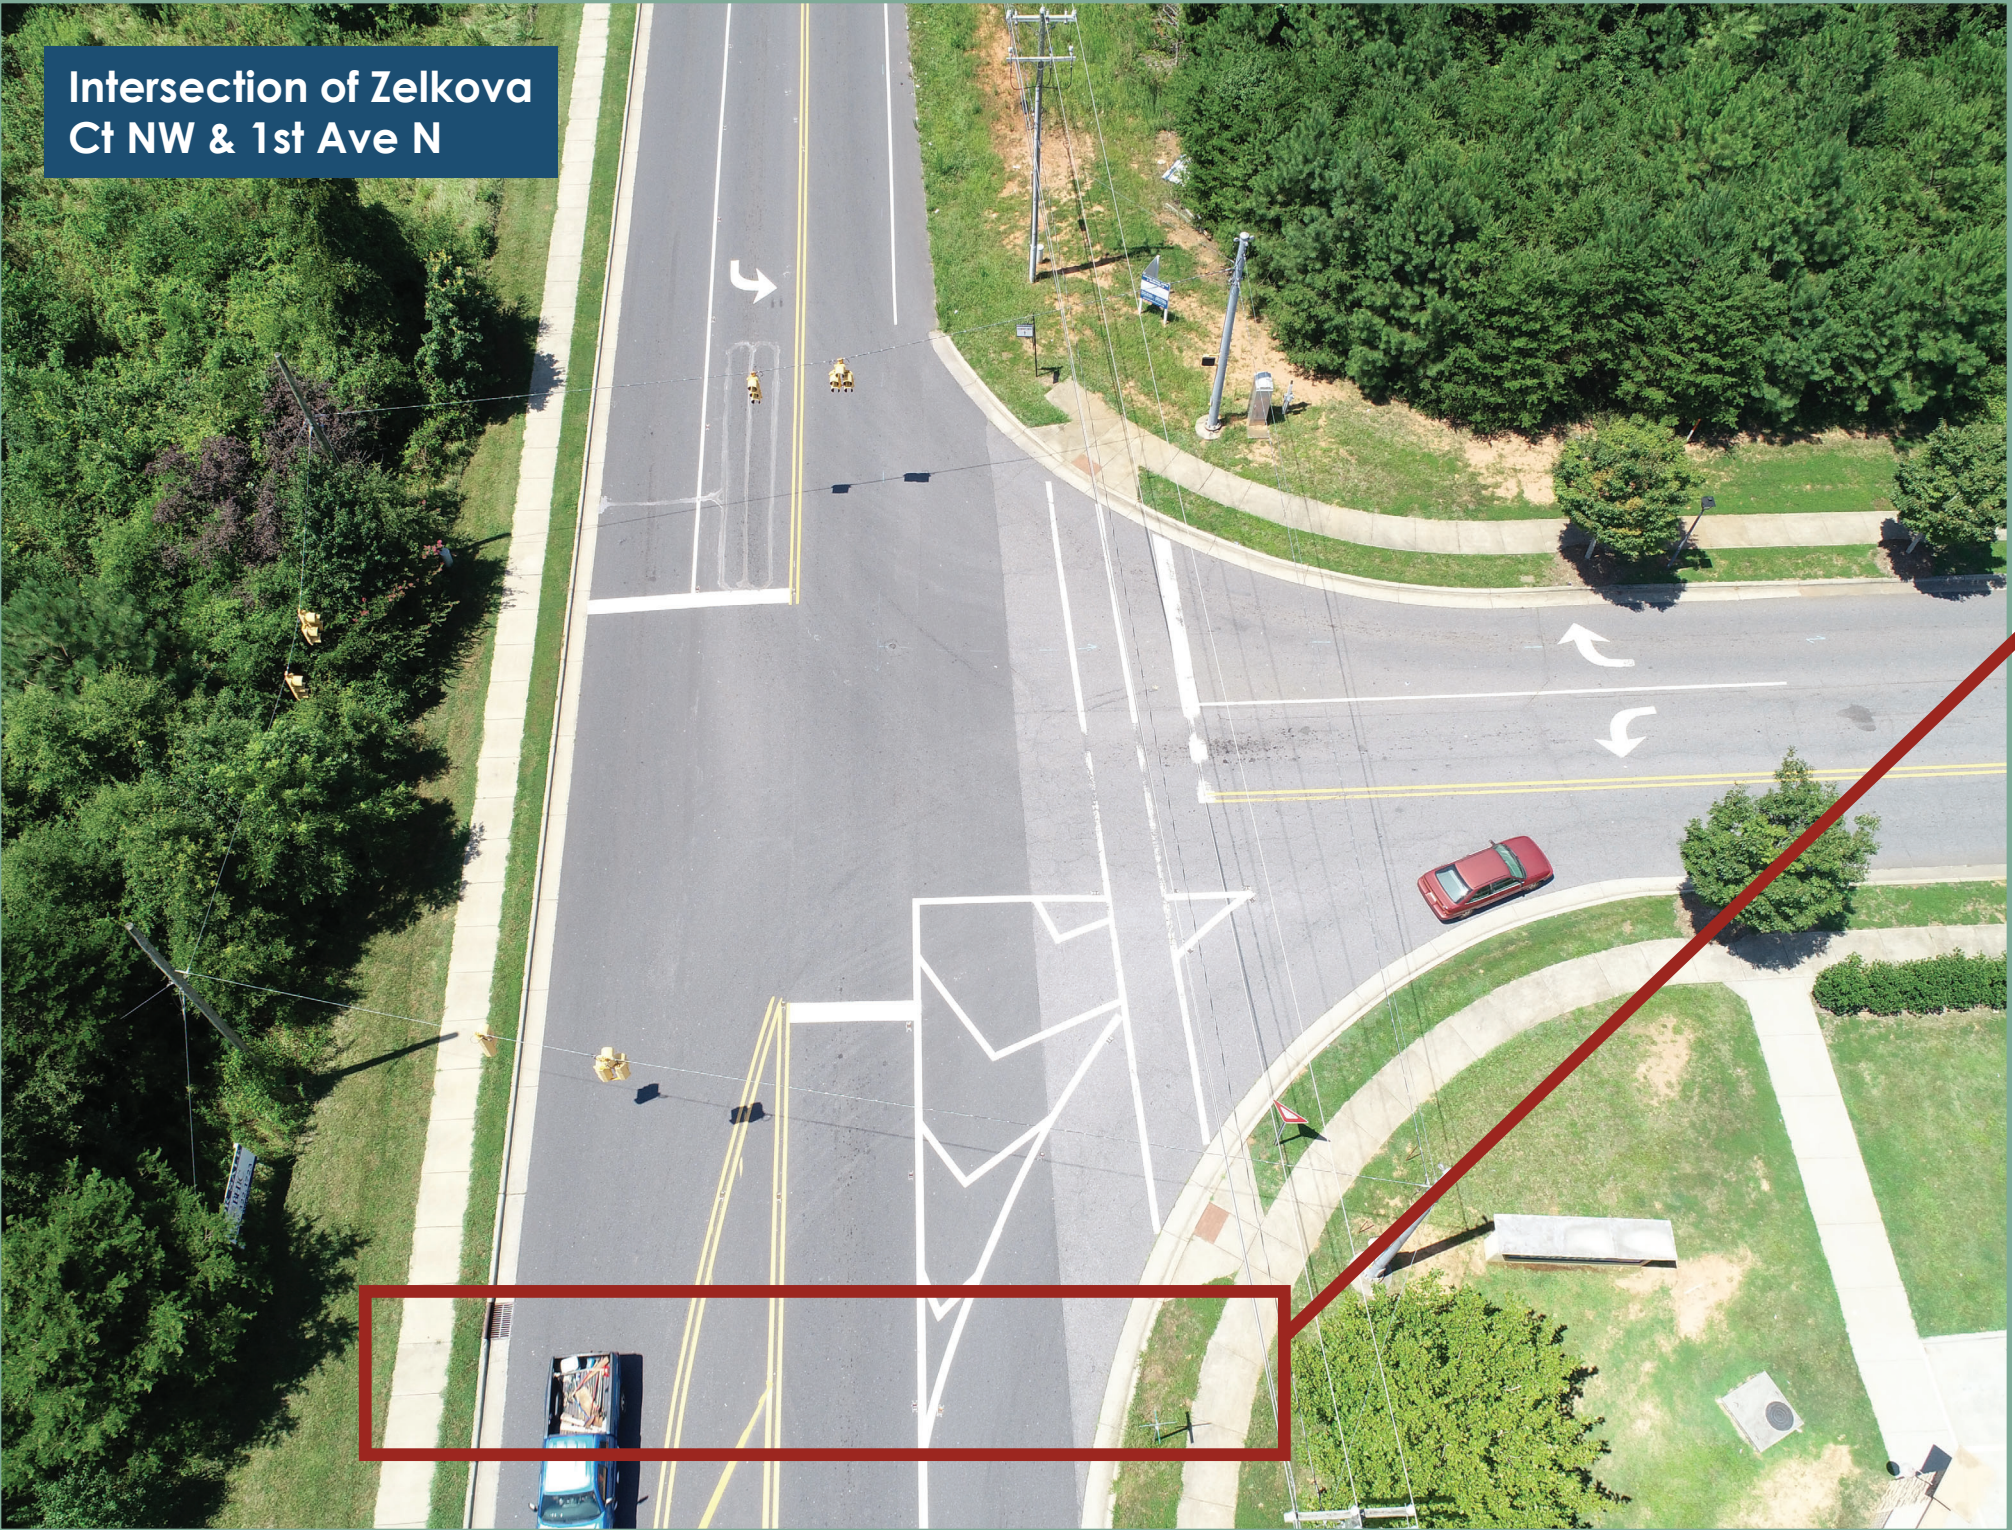
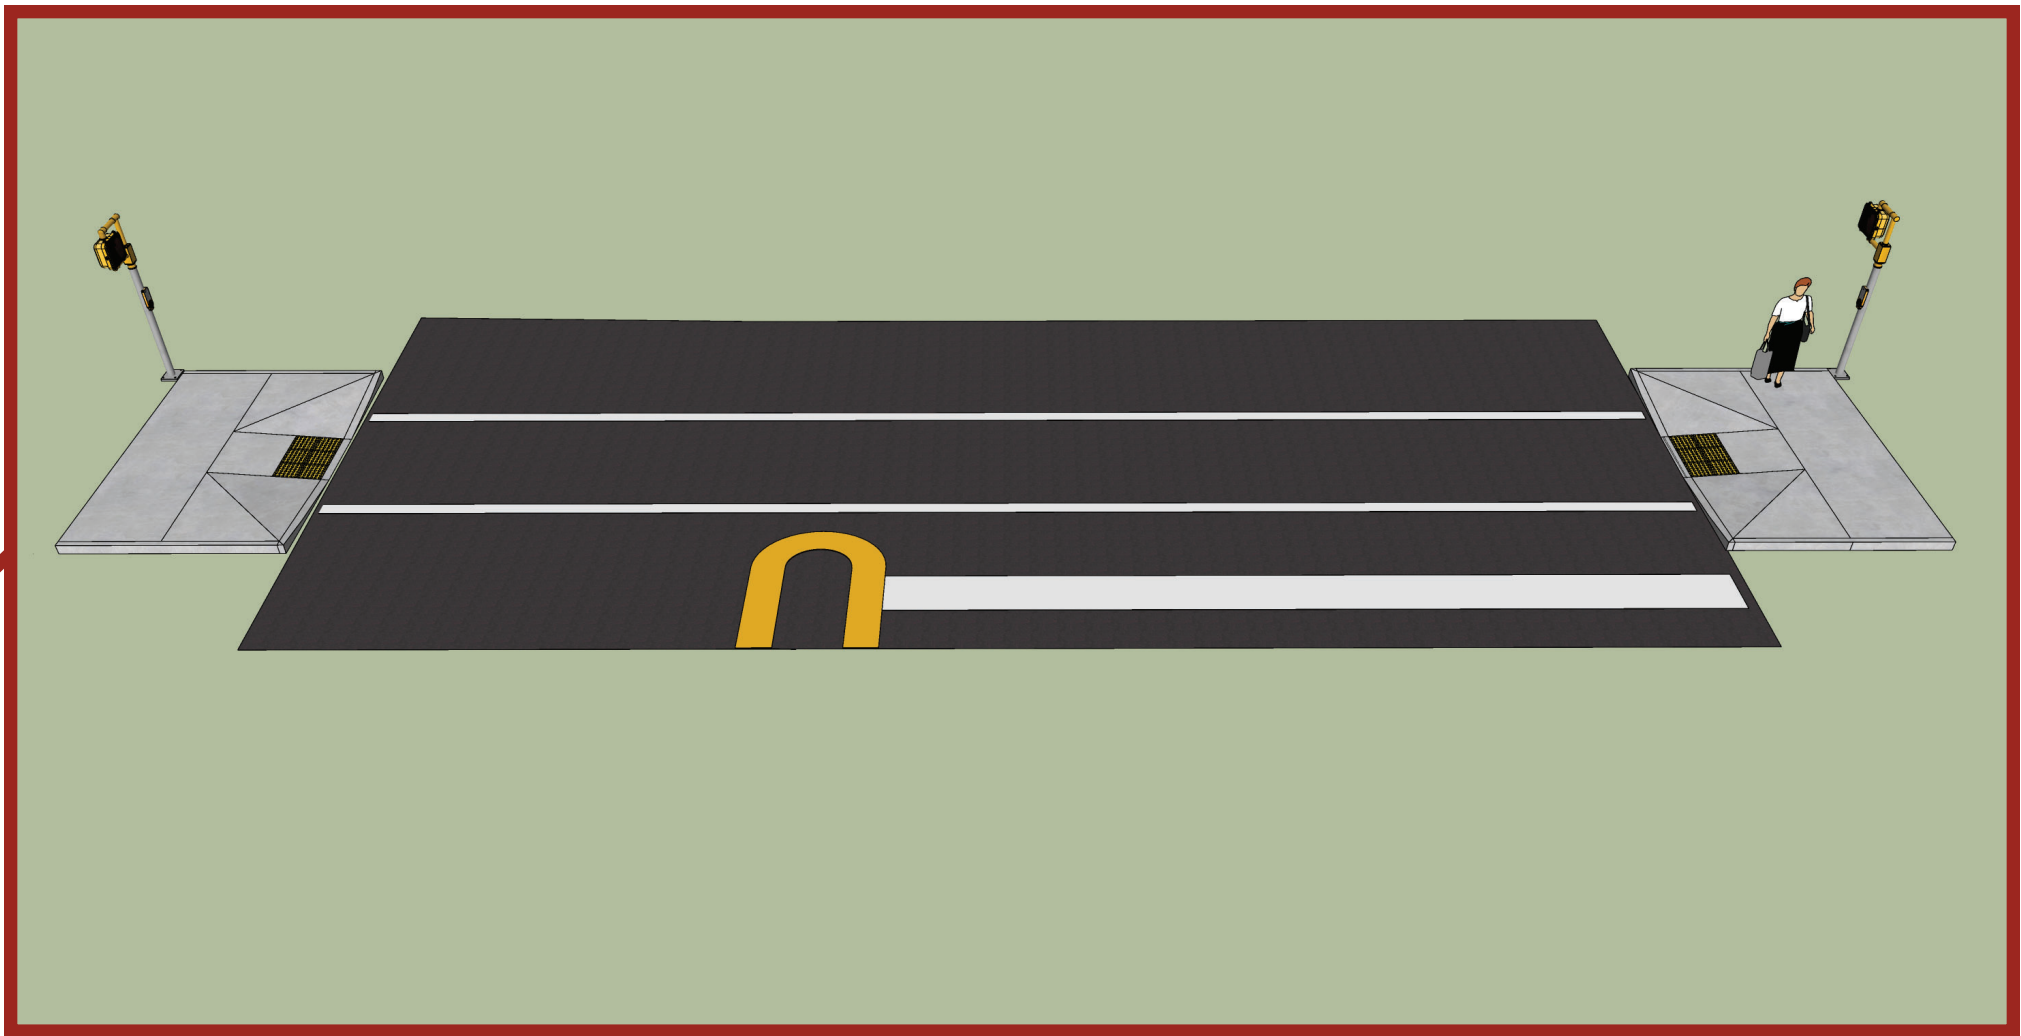
Intersection of Zelkova Ct NW & 1st Ave N

- » **Marked crosswalk added from SW-SE quadrant**
- » **Stop bar and painted medians moved 4 feet behind crosswalk**
- » **Separate curb ramp (with detectable warning) recommended but not required in SE quadrant**
- » **SW quadrant has curb ramp with detectable warning**
- » **Pedestrian signals for new crossing**
- » **Evaluate green times for traffic signals to ensure all pedestrians have sufficient crossing time**
