Executive Summary

The Western Piedmont Council of Governments (WPCOG) prepared this ADA Transition Plan on behalf of WPRTA to evaluate the full system of 346 bus stops and determine their compliance with ADA design standards. The plan identifies and documents accessibility

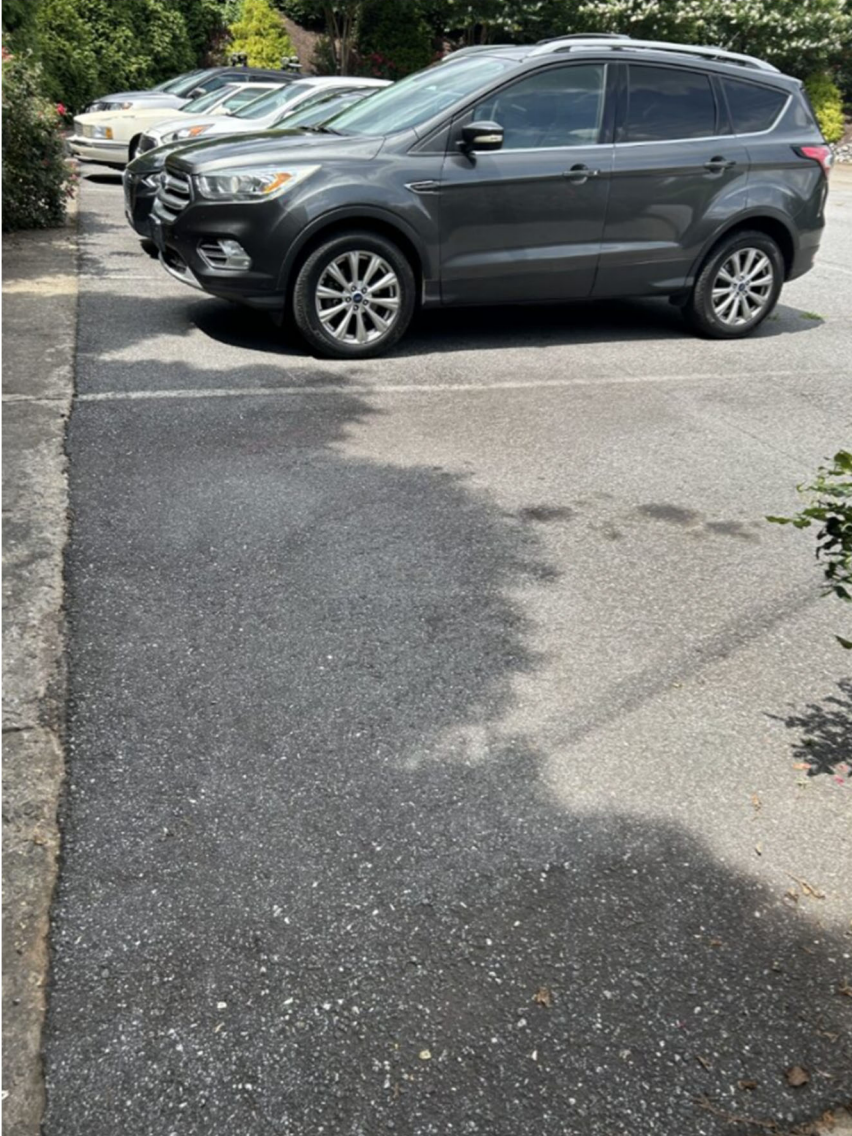
No accessible parking is provided. Because the facility must provide accessible parking proportional to its total number of spaces, this is non-compliant. Accessible spaces should be located as closely to the accessible entrance as possible. (high priority)

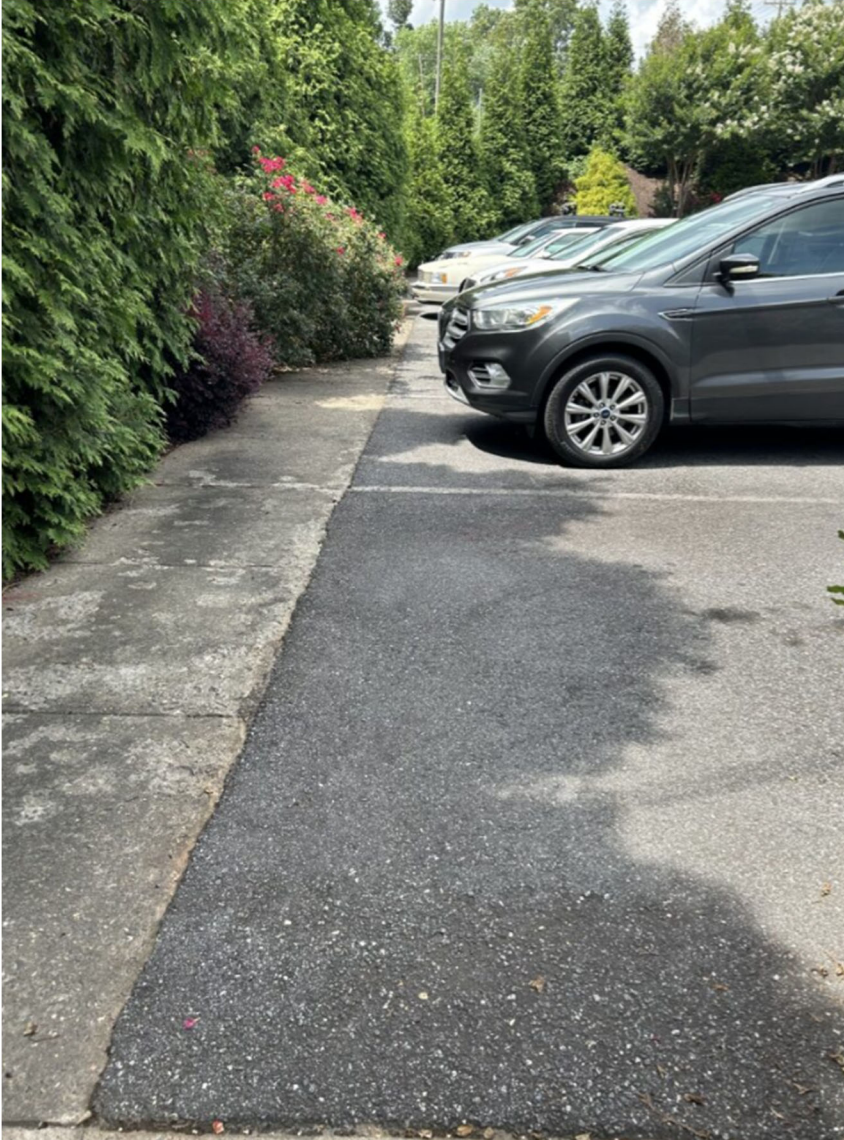
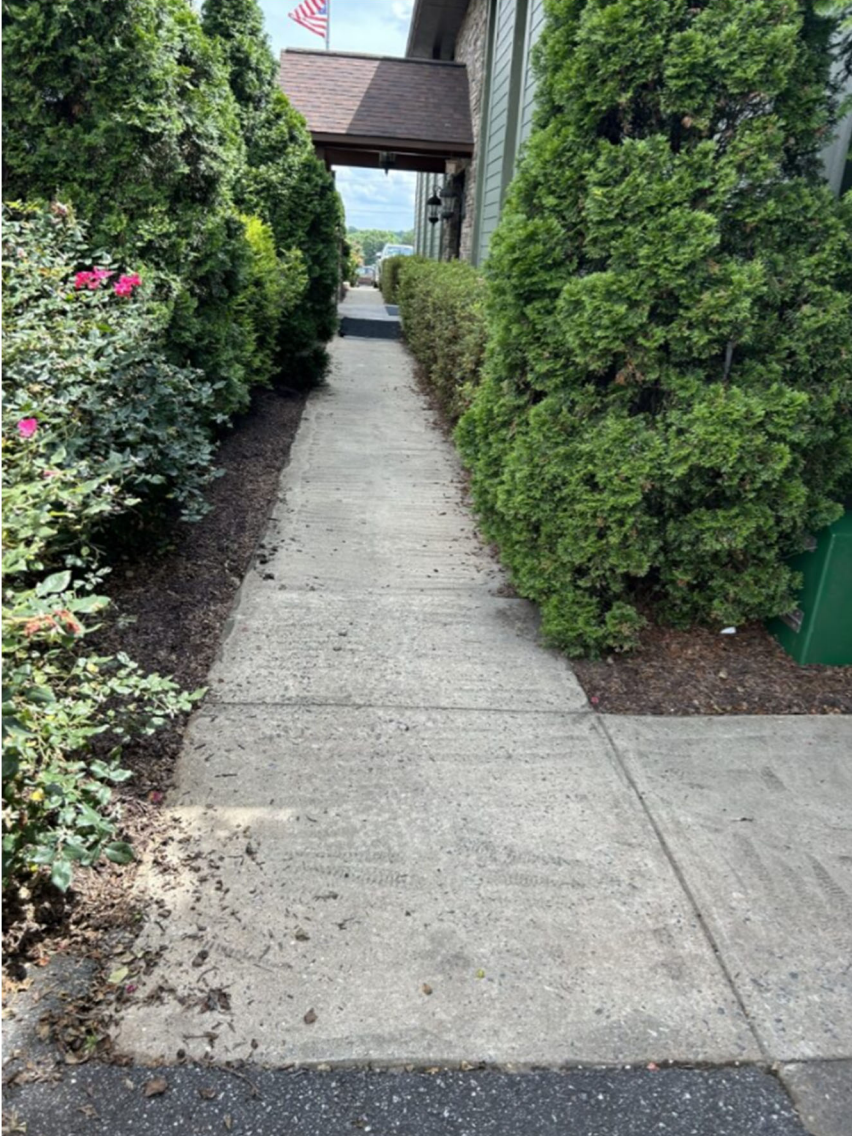
The accessible route at the entrance of the building is compliant. It should, however, connect to the striped access aisle of an accessible parking space once accessible parking is designated. It also should be free of shrubbery and other obstructions. (high priority)

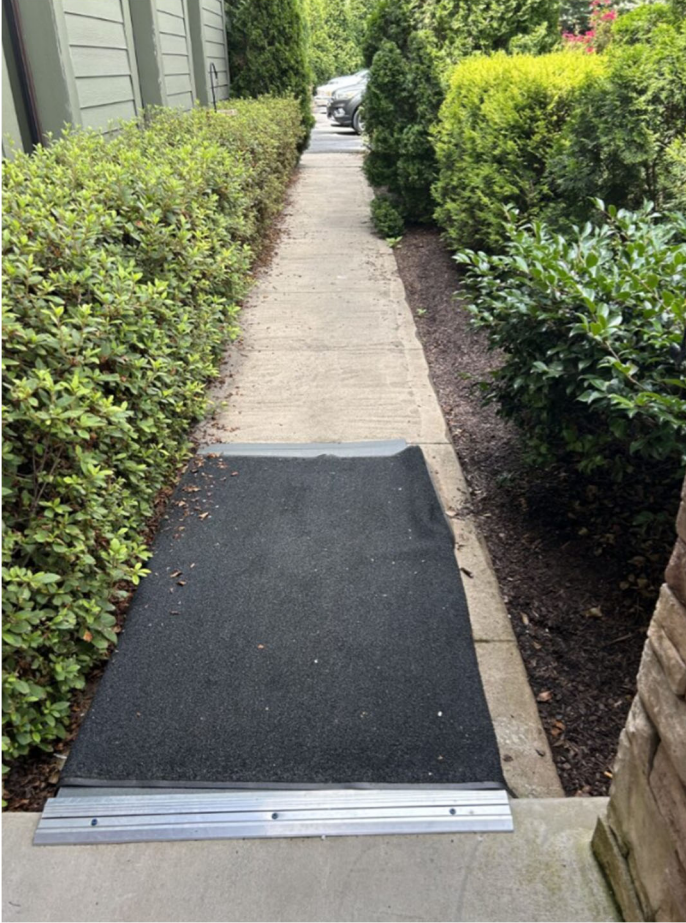
Entrance Ramp:

Ramp does not span the full width of the walkway and could become a slip hazard. The ramp is 36" wide, however, it does not have edge protection. (high priority)

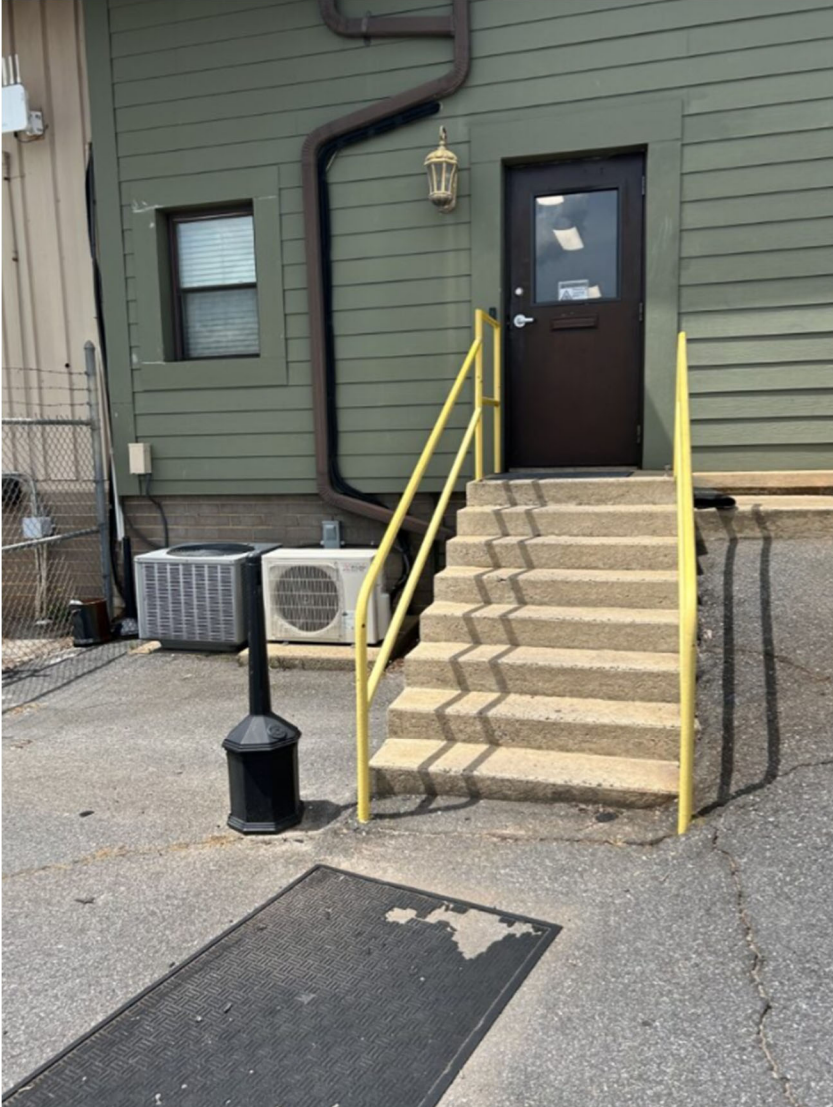
Rear Exit:

Exit includes only stairs. (high priority)

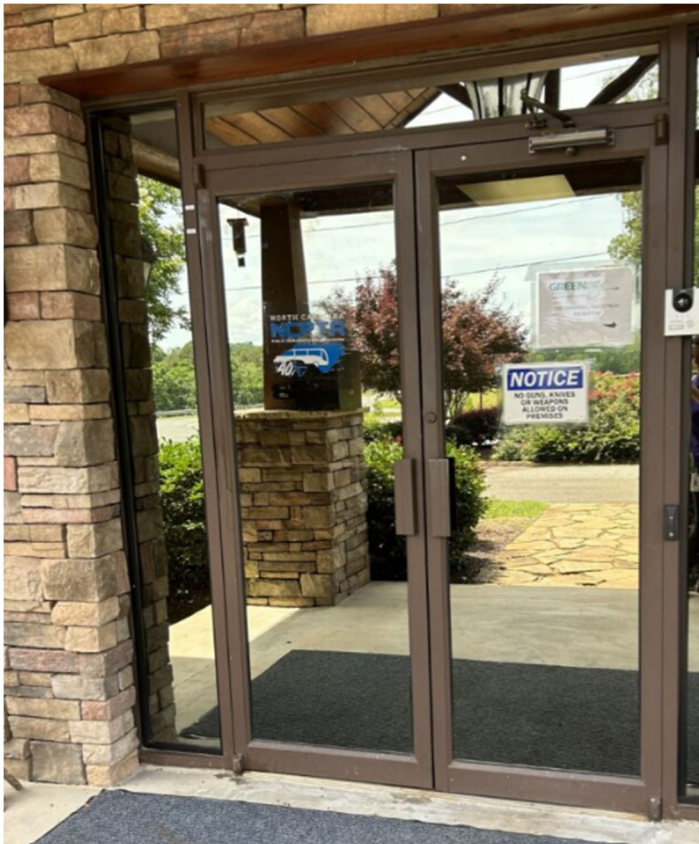
Closure Time: 6.15 seconds (compliant)

These values are significantly above typical accessible thresholds, making the doors difficult to operate.

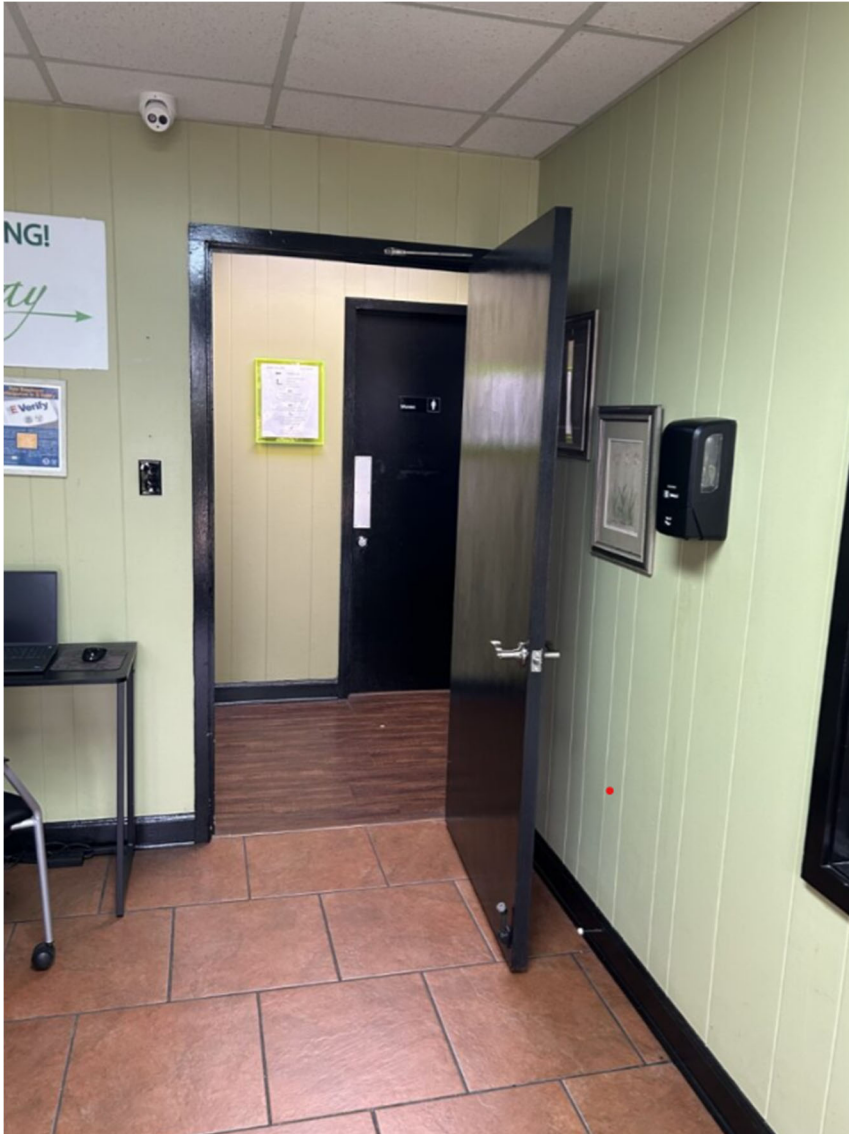
Door from Lobby into Main Building

- Pull: 4 pounds of pressure (**compliant**)
- Push: 4 pounds of pressure (**compliant**)
- Closure Time: 3.1 seconds (**high**)
- Help desk at 29": Within 28–34" standard counter height range (**compliant**)

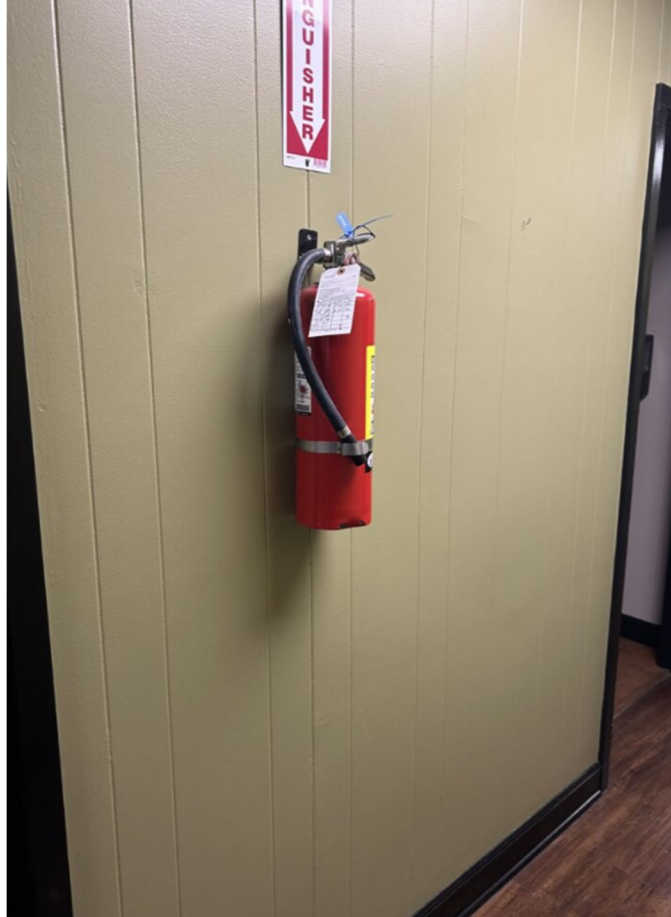
- No sign in Braille at fire extinguisher? There is signage for the extinguisher, however, it does not include Braille. **High priority**
- Hand sanitation station mounted 47.5" from the floor (**compliant**)
- Light switch in hallway mounted 51" from the floor (**low priority**)
- Fire extinguisher height is 62" to handle. **High priority**

- The operable part (handle) of a fire extinguisher must be within reach ranges, generally **no higher than 48 inches** for unobstructed forward/side reaches (15-48" AFF), but lower to **44-46 inches** if reaching over an obstruction, with the bottom at least 15 inches up. For heavier extinguishers (over 40 lbs), the top is limited to 42 inches (3.5 ft) high, with the base at least 4 inches off the floor.

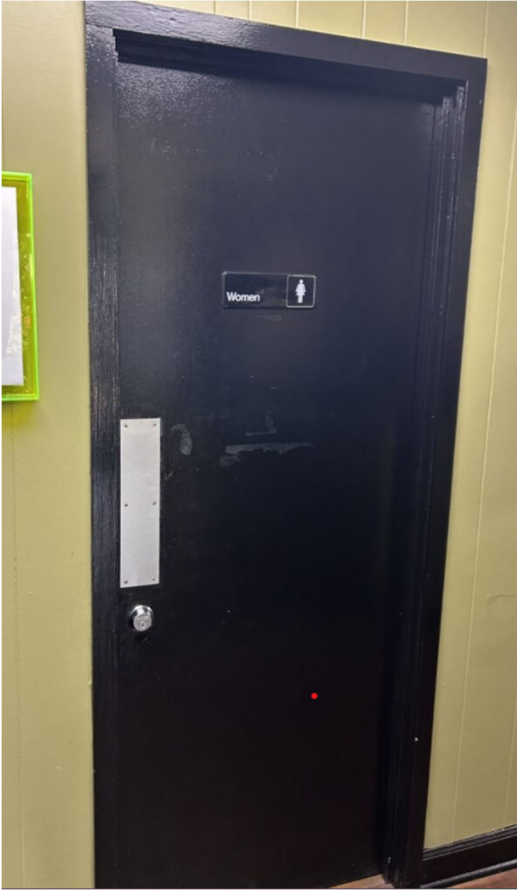
Restroom signs must include tactile characters, Braille, and be mounted on the latch side at 48–60 inches above the floor. Currently the signage is not in Braille and located on the door of the restroom. (moderate priority)

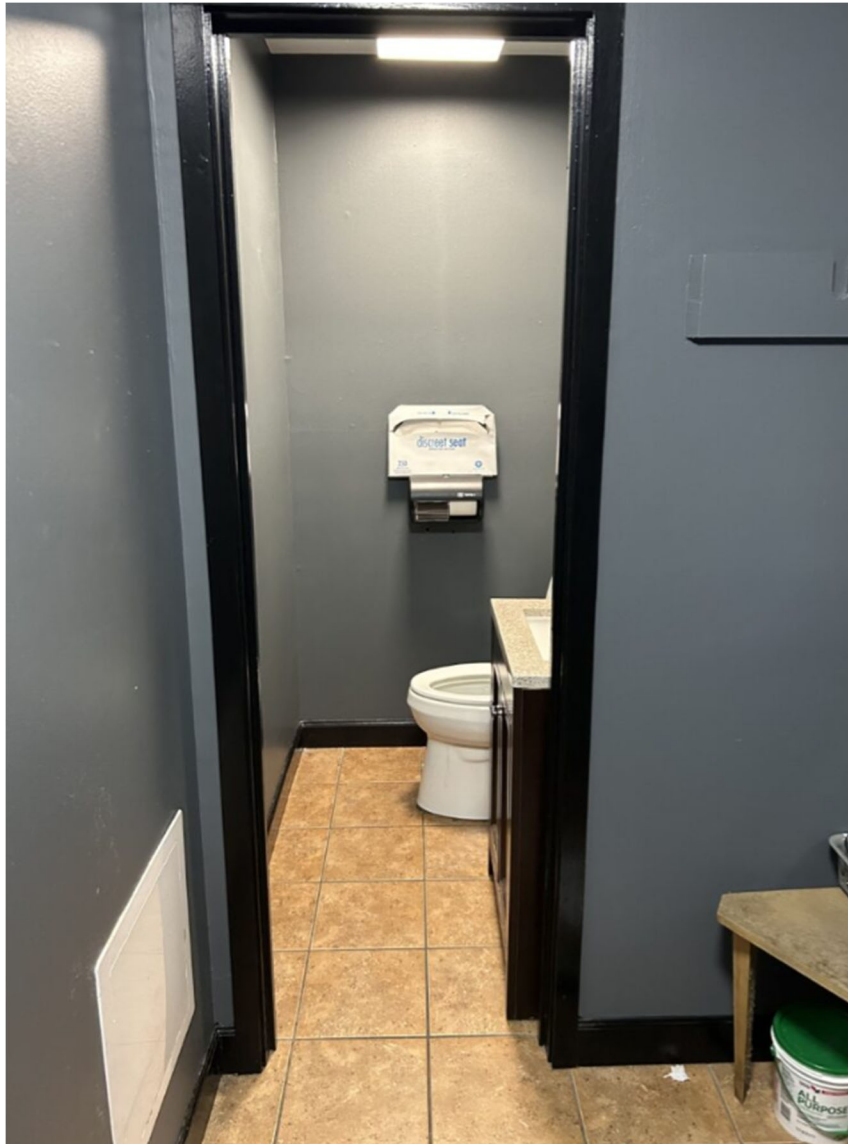
- The hallway in the restroom is 35" wide. This hallway, however, narrows at the doorframe to 21" when entering/exiting the room. **High priority – this deals directly with access**

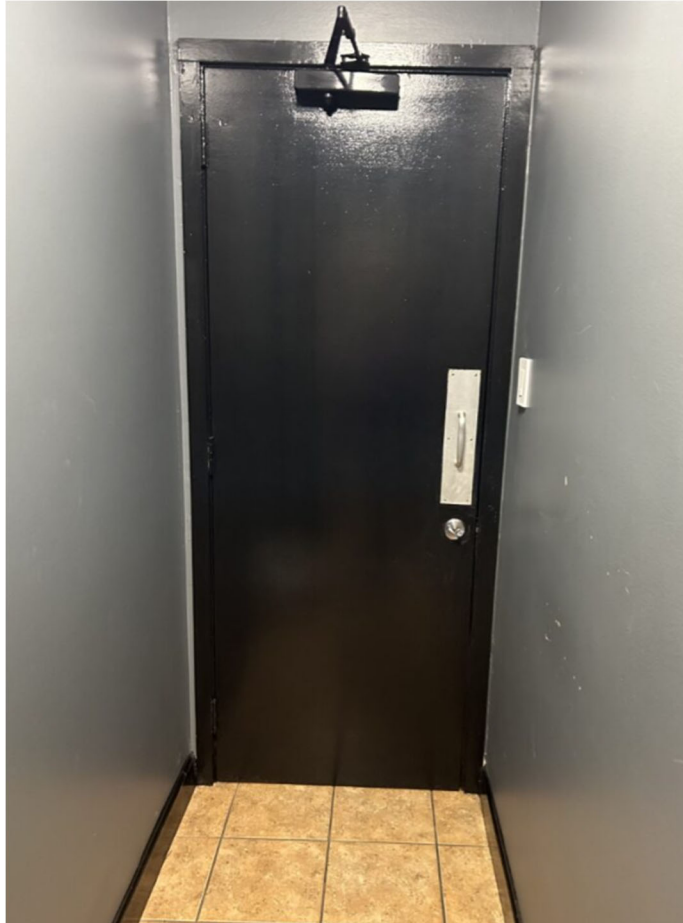
- Doorway width into the overall restroom: 29" – **high priority – this deals directly with access**

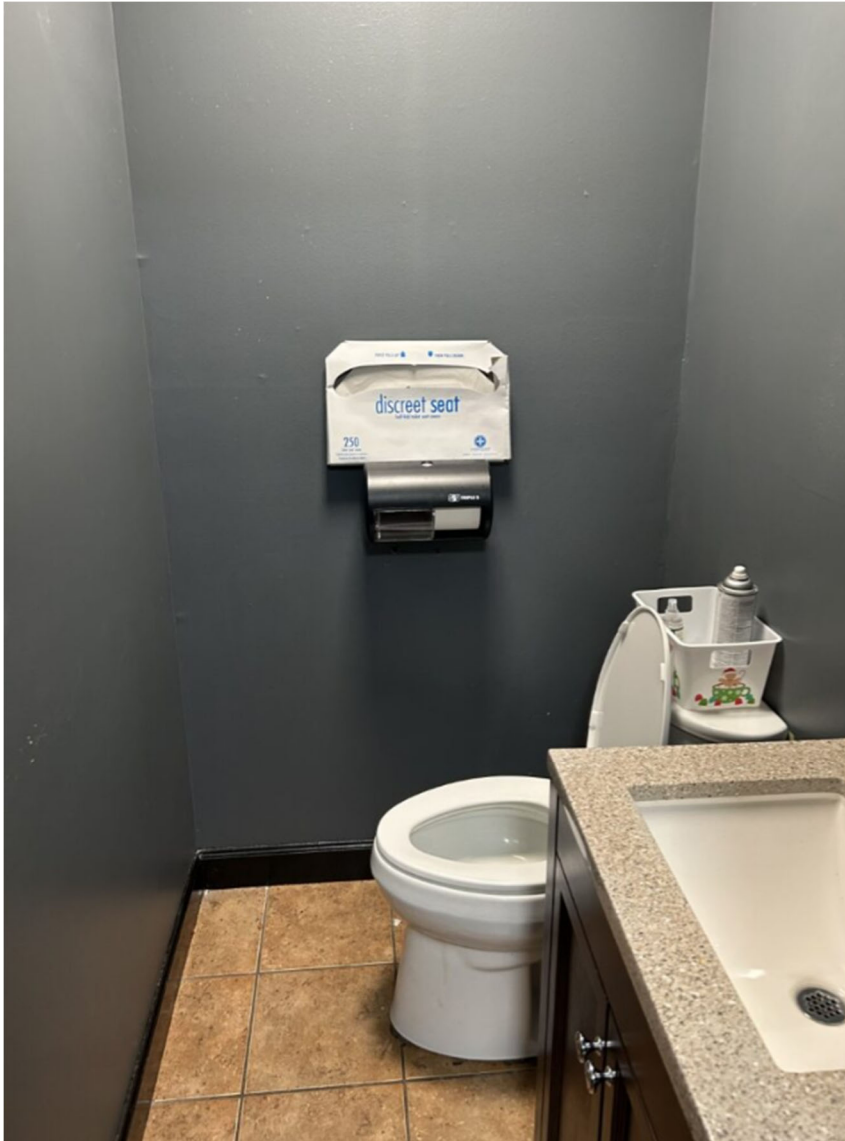
- No grab bars installed **high priority**
- ADA Standards require an open side of the toilet where the flush handle is located. The current flusher is not located on the open (accessible) side **moderate priority**
 - The toilet paper dispenser is 37" high and located directly next to the toilet. The toilet seat covers are located above the toilet paper dispenser. **Low priority**

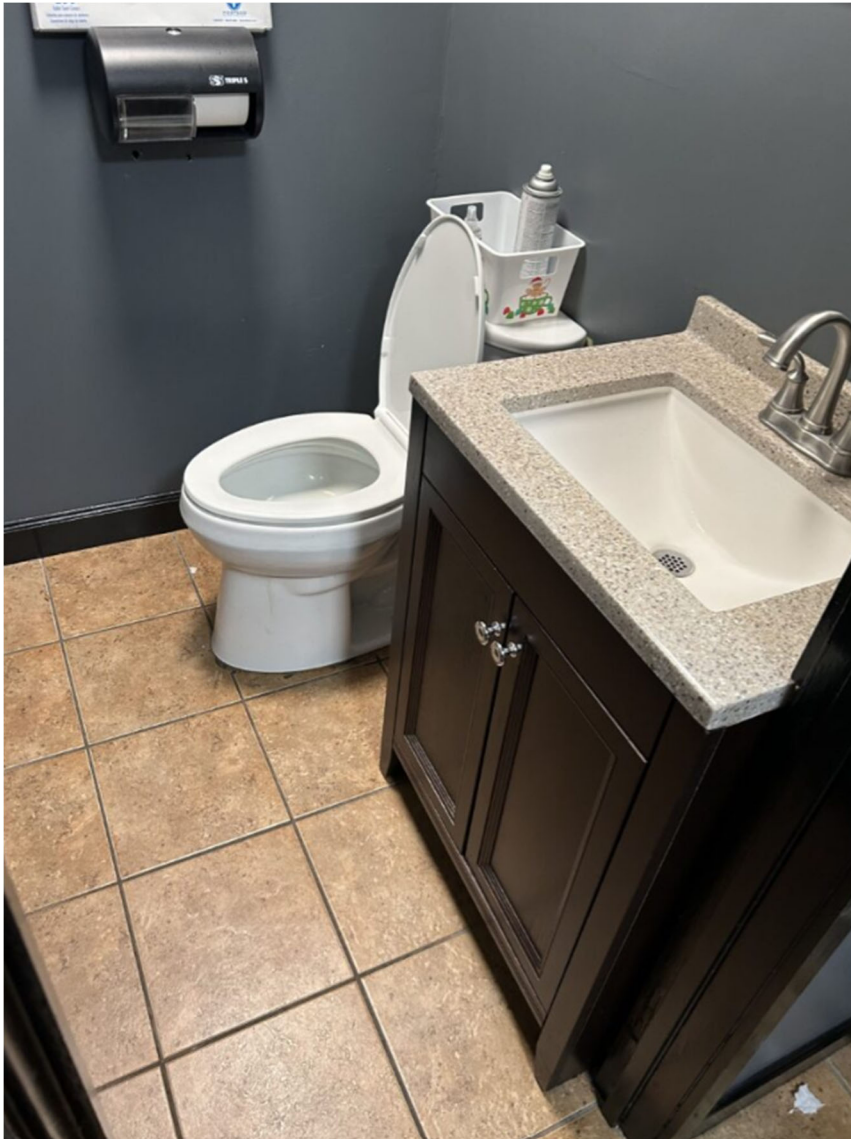
Sink has no knee clearance → moderate priority

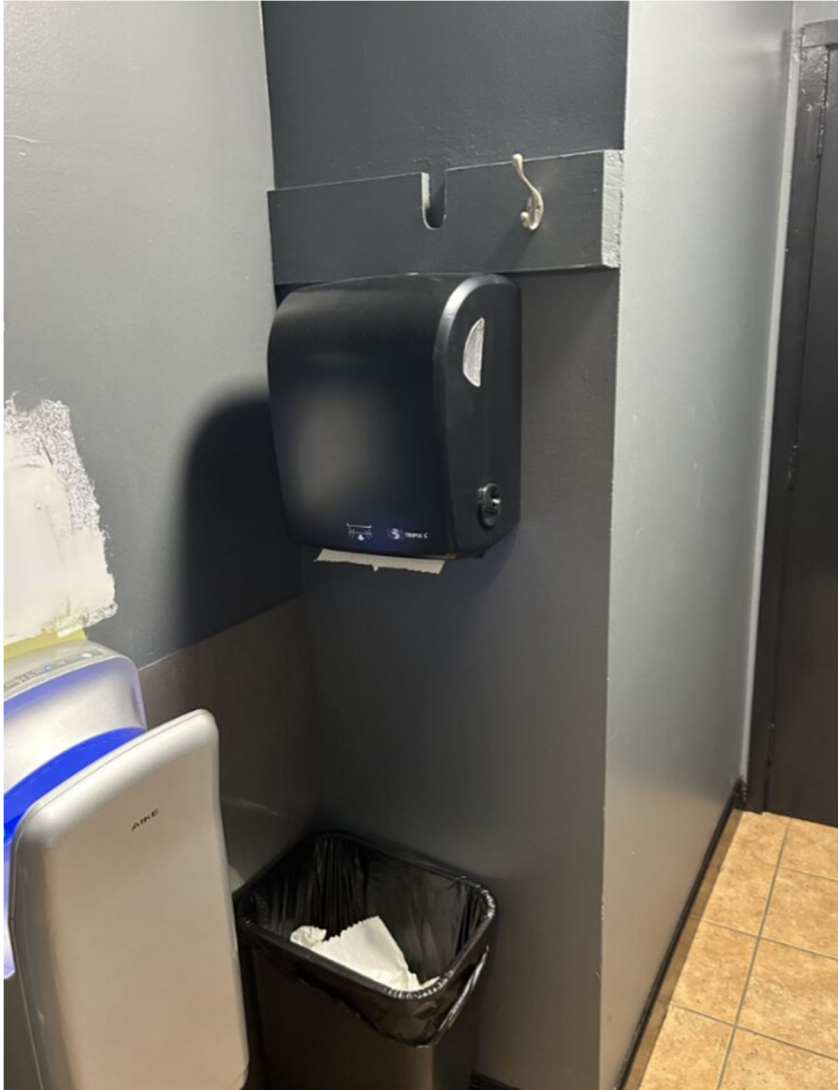
- Mirror at 51.5" → moderate priority
- Coat hook at 62.5" → high priority – While coat hooks are not required, the current hook is mounted at a height that could be a safety concern for some users.

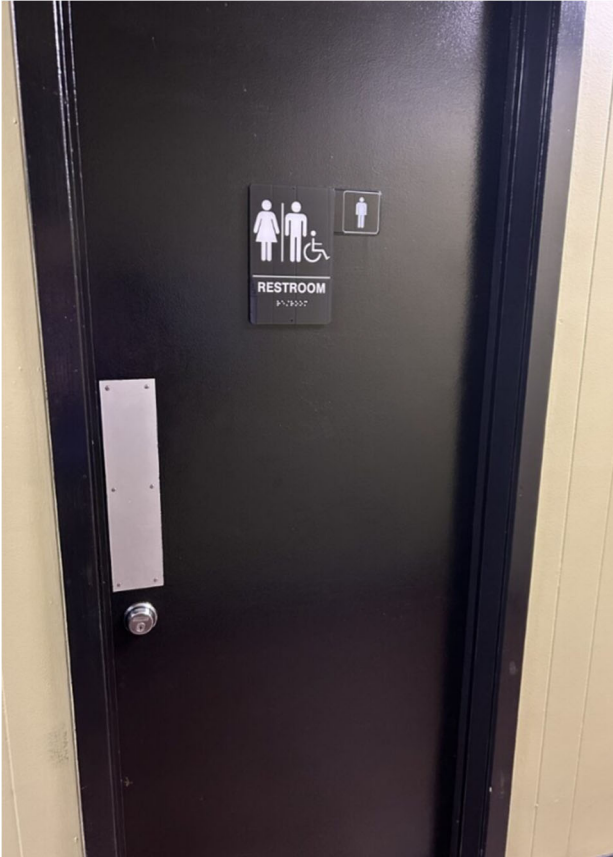
Current placement on the door is non-compliant. Moderate priority

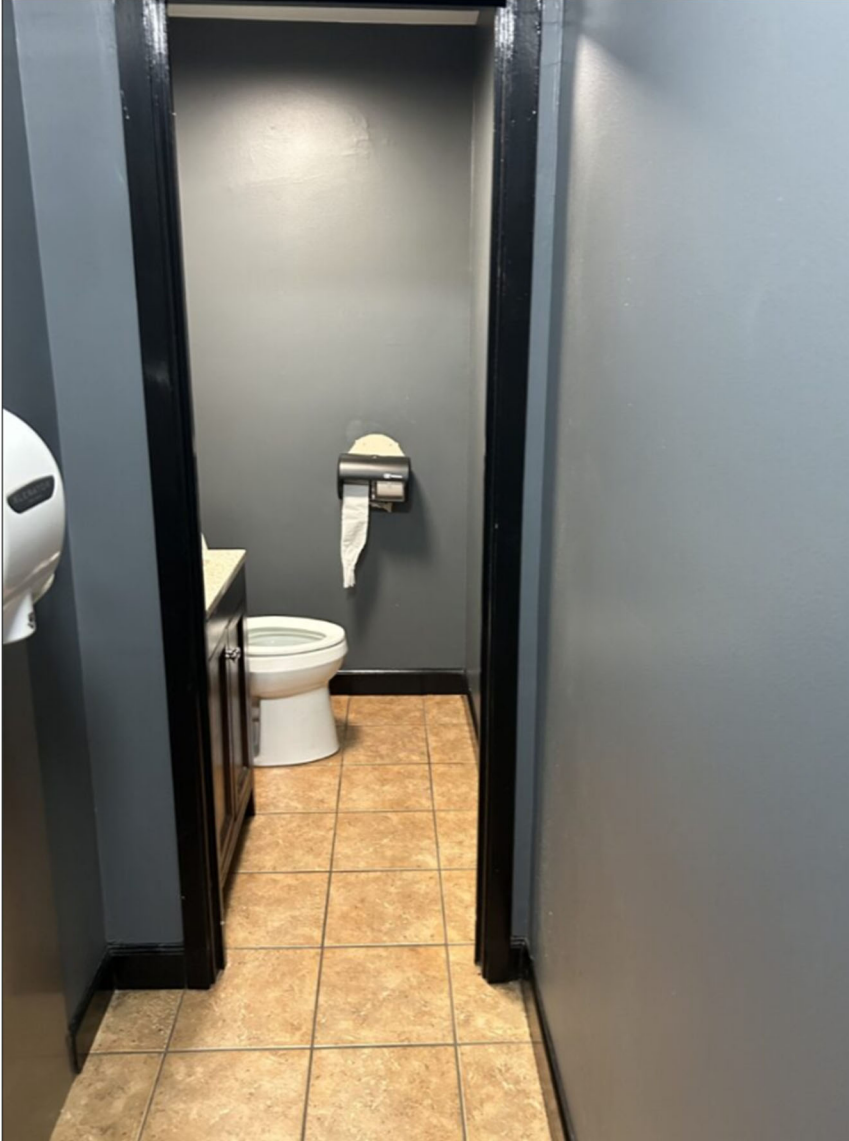
Toilet room entrance at 23" wide → **high priority**

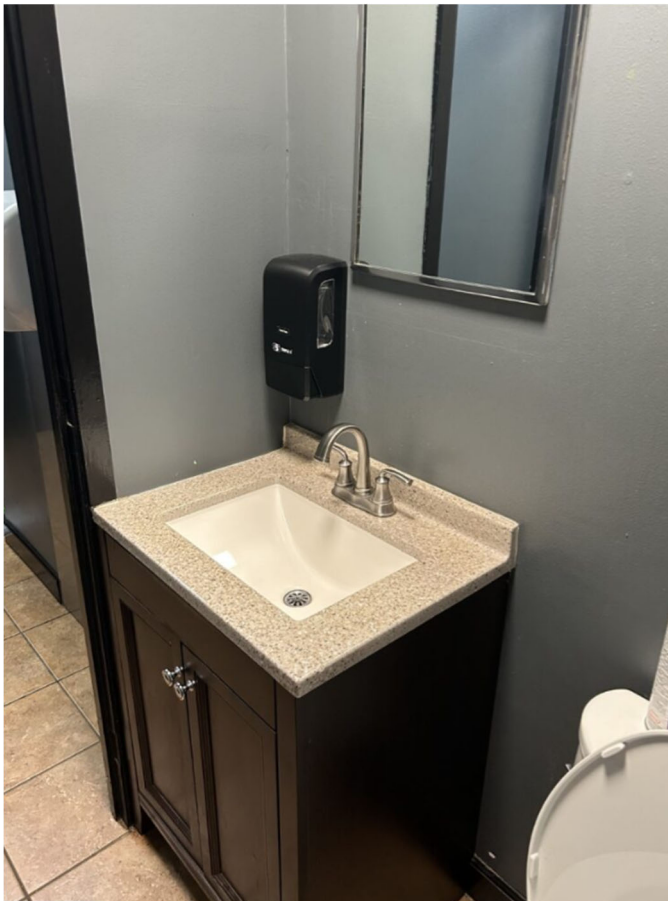
Cabinetry blocks access → **moderate priority**

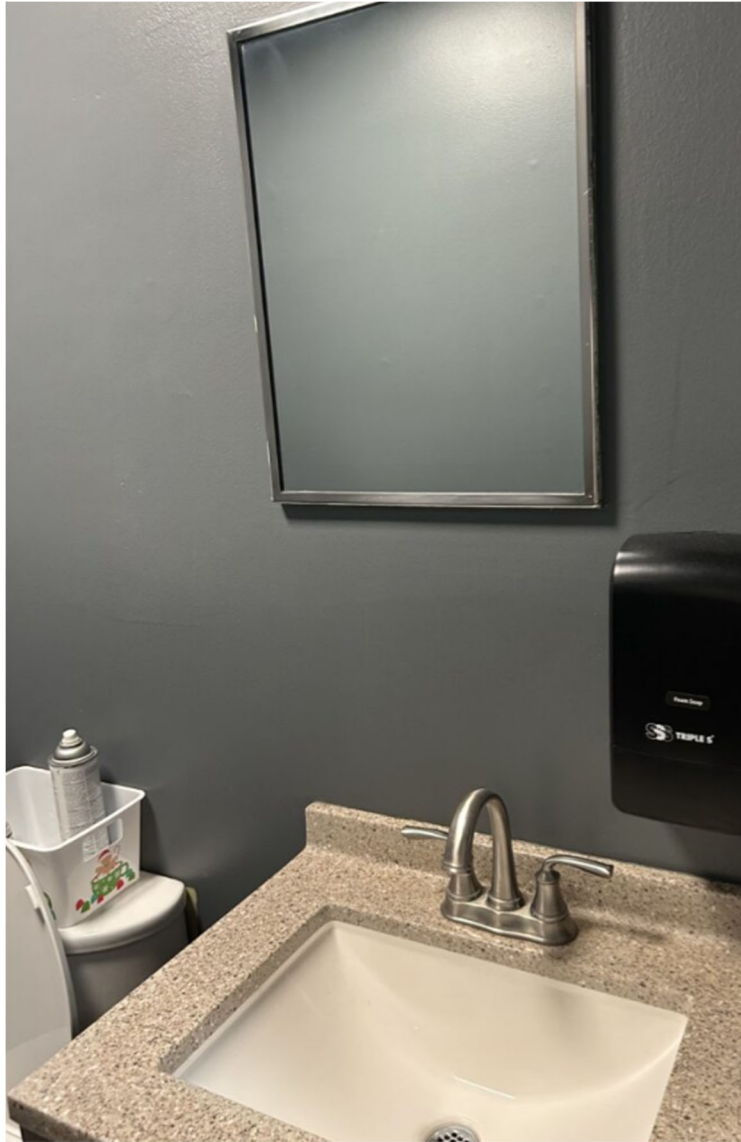
- The mirror is mounted 50" high to the bottom. **Moderate priority**

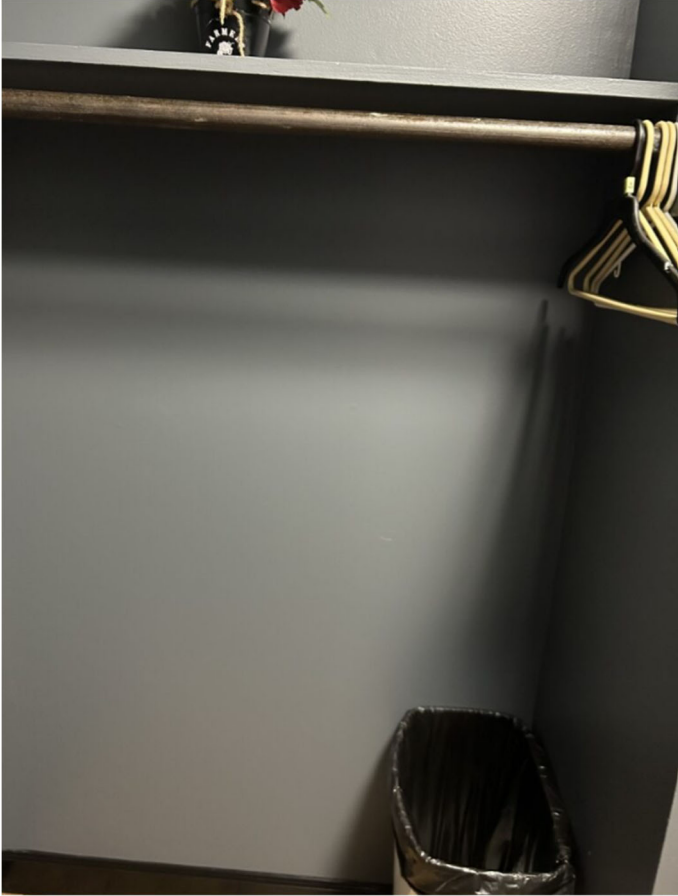
- There is 63" from the floor to the hanger space for clothing. **High priority - While coat hooks and hanger spaces are not required, the current hanger space is mounted at a height that could be a safety concern for some users.**

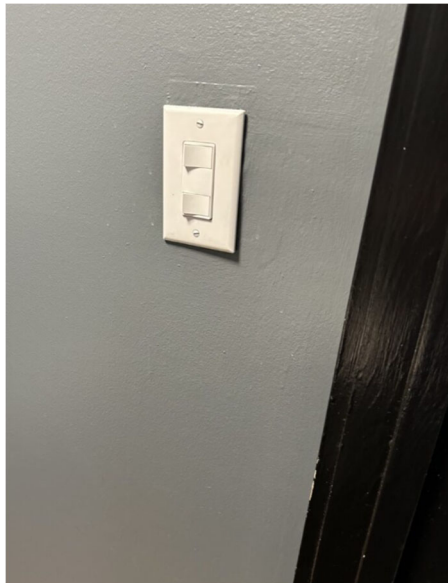
- The lock measures 33" from the floor. (compliant)
- The light switch is mounted 51" high. Low priority

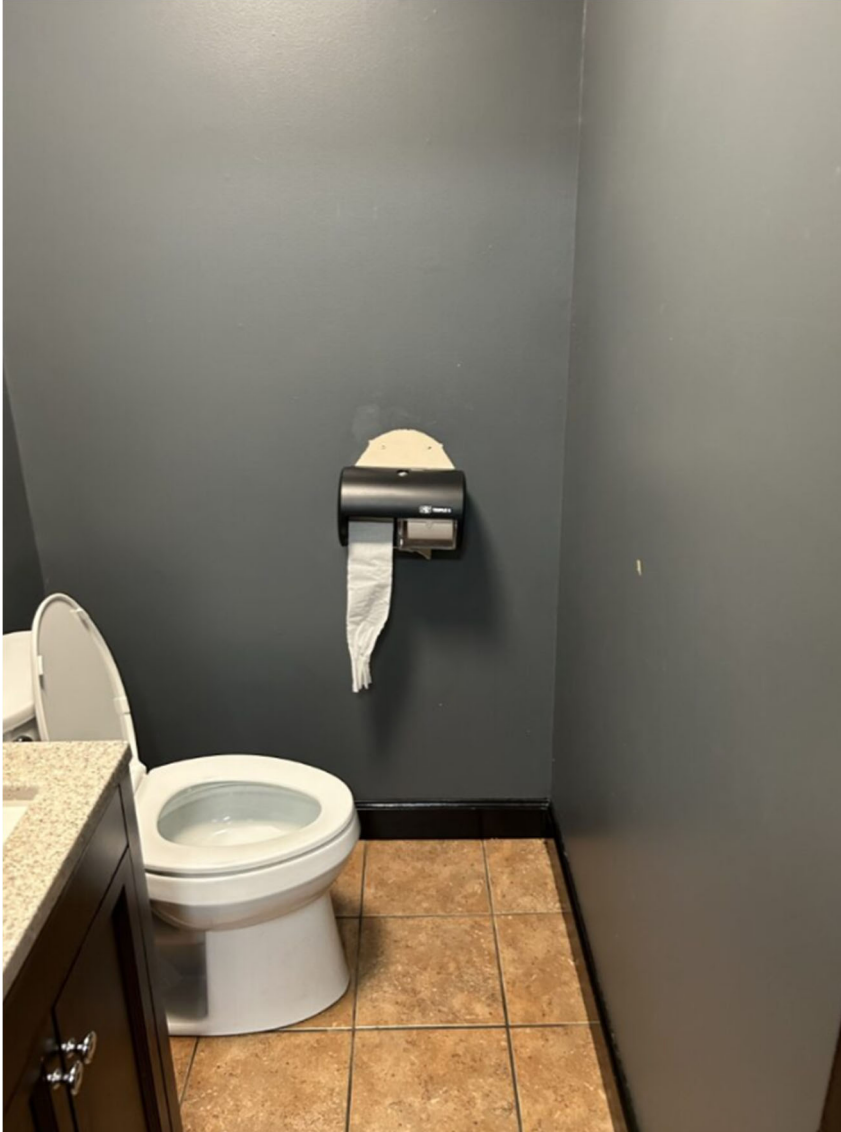
- There are no grab bars mounted on the wall beside or behind the toilet. **High priority**
- The toilet is 18" high. **(compliant)**
- The toilet paper dispenser is mounted 33" high and is nearly beside the toilet (2" ahead of toilet). **Low priority**

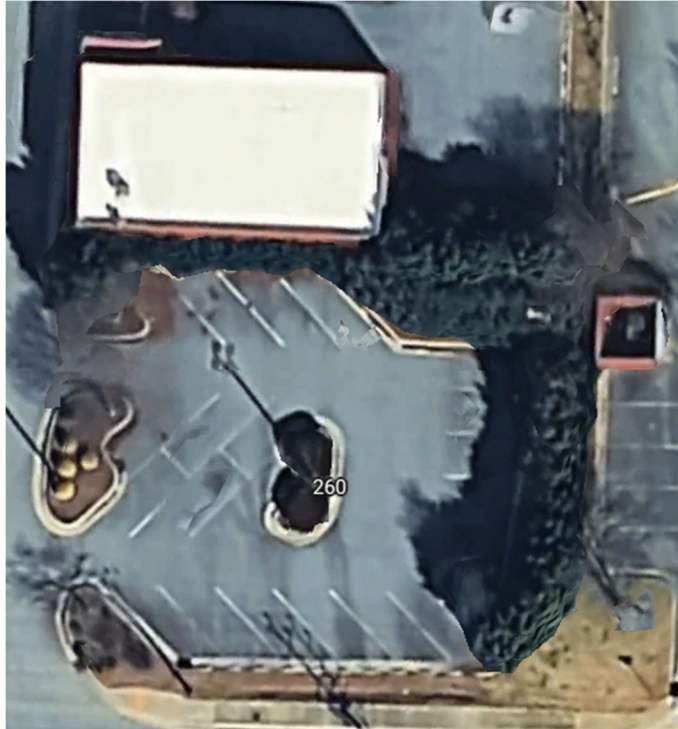
- There is no accessible parking in the lower parking lot along 2nd Ave SW.
 - This lot is not owned by Greenway Public Transportation. Recommend placing signage at all of the lots managed by Greenway Public Transportation. **High recommendation**

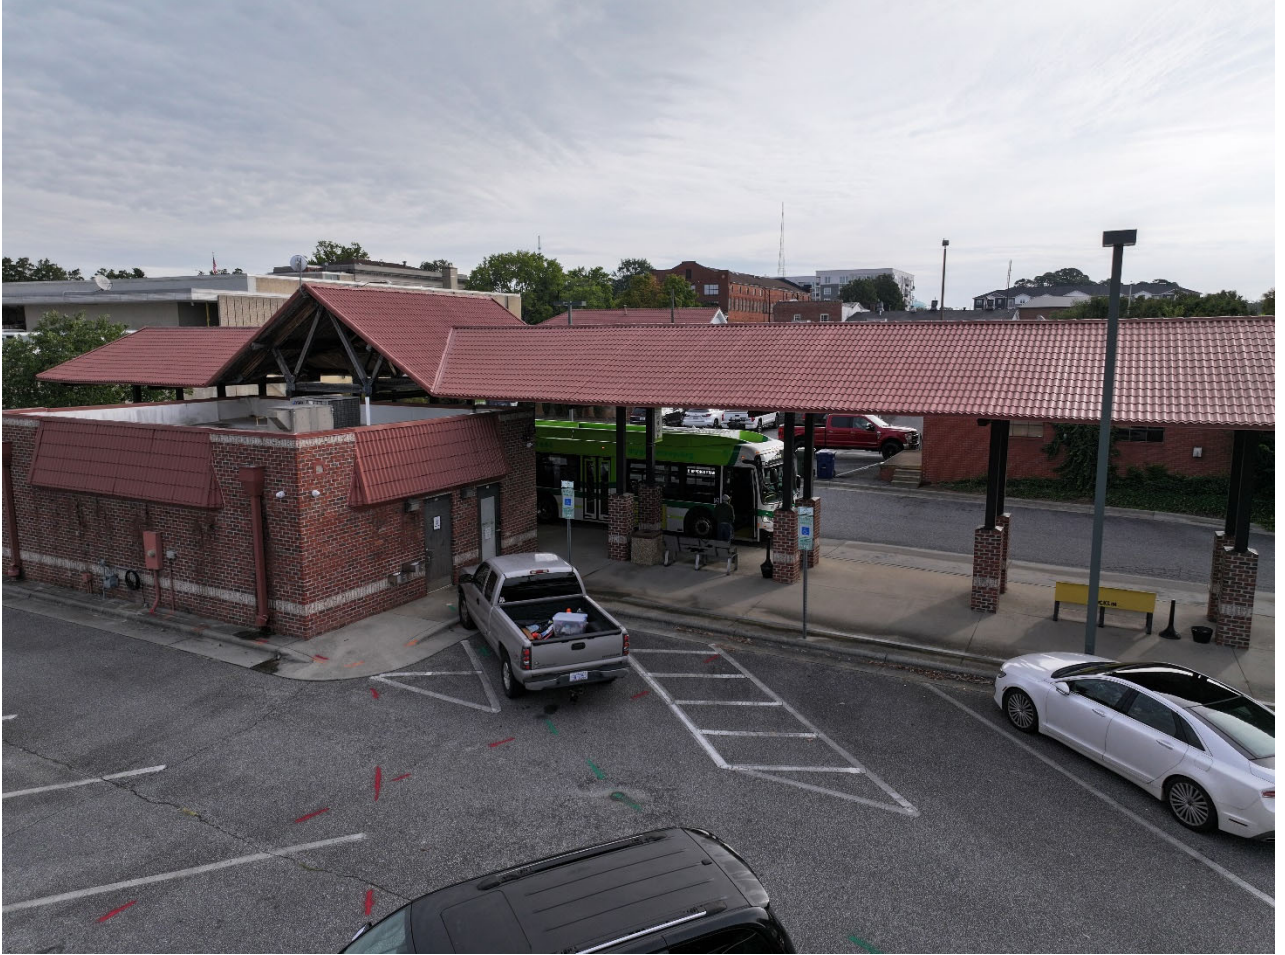
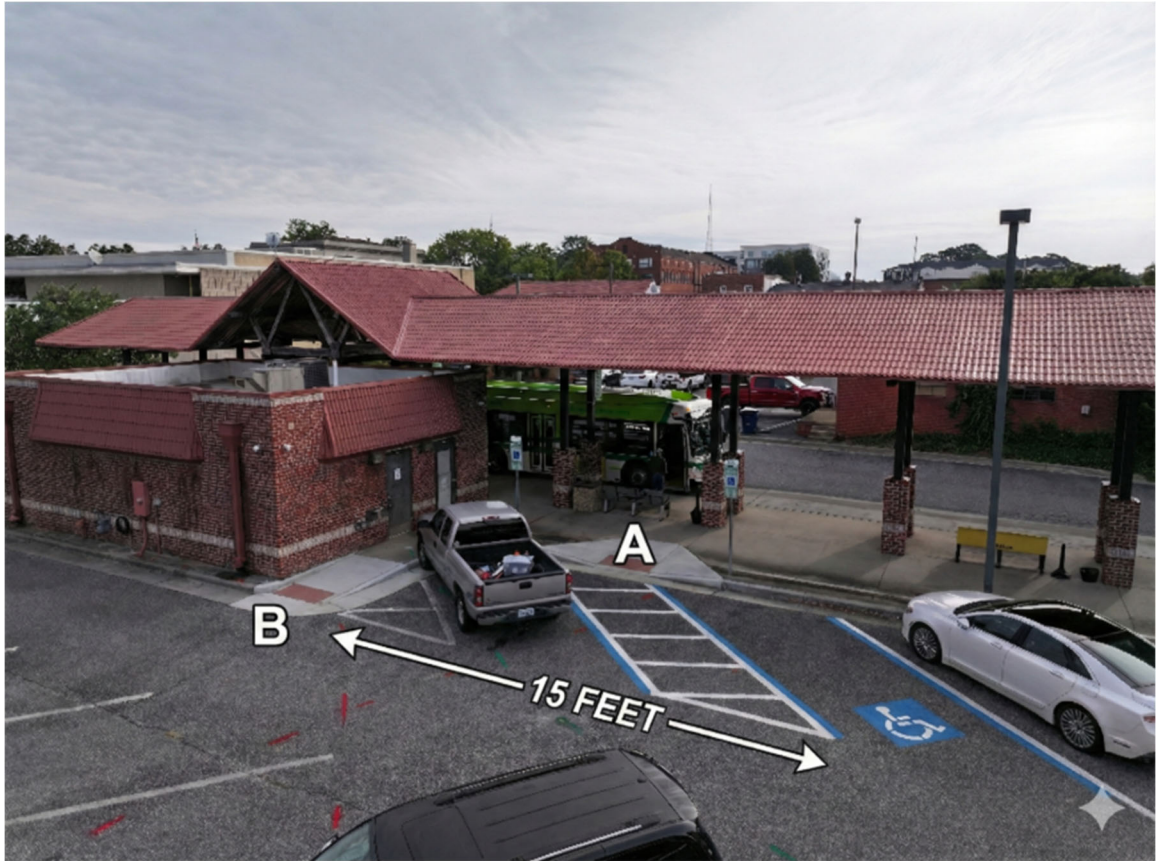
- There is currently no curb ramp at the accessible spaces connected to the transit hub. This would be an ideal placement for the curb ramp. Please see curb ramp “A” in the picture below. **High recommendation**

After recommended improvements. A curb ramp was added at the accessible parking (A). The curb ramp was corrected at the corner or the transit hub (B). The parking space was expanded to meet accessible van ADA standards.

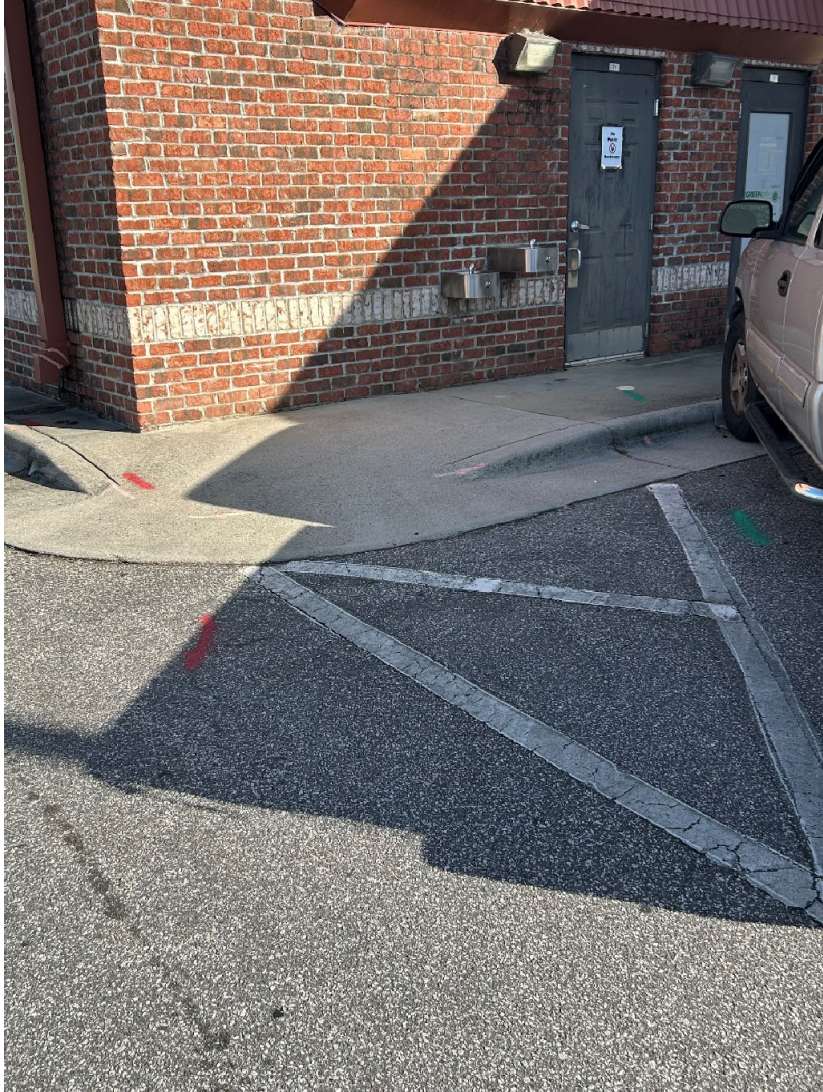
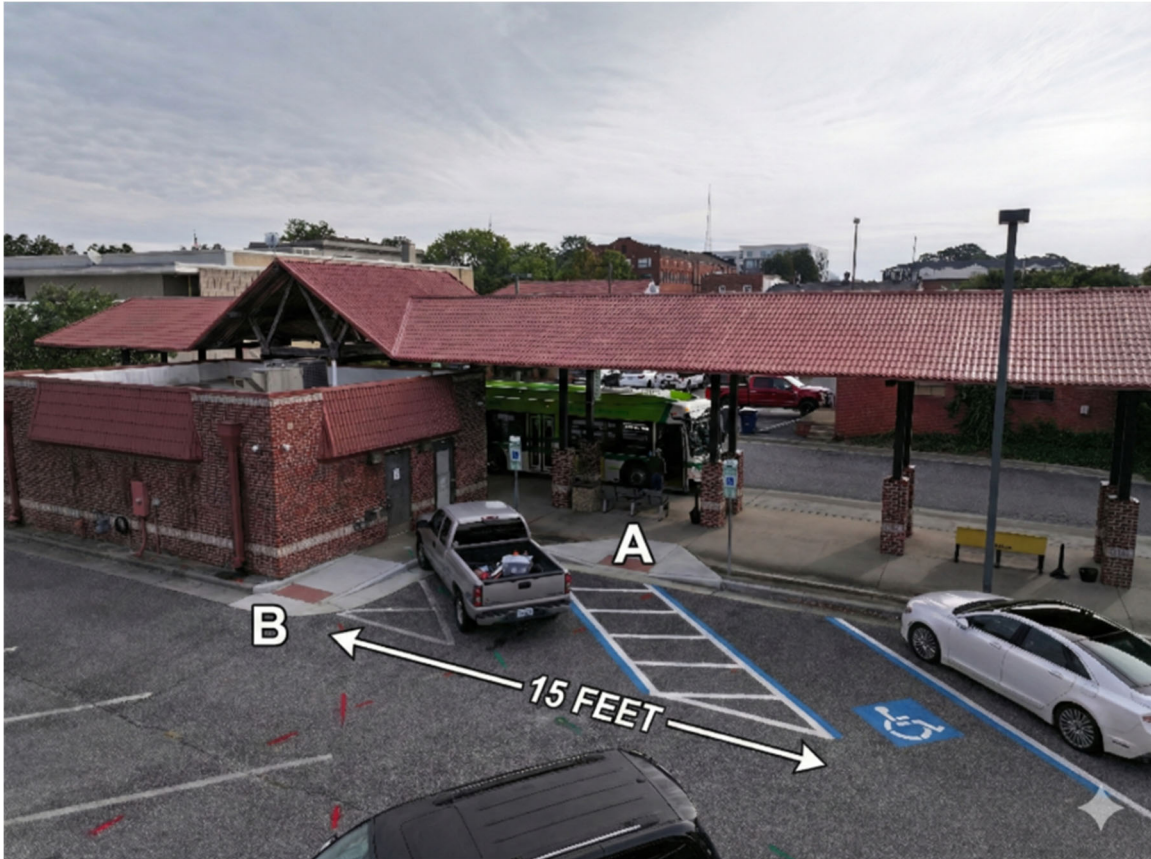
- The existing curb ramp next to the accessible spaces at the back of the transit hub does not meet ADA standards. Please see below and the recommended changes on curb ramp "B." **High priority**
