Executive Summary

The Western Piedmont Council of Governments (WPCOG) prepared this ADA Transition Plan on behalf of WPRTA to evaluate the full system of 346 bus stops and determine their compliance with ADA design standards. The plan identifies and documents accessibility

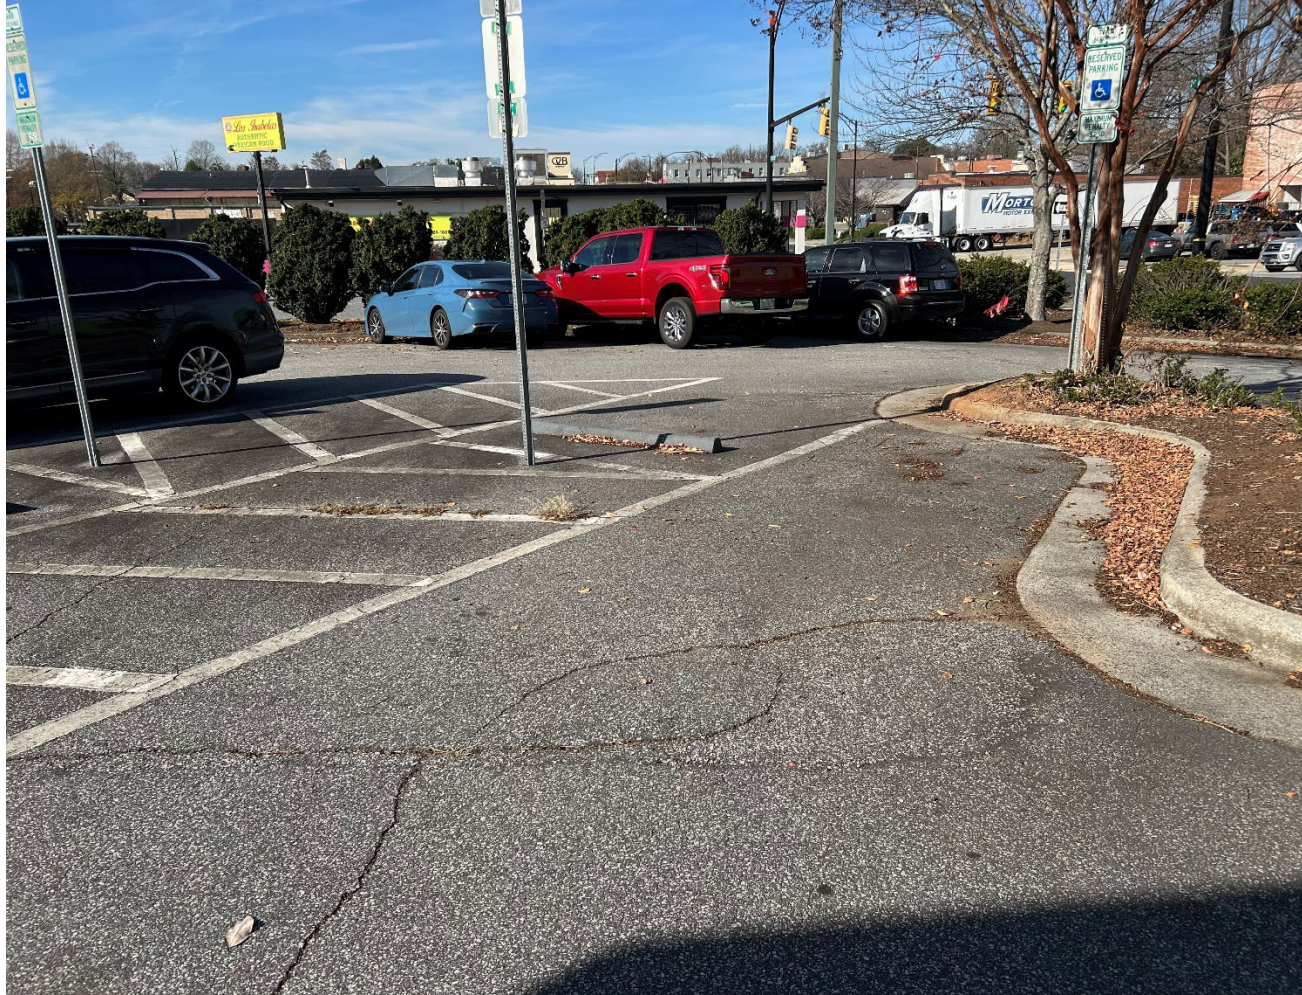
- The following accessible space does not meet ADA standards. The striped access aisle does not align with the space. **High priority**

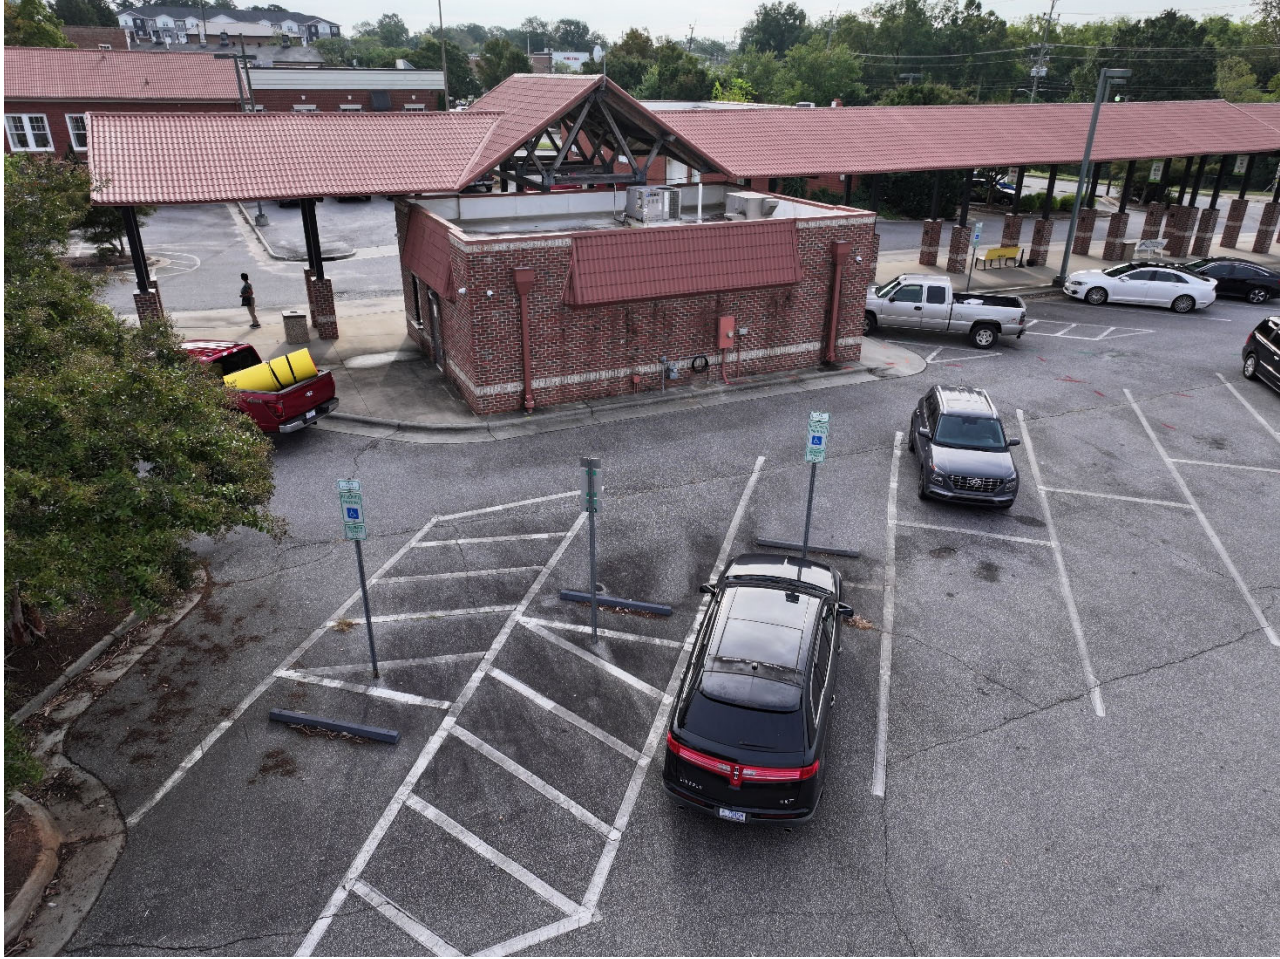
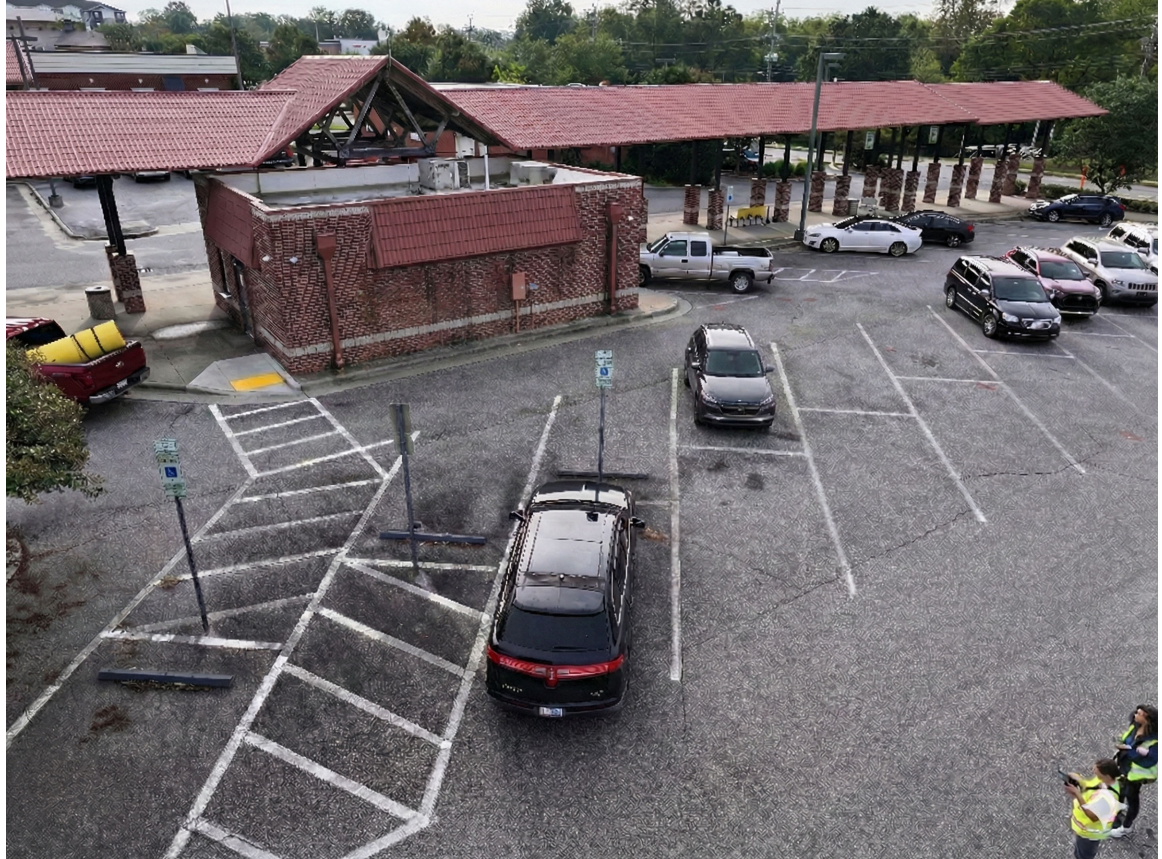
- All accessible spaces should have a striped access aisle that connects to the accessible entry of the transit hub. There are currently several accessible spaces that do not have a striped accessible pathway to the transit hub entry. Please see below.
High priority
Before:

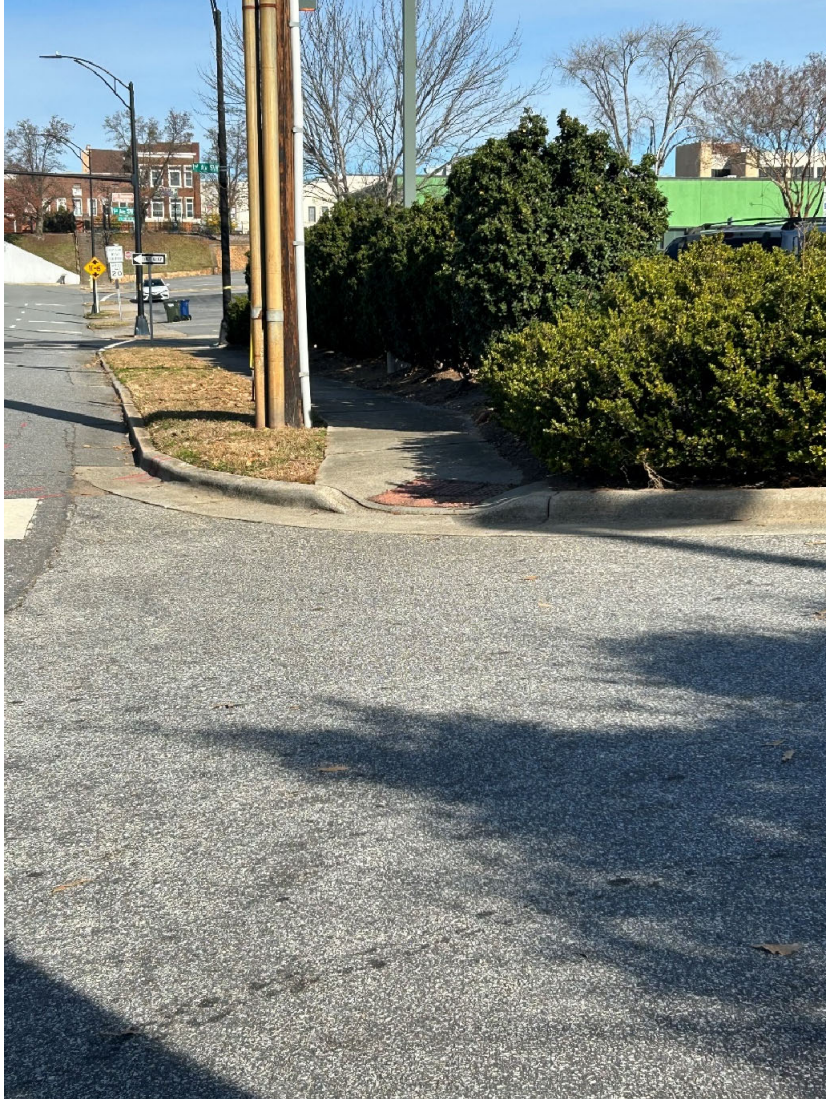
- 28" to service desk at the ticket office. **(compliant)**
- The curb ramps at the driveway cut on 3rd St SW should be addressed. These ramps are not compliant and pose a safety risk to those walking to the transit hub. **High priority**
 - The cross slope across this driveway cut exceeds the allowable 2%, making the crossing very unsafe for pedestrians.
 - The driveway cut should be a striped crosswalk for pedestrians. **High recommendation**

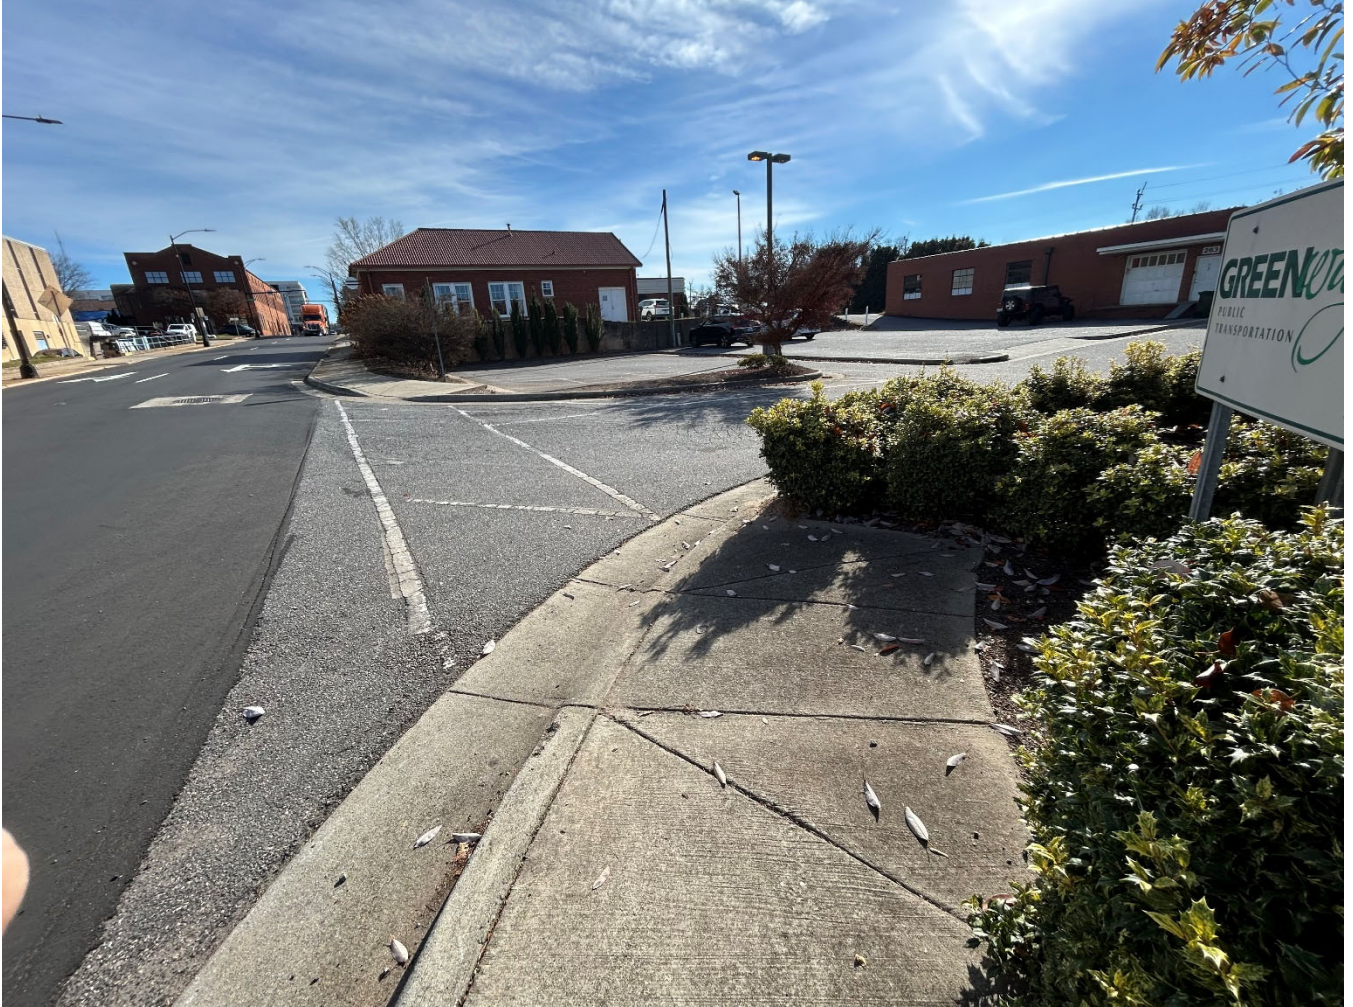
- The curb ramps at 1st Ave. SW do not meet ADA standards. In addition to correcting the slopes and resting areas, they should be realigned and detectable warnings should be added. **High priority**
 - The crosswalk at these curb ramps should be restriped. **Moderate priority**

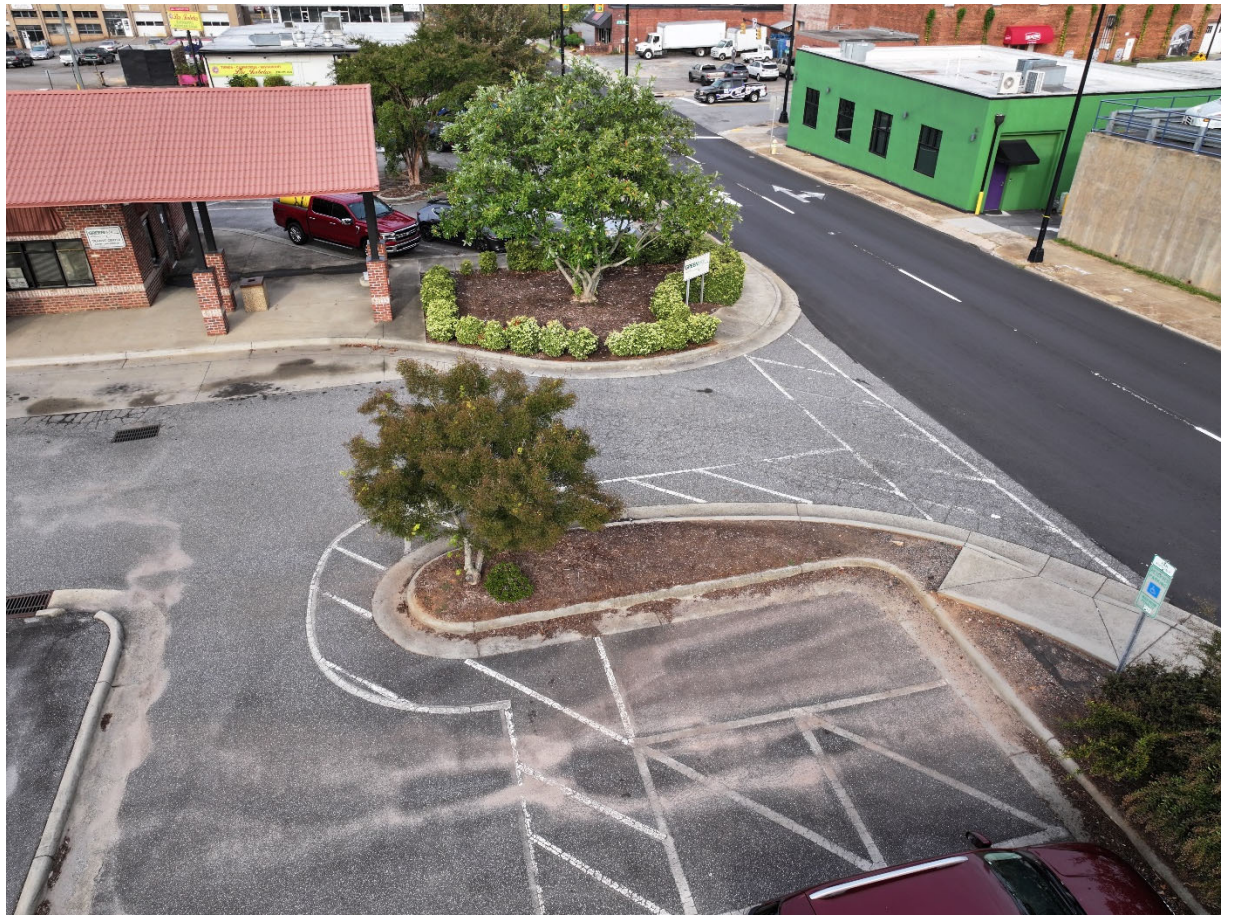
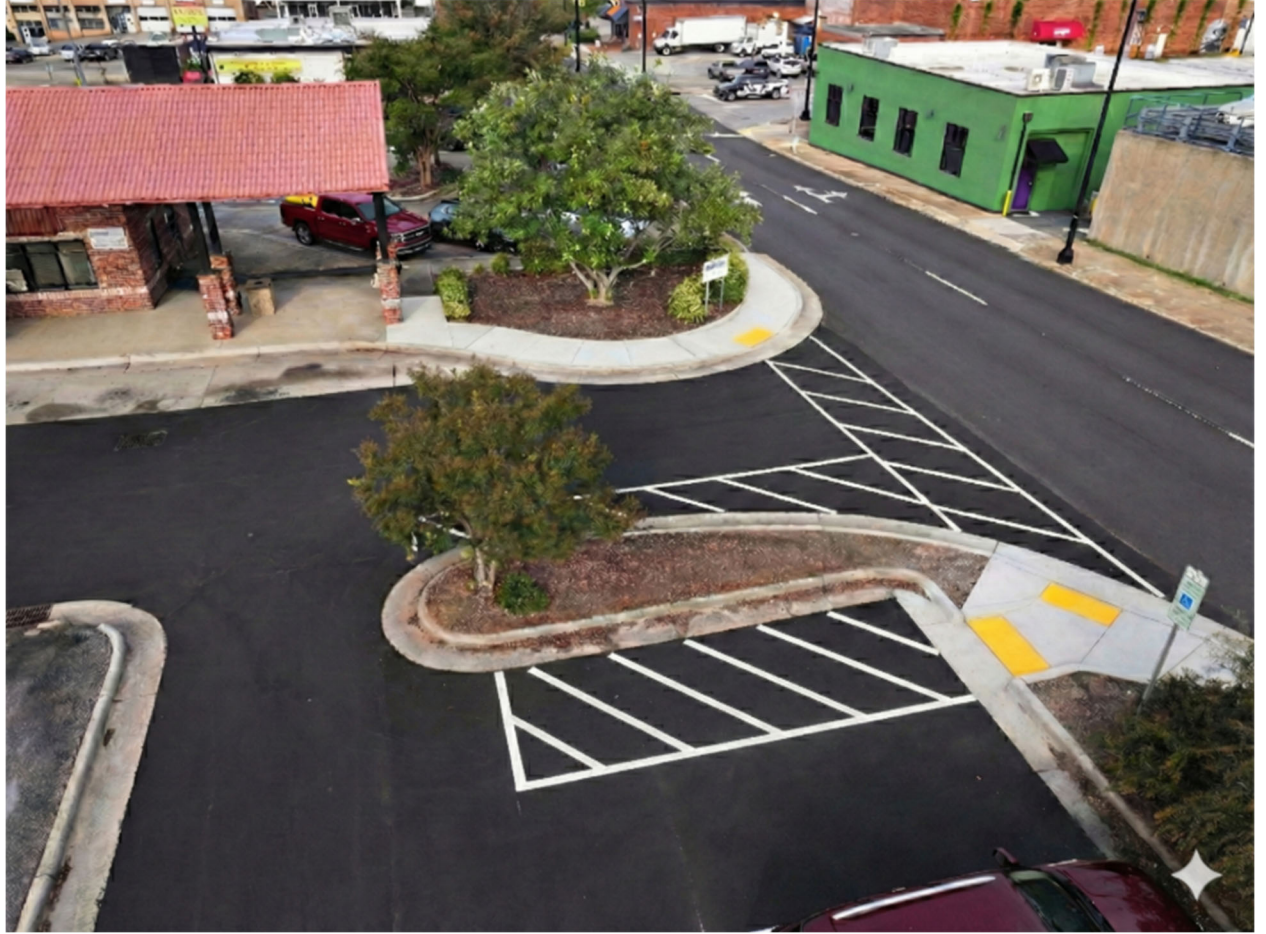
- For more direct access to the accessible parking to the smaller lot on 1st Ave. SW, it is recommended to extend the existing curb ramp on 1st Ave. SW to meet the striped access aisle of the accessible parking space. This would eliminate the need to have a striped access aisle from the current space and next to the driveway cut. This would also result in higher visibility of pedestrians at the driveway cut of the transit hub. Please see below. **High recommendation**

After, with suggested improvements. The sidewalk is extended to the transit hub. The curb ramps have detectable warnings. The curb ramp to the right of the driveway cut is extended to shorten the accessible pathway and create greater visibility for pedestrians.

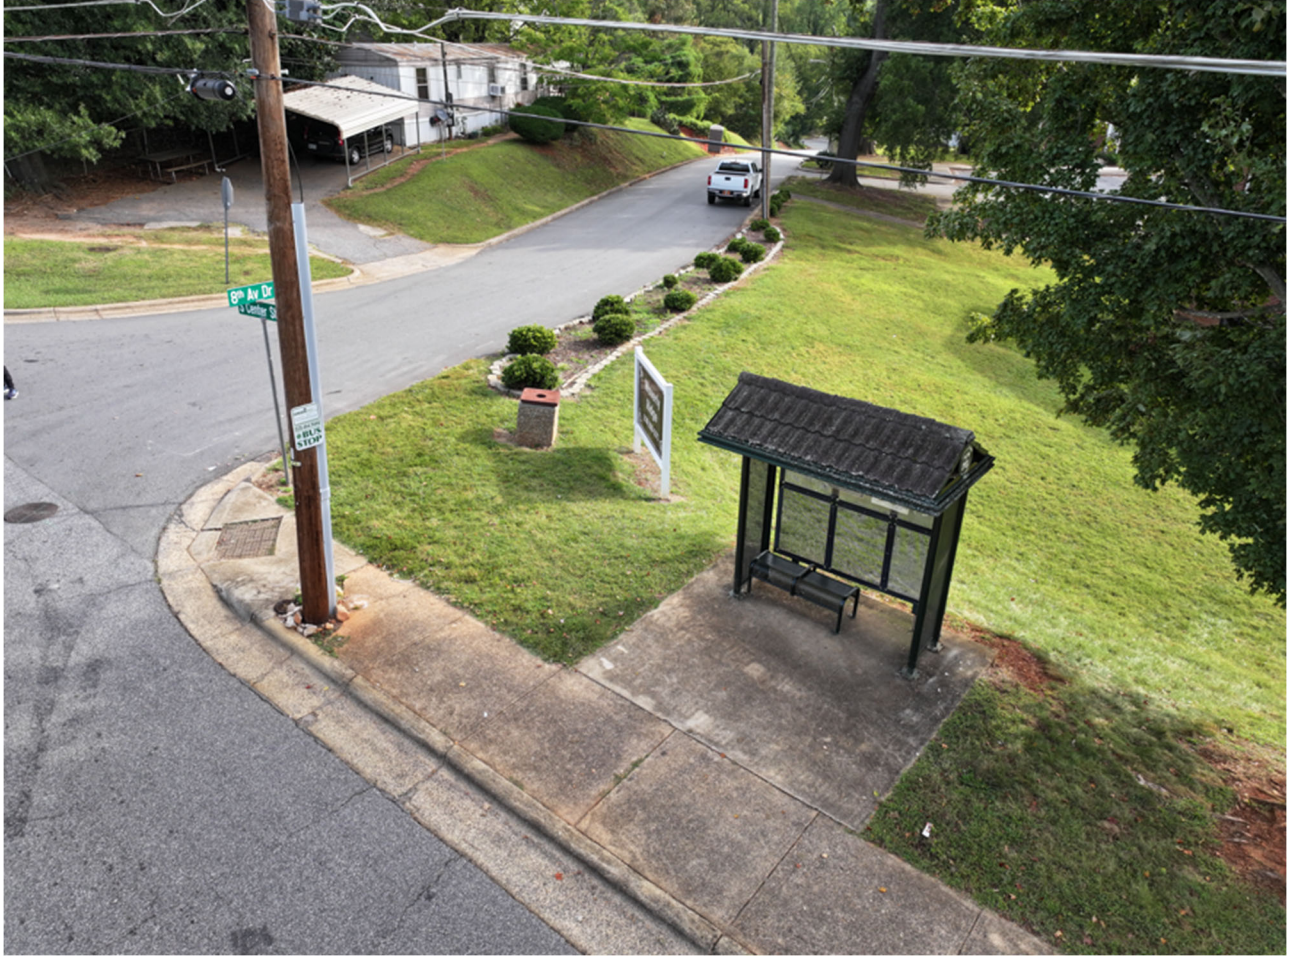
No Priority – The bus stop is fully compliant.

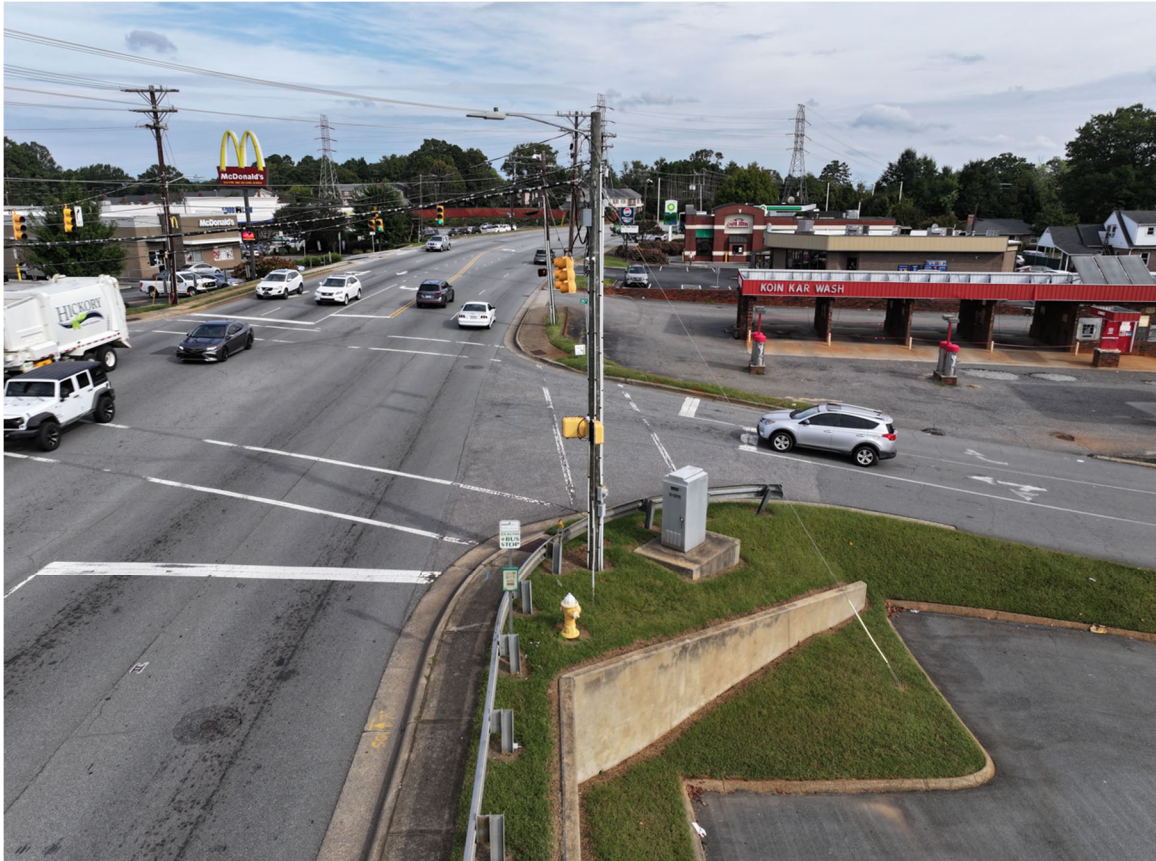
****Due to existing physical constraints, this transit stop is recommended for relocation. No renderings are available for this location.**

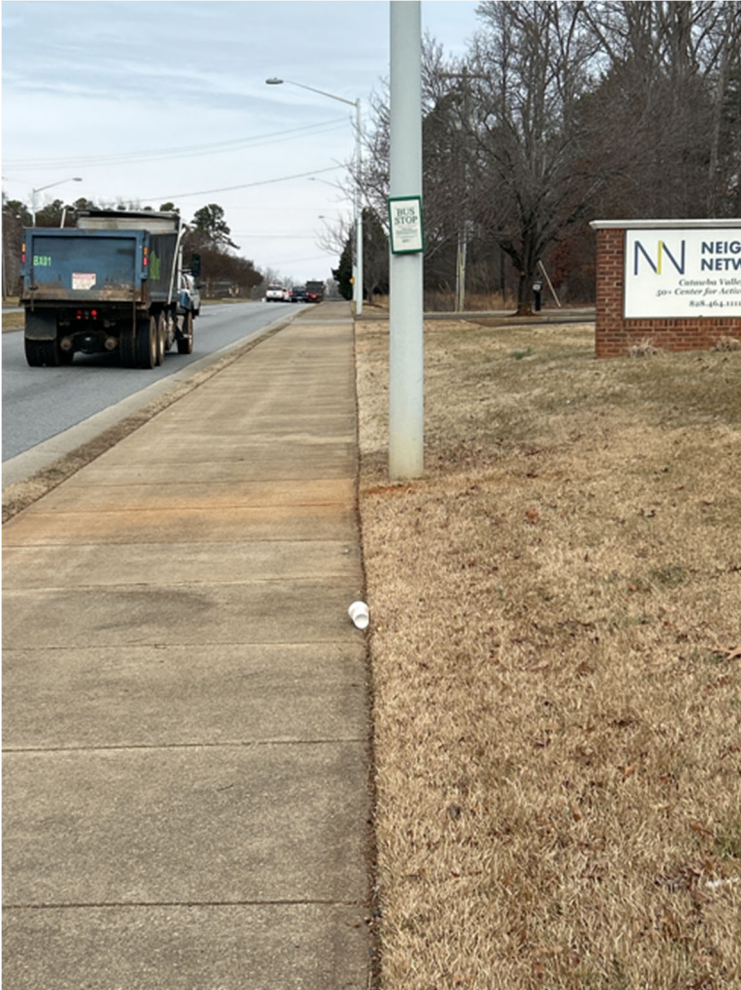
**This transit stop was labeled “low priority” due to its proximity to a major roadway. The sidewalk is wide enough to be considered an accessible pad, however, the sidewalk is slightly above the allowable cross slope for an accessible pad.
