City of Conover

ADA Transition Plan

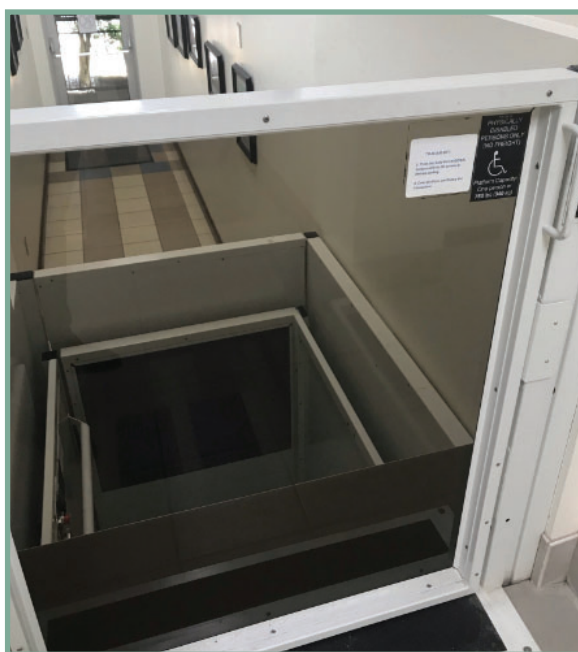
**Does not specify pressures and closure times for platform lifts. The following are our recommendations:

- » **Lift Doorway at Community Room (Floor 1):**
 Door Pull: 17 pounds (recommend 5 pounds)
 Door Push: 17 pounds (recommend 5 pounds)
 Closure Time: 3.02 seconds (recommend 5 seconds)
- » **Mid-Level Lift Door at Planning Offices:**
 Door Pull: 10 pounds (recommend 5 pounds)
 Door Push: 11 pounds (recommend 5 pounds)
 Not self-closing
- » **Lift Door at Utility Floor (across from steps):**
 Door Pull: 10 pounds
 Door Push: 13 pounds
 Not self-closing
- » **Lift Door (top):**
 Door Pull: 16 pounds
 Door Push: 16 pounds
 Closure Time: 3.01 seconds
 - (recommend 5 seconds)

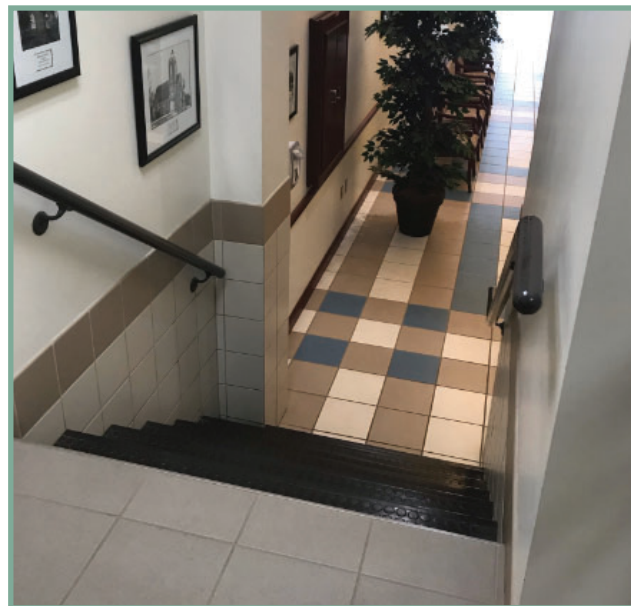
- » Recommend adding more directional signage throughout City Hall leading to LULA lift.
- » Recommend adding accordion gate or removable barrier at the upper lift in front of the stairway for safety (lift leading from the Planning Department to the Utilities Desks). A gate would prevent wheelchair accidents on stairway after exiting lift.

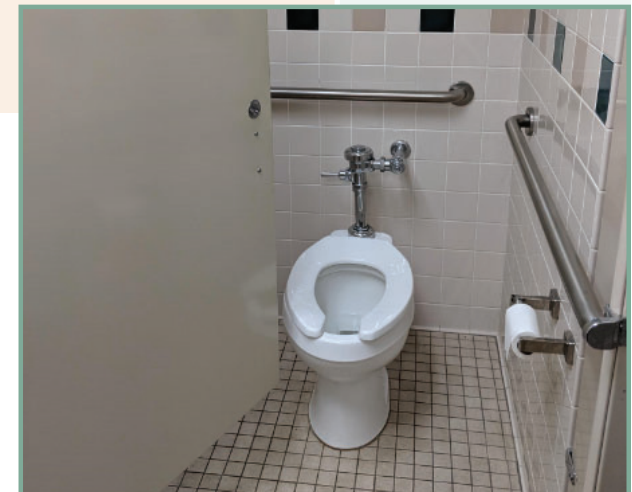
Women's Restroom - at the Council Chambers

High Priority	No Moderate Priority	Low Priority
<ul style="list-style-type: none"> » Push pressure of restroom entry door: 8 pounds » Pull pressure of restroom entry door: 7 pounds » Closure time of restroom entry door: 3.55 seconds 		<ul style="list-style-type: none"> » Coat hook not required, however, if present, must be installed 15-48" above floor. Coat hook is currently 53" high » Operable portion of soap dispenser is currently 48" above floor. Since the sink is 21.25" deep, soap dispenser should be mounted less than 44" above floor » Side grab bar in accessible stall should be located 12" from rear wall and extend 54" from rear wall. Grab bar is currently 6" from rear wall and extends 48" total from rear wall » Accessible stall doors should be self-closing » Currently, door pulls only on one side. Install handle 34-48" above floor

- » Operable parts of light switch 50" above floor – recommended height of operable parts: <48" (If constructed before 3/15/2012 and a parallel approach is provided, controls can be 54" above floor)
- » » Side grab bar should be mounted 33-36" high to top of grip. Currently 37" to top of grip
- » » Rear grab bar should be mounted 33-36" high to top of grip. Currently 37.5" high
- » ADA Standards recommend toilet paper dispensers should be located 7-9" from the front of the toilet to the centerline of the dispenser. Currently, the dispenser is 12" from the front of the toilet to the centerline of the dispenser. This is not applicable since built prior to 2012.
- » Restroom sign is located on the door. Restroom signs must be on latch side of the door, however, due to the layout, the sign cannot meet the 18"x18" clear floor space requirements next to the latch side of door.

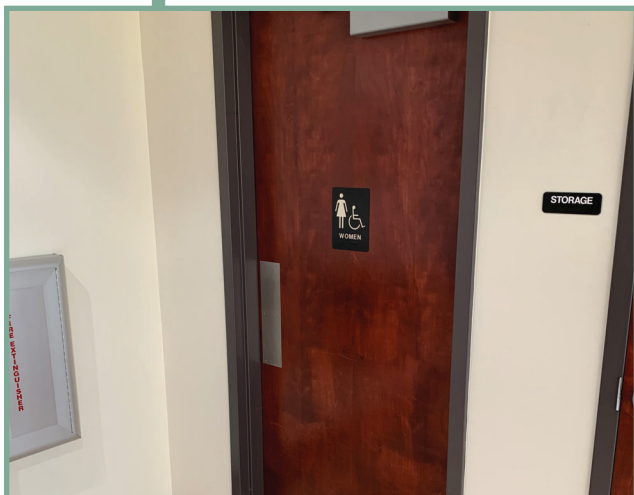
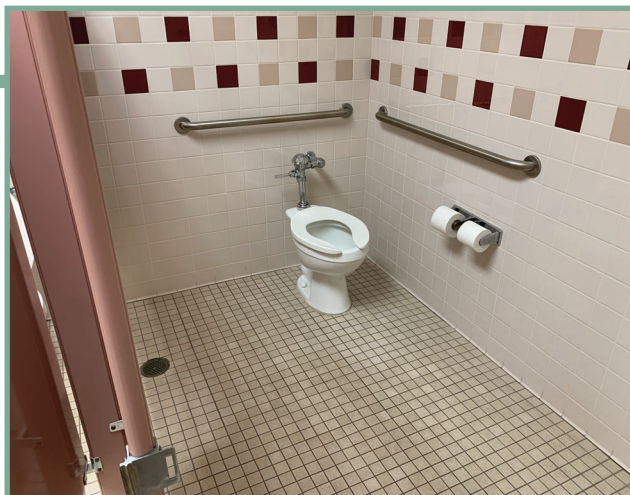
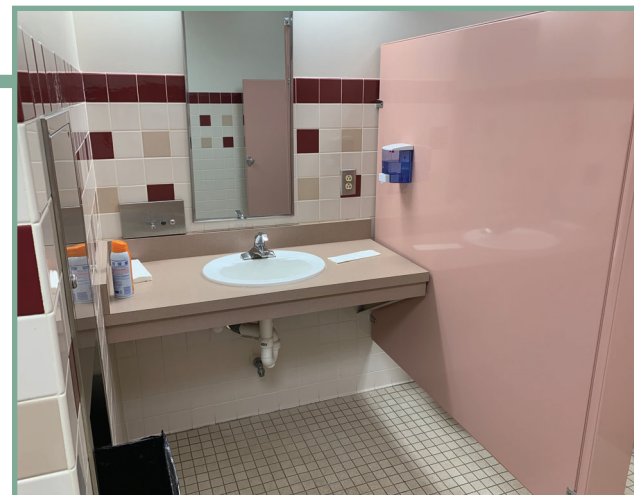
Men's Restroom - at the Council Chambers

High Priority	Moderate Priority	Low Priority
<ul style="list-style-type: none"> » Push pressure of restroom entry door: 7 pounds » Closure time of restroom entry door: 3.29 seconds 	<ul style="list-style-type: none"> » Restroom sign is located on the door. Restroom signs must be on latch side of the door. 	<ul style="list-style-type: none"> » Operable portion of towel dispenser should be less than 44" above floor currently 46" » Operable portion of soap dispenser (on left) should be mounted less than 44" above floor – currently 47" » Side grab bar in accessible stall should be located 12" from rear wall and extend 54" from rear wall » Accessible stall doors should be self-closing » Currently, door pulls only on one side. Install handle 34-48" above floor

» Operable parts of light switch 49.5" above floor – recommended height of operable parts: <48" (can be 54" above floor if constructed before 3/15/2012)

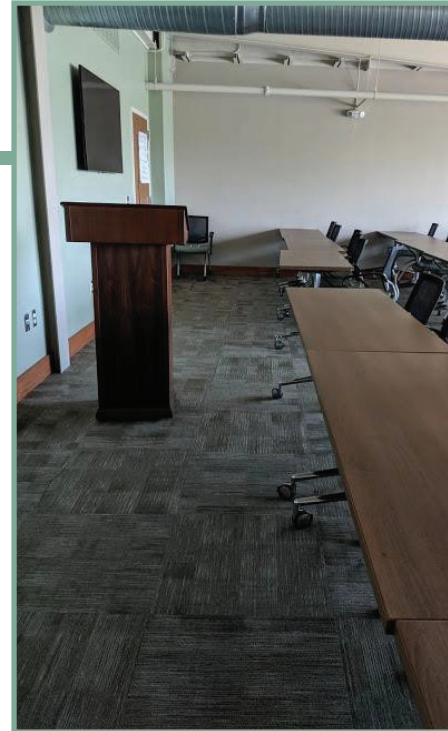
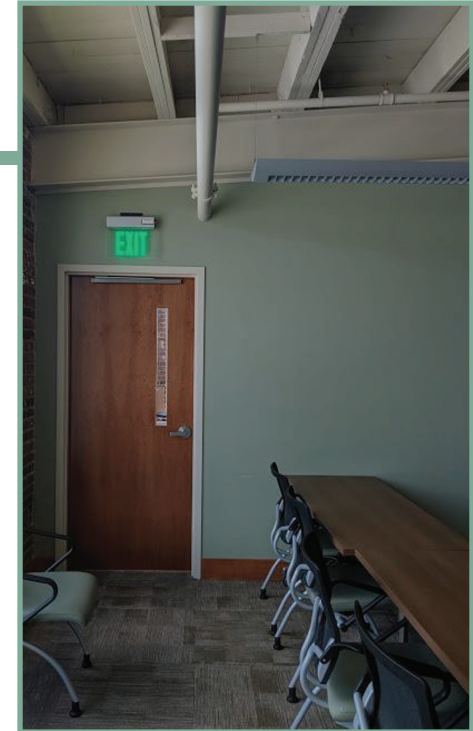
- » Move podium to allow for 36" pathway to seats.
- » Wheelchair accessible spaces at tables need to be 36" wide (recommend spaces on the end of each row). There needs to be 1 space for every 25 seats.

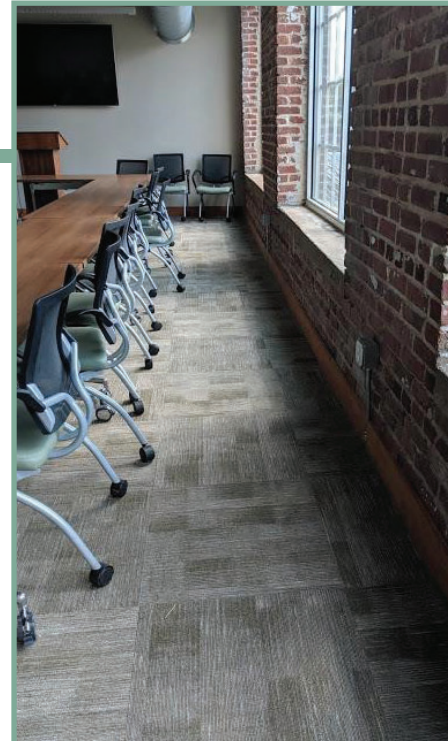
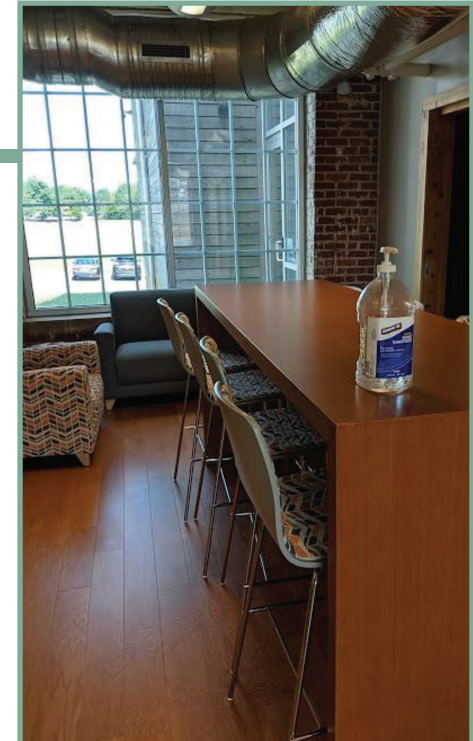
- » Back of meeting room: aisle not 36" wide
- » Allow for 36" wide wheelchair spaces in meeting room (1 wheelchair space for every 25 seats)
- » <36" at corner of meeting room at time of inventory
- » Waiting areas should have wheelchair space 36" wide by 48" long

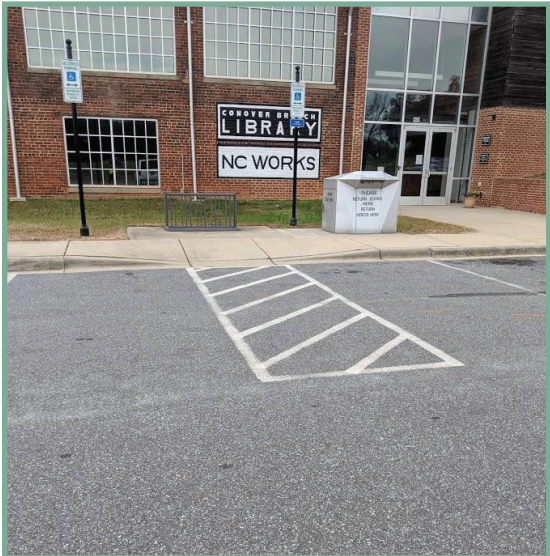
Spaces in Front of Drop-off

- » There should be an accessible parallel space at the front of Conover Station as close to the ramp as possible. A curb ramp should be installed that connects to the space in the picture at the bottom right (please see curb ramp measurements in application).
- » There is currently not an accessible space that meets the proper dimensions of an accessible van space at the Library Dropoff. A van accessible space must be at least 11 feet wide with an access aisle at least 5 feet wide OR at least 8 feet wide with an access aisle at least 8 feet wide. There must be at least one accessible van space (can be the same space as the regular accessible space). Van sign mounted 60" above the ground is required.

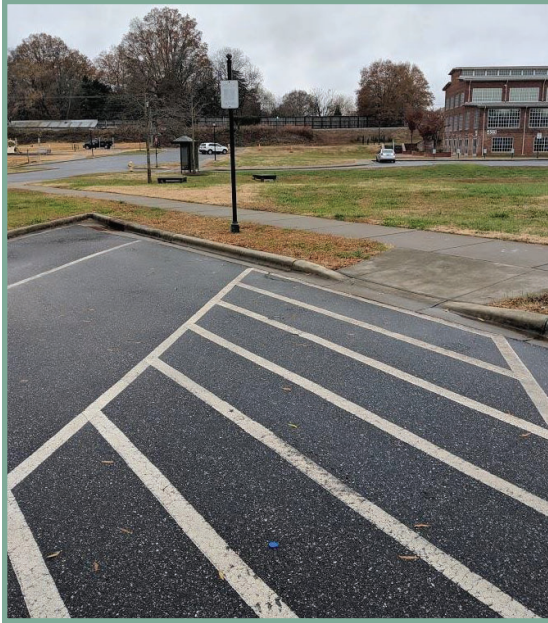
Accessible space closest to Conover City Park Sign

- » Evaluate the ratio of standard parking spaces to accessible spaces. For every 25 spaces there should be 1 accessible space present. For every 6 accessible spaces, 1 should meet the dimensions and have the proper signage for a van accessible space. If there are not 6 accessible spaces, at least one must still be van accessible. Spaces should be evenly dispersed at park and building entry points.
- » Sign is faded and needs to be replaced. The space meets the proper dimensions for an accessible van space – recommend signing accordingly.
- » There should also be an accessible space at the entrance of the park to make the entrance of the park as close as possible to the space.

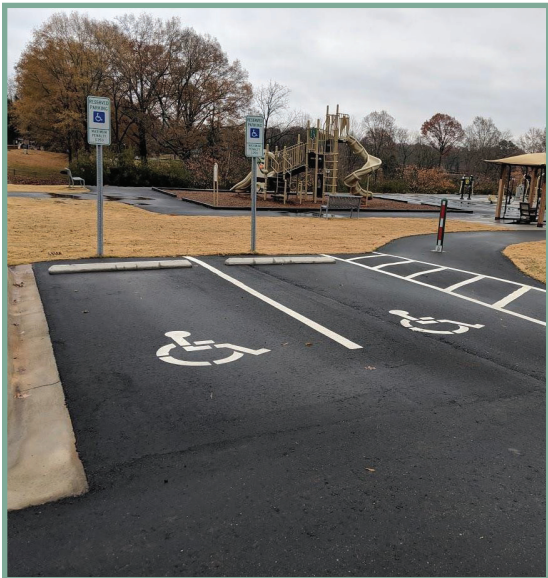
Accessible spaces at end of Conover Station SE overlooking upper section of park

- Left Space (when looking at park):**
- » 7 foot wide – ADA Standards require 8 foot width with a 5' access aisle
 - » No access aisle – the access aisle can be shared but is required of all accessible spaces
 - » No van accessible space

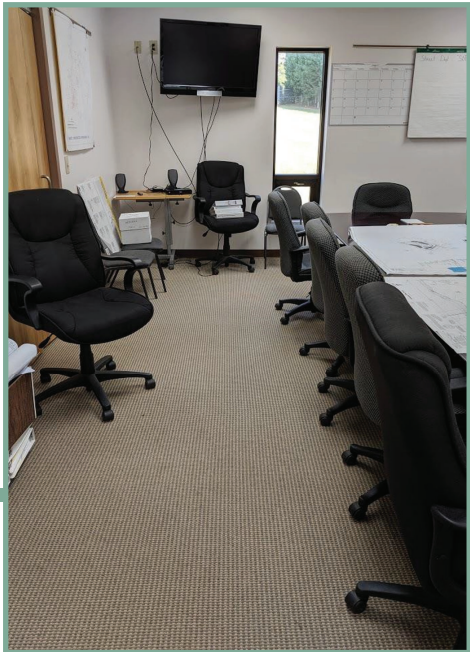
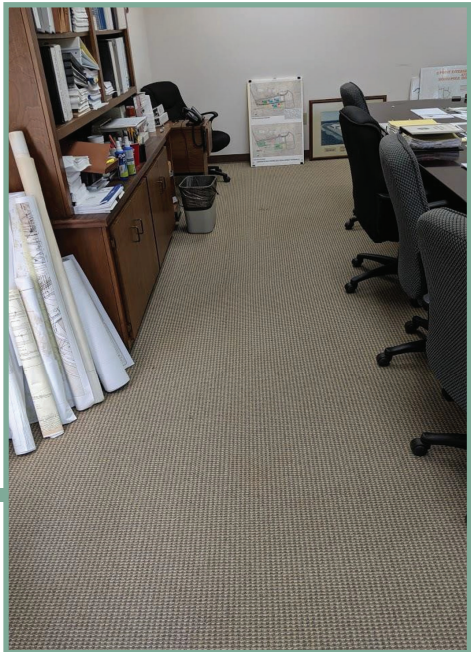
Conference Room

<p>No High Priority</p>	<p>Moderate Priority</p>	<p>No Low Priority</p>
	<p>» Make sure there is a clear 36" wide circulation path around the table and adequate room for wheelchair spaces at the table. Generally, allow 1 wheelchair space per every 25 seats. The wheelchair spaces need to be 36" wide and 48" deep. If the space can only be entered from the side, then the space needs to be 60" deep. The spaces cannot overlap circulation paths.</p>

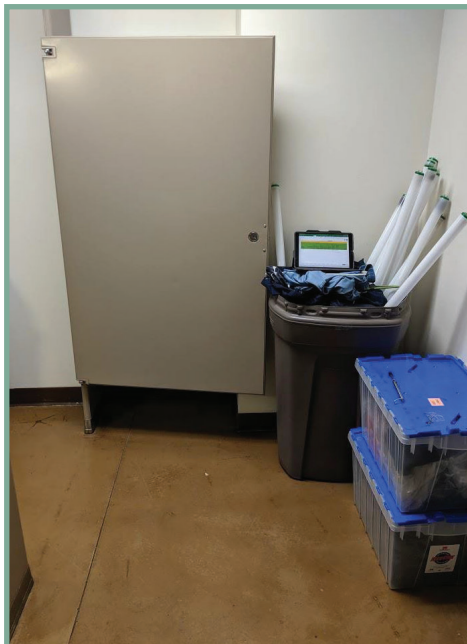
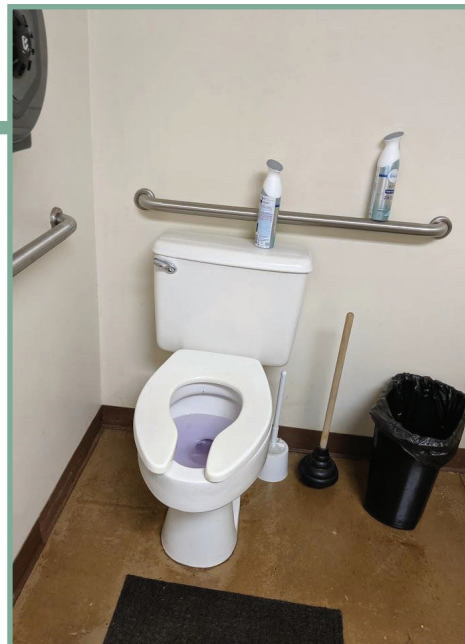
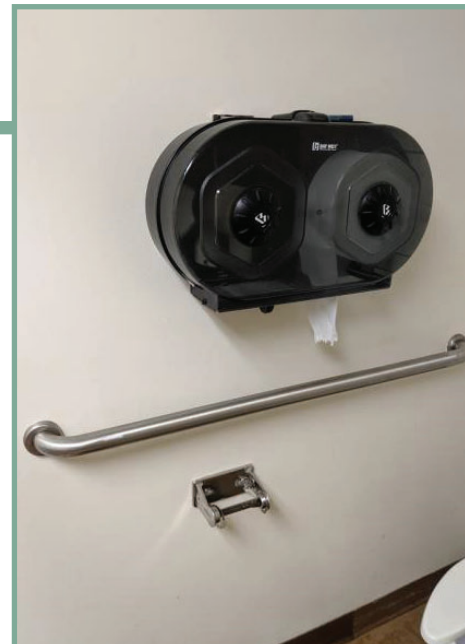
- » The stall door/circulation path cannot be fully accessed due to obstructions. Recommend moving the obstructions for wheelchair access.
- » **Door Pressures**
Push Pressure: 9 pounds
Pull Pressure: 8 pounds
Closure Time: 2.81 seconds
- » Coat hooks are not required, however, if present, must be 15-48" high. The current coat hook is 65" high and could be hazardous to safety.

- » 2010 ADA Standards require a 12" clearance between the grab bar and protruding objects above. There are 9" between the side bar and the toilet paper dispenser above the side bar. If the facility was built prior to 2012, there are no space requirements above or below bars.
- » Door pulls on stalls (both sides) are recommended but not required if the facility was constructed prior to 3/15/12.

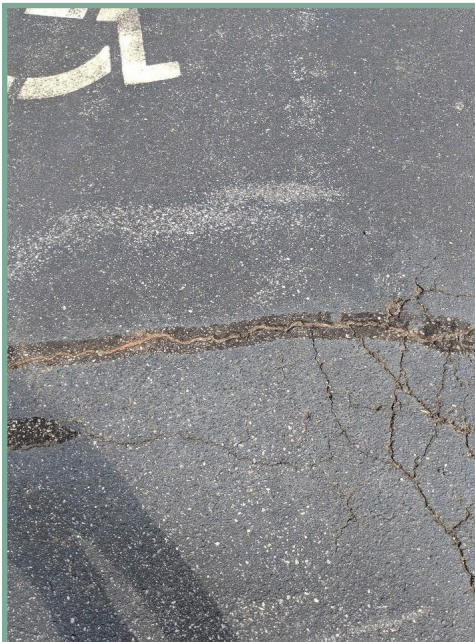
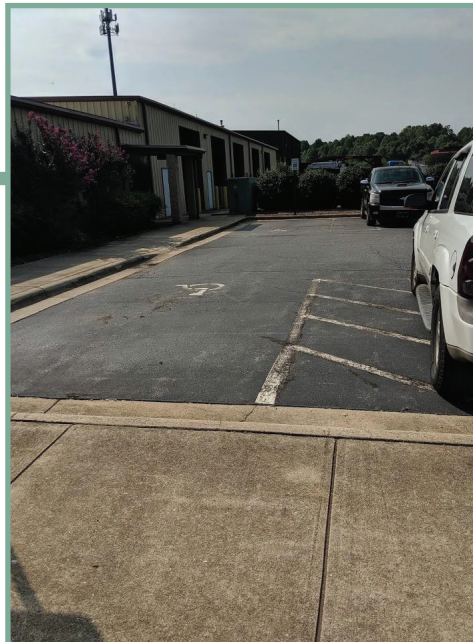
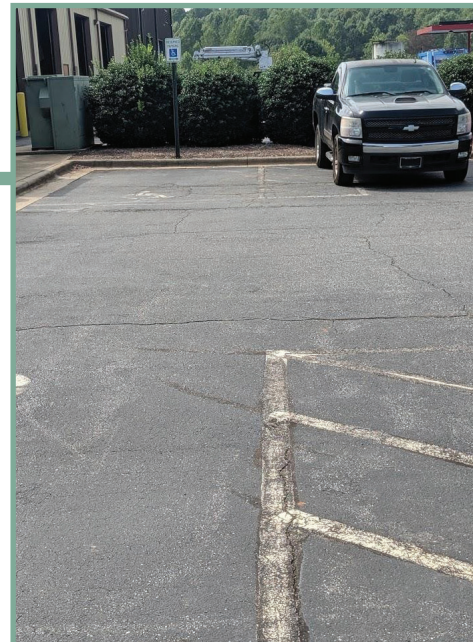
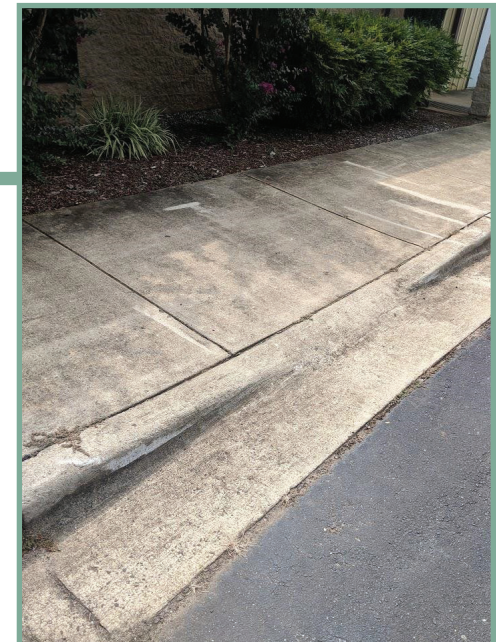
Public Works Parking Lot

- » Access aisles are supposed to connect to the accessible route. Recommend switching spaces and access aisles so they connect to the curb ramp.
- » The accessible spaces are not signed for van parking but are the proper dimensions for an accessible van space. One space must have accessible van signage. Van sign mounted 60" above ground is required.
- » There should be a smoother transition for the curb ramp leading from the spaces to Public Works. The standards for curb ramps leading from parking lots to facilities differ slightly from curb ramps within the right-of-way. Please see Priority 1 – Approach and Entrance standards 1.19 – 1.24 for proper curb ramp standards.

- » Seal any cracks exceeding 1/2". There were no notable ones that were obvious safety hazards.
 - » The top and middle of the access aisle closest to Public Work's main entry exceed a 2% cross slope. Top cross slope: 2.9%, Middle cross slope: 3.1% All other measurements meet proper dimensions.
 - » Space closest to break room:
Cross slope at top of space: 2.8%
Cross slope at top of aisle: 2.8%
Cross slope at middle of space: 2.7%
Cross slope at middle of aisle: 2.8%
- All other measurements meet proper dimensions. The listed ones are not far out of compliance.

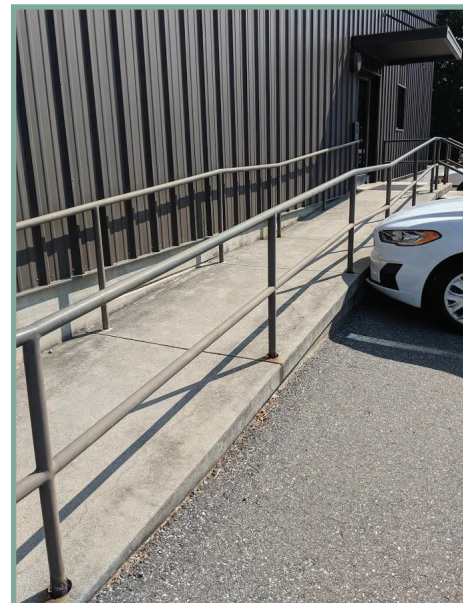
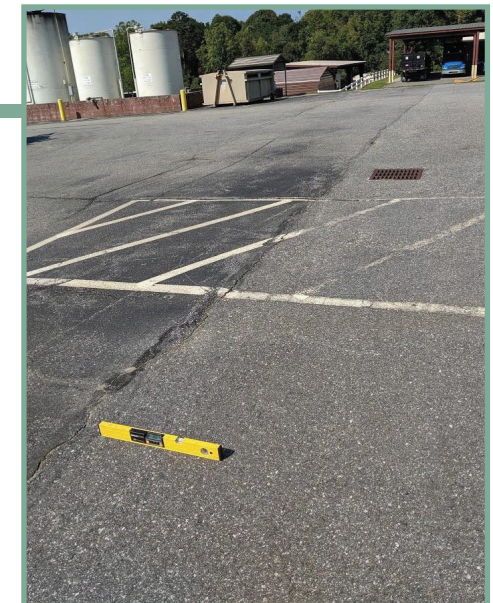
Low Priority (Fleet Maintenance Accessible Parking Space)

- » Fill in all pavement cracks that exceed 1/2". This does not present immediate safety hazard.
- » The running slope at the top of the accessible space measures 3%. The running slope in the middle of the space measures 3.3%. All other measurements are within range and does not pose an immediate safety hazard.
- » The running slope in the middle of the accessible aisle measures 3.4%. The running slope at the bottom of the accessible aisle measures 3.1%. All other measurements are within range and do not pose an immediate safety hazard

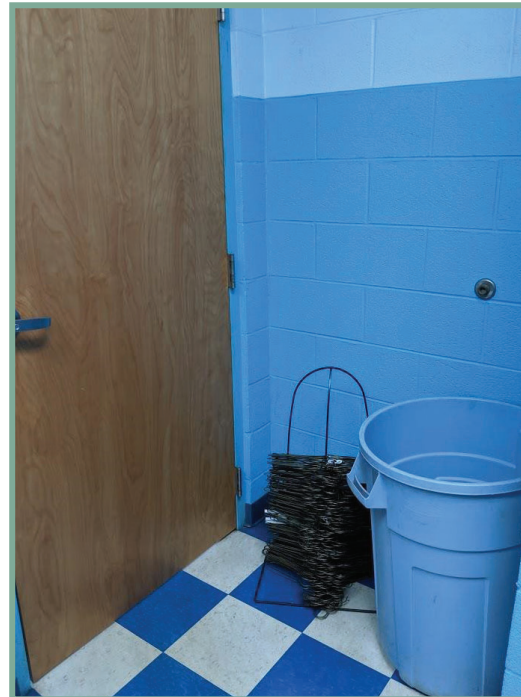
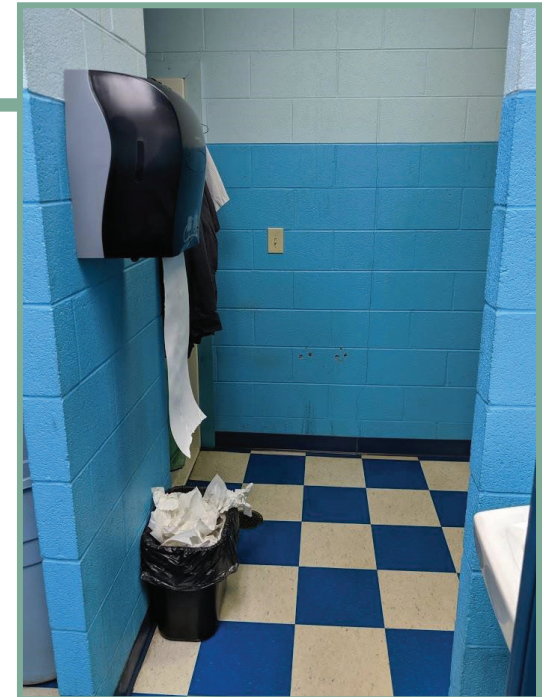
Men's/Women's Room

- » 2010 ADA Standards require a 12" clearance between the grab bar and protruding objects above. There are 10.5" between the side bar and the toilet paper dispenser above the side bar. If the facility was built prior to 2012, there are no space requirements above or below bars.

- » Currently there are no door pulls on the stall door. If constructed before 3/15/2012, door pulls do not need to be added.

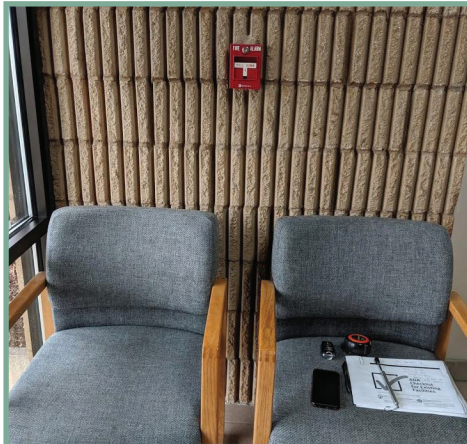
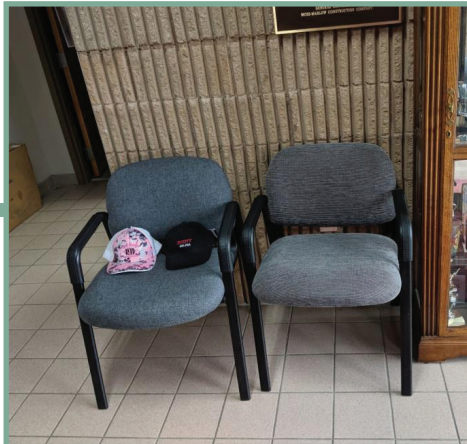
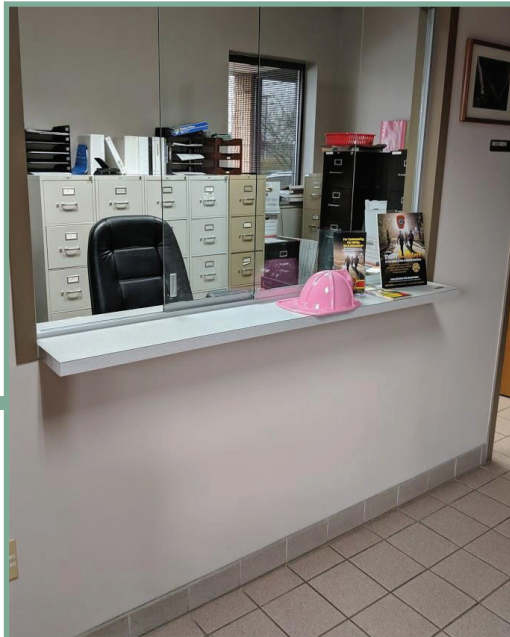
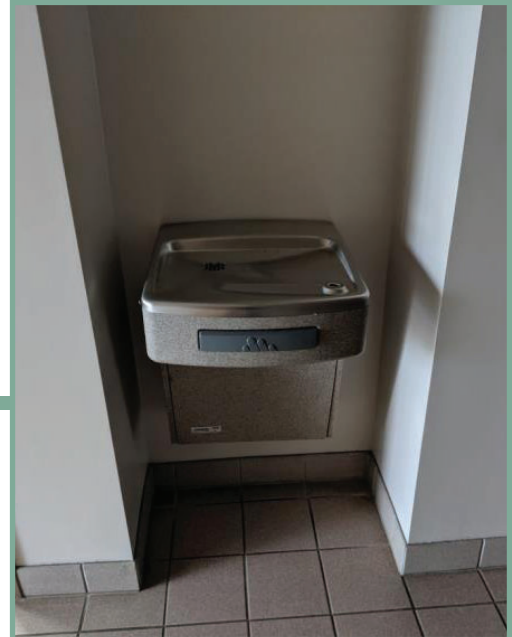
Approach & Entry Area

» Install all future pulls no higher than 48". Current alarm pulls are 50.5" high.

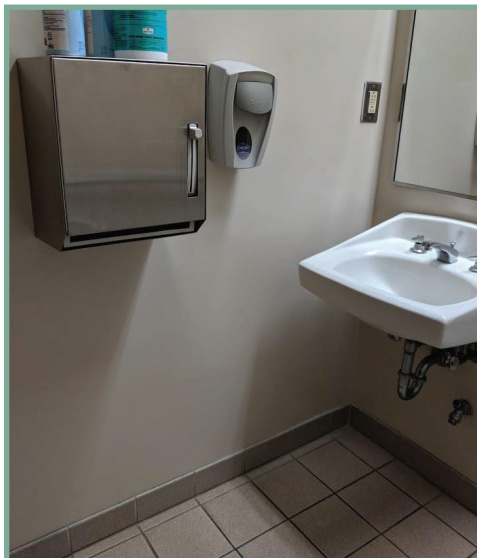
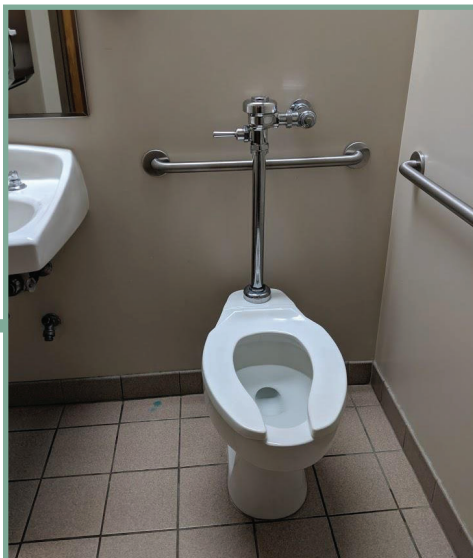
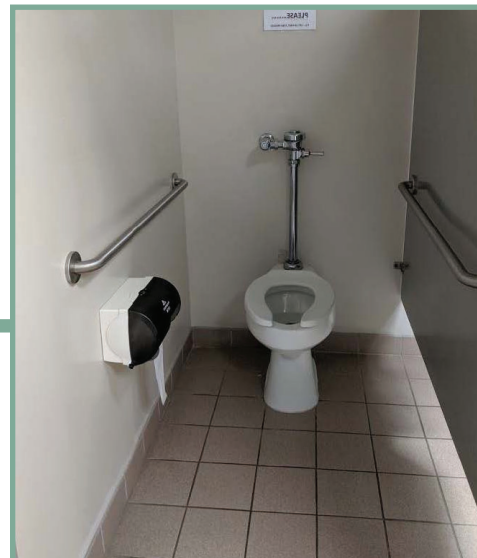
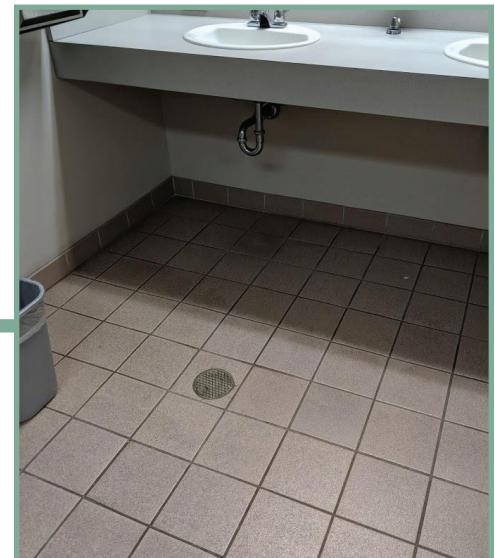
- » No coat hook present, however, if installed, needs to be between 15-48" above the floor.
- » The rear grab bar is 25" long due to space restrictions. ADA Standards require a rear grab bar 36" long.
- » ADA Standards require that the toilet paper dispenser be installed 7-9" from the front of the toilet to the centerline of the dispenser. The dispenser is currently 16" from the toilet to the center of the dispenser.
- » Operable portion of light switch 50" high – in the future, install operable parts no higher than 48" above the floor.

Note: The restrooms in the back (at the Multi-Purpose Room) should not be open to the public. There is accessible signage present, however the restrooms do not meet ADA Standards. Recommend signage either discouraging public use or stating "accessible restroom in lobby." **There are no high, moderate, or low recommendations.**

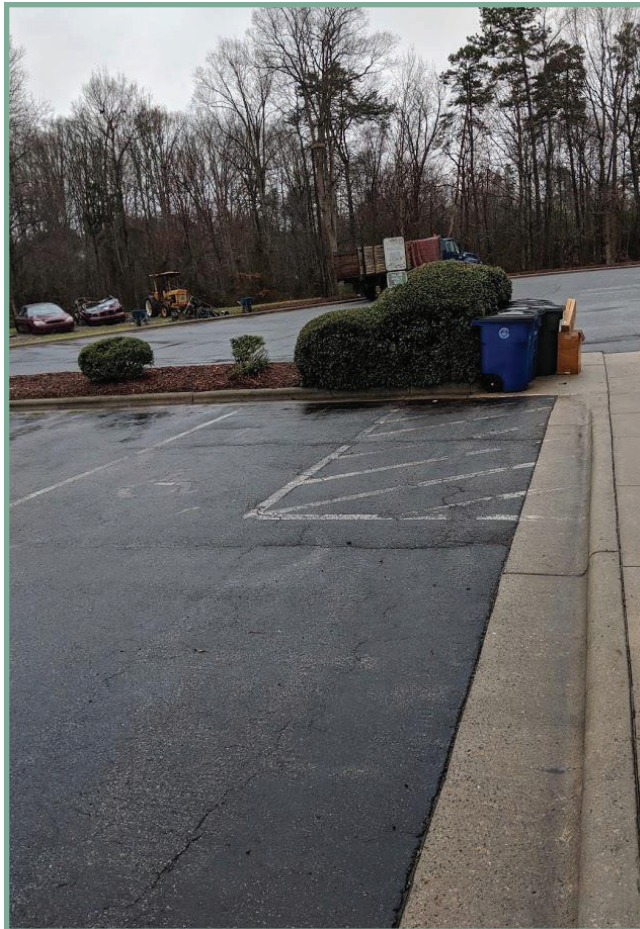
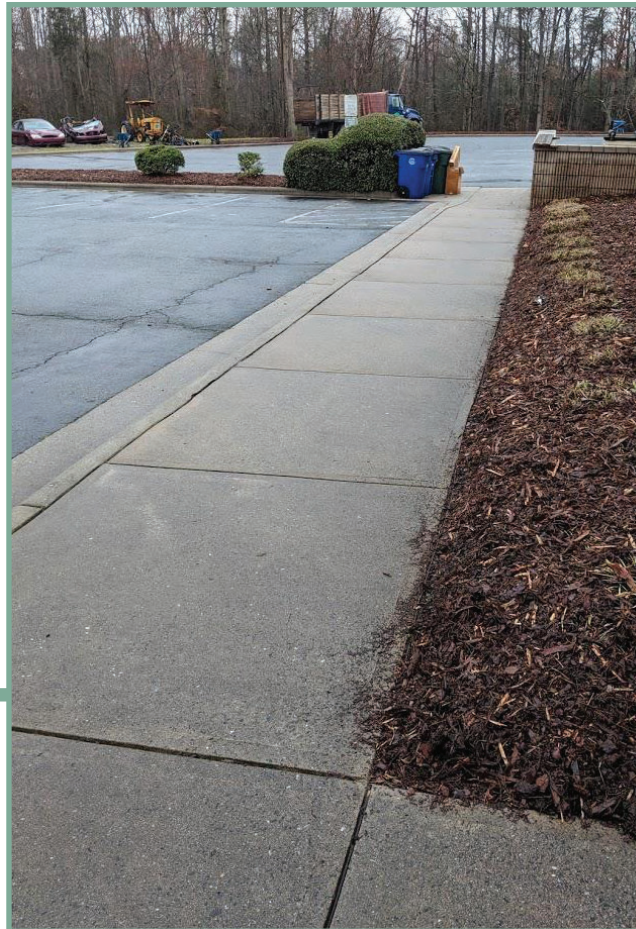
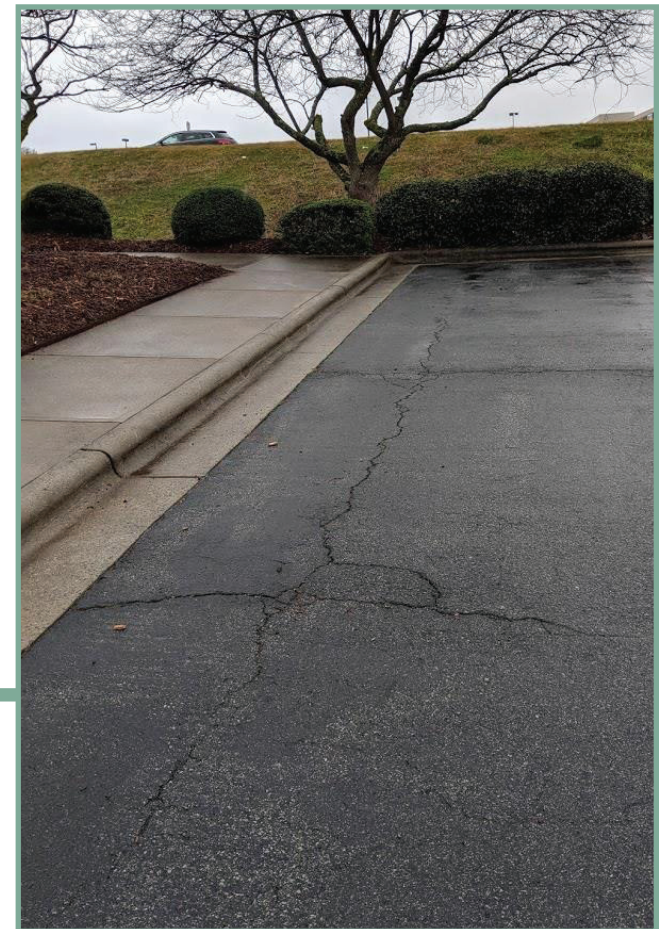
Accessible Parking

- » The accessible parking is not located close to the main entrance of the building and the sidewalk is very steep. The space needs to be moved as close to the main entrance as possible and a curb ramp should be installed. The bottom right picture is the recommended space location.
- » The accessible aisle leading onto the walkway is blocked by trash receptacles.
- » The space and access aisle need to be as flat as possible. ADA Standards require the slope measure less than 2% in all directions.

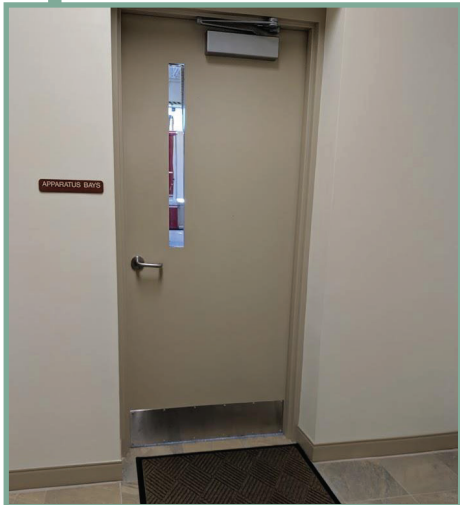
Interior and Exterior Door Pressures

High Priority		No Moderate Priority	No Low Priority
<ul style="list-style-type: none"> » Exterior Door at Accessible Parking Space: Push Pressure: 11 pounds Pull Pressure: 11 pounds Closure Time: 4.07 seconds » Interior Door (after entering from accessible space): Push Pressure: 7 pounds Pull Pressure: 6 pounds » Interior Door (from hallway leading into lounge): Push Pressure: 9 pounds Pull Pressure: 7 pounds Closure Time: 3.99 seconds 	<ul style="list-style-type: none"> » Interior Door (Lounge at phone next to Kitchen): Push Pressure: 9 pounds Pull Pressure: 9 pounds Closure Time: 3.95 seconds » Interior Door to "Exercise Room": Push Pressure: 12 pounds Pull Pressure: 6 pounds Closure Time: 2.43 seconds » Exterior Door of "Exercise Room": Push Pressure: 15 pounds Pull Pressure: 11 Pounds Closure Time: 2.42 seconds

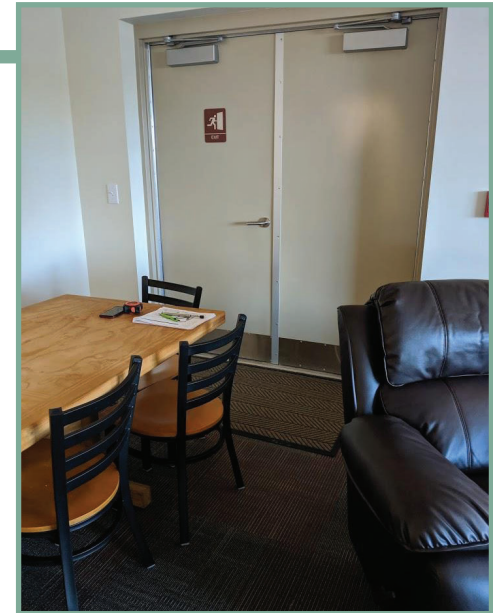
High Priority	Moderate Priority	No Low Priority
<ul style="list-style-type: none"> » The exit is difficult to access due to the table. There should be an accessible path leading to the doorway for safe entering/exiting. 	<ul style="list-style-type: none"> » Be sure to include a space large enough for someone in a wheelchair to sit in the furniture area and at the table. This space should be 36 inches wide (30 inches wide at the table) by at least 48 inches long.

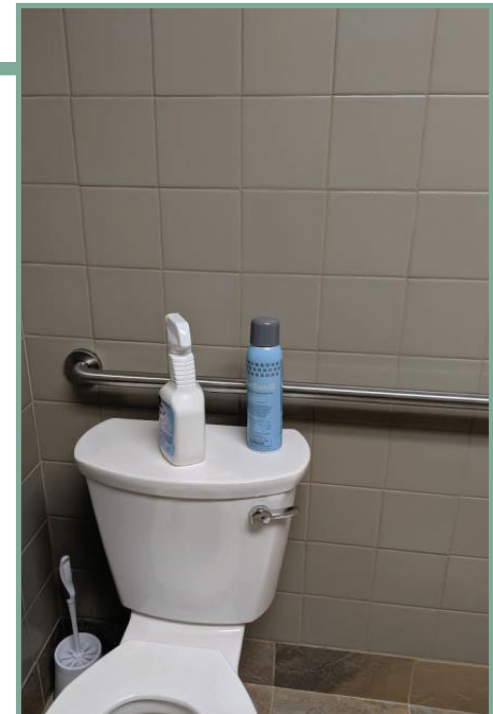
Women’s Restroom (Single Compartment)

High Priority	Moderate Priority	No Low Priority
<ul style="list-style-type: none"> » Women’s Restroom Door Pressures: Push Pressure: 12 pounds Pull Pressure: 10 pounds Closure Time: 2.49 Seconds 	<ul style="list-style-type: none"> » Move cleaning supplies from the back of the toilet so the rear grab bar isn’t blocked.

- » The highest grab bar is located 6” above the side grab bar. ADA Standards require a 12” clearance between the grab bar and protruding objects above. If the facility was built prior to March 15, 2012, there are no space requirements above or below bars.
- » There is no hook present. Hooks are not required, however, if installed, must be placed 15-48” high.

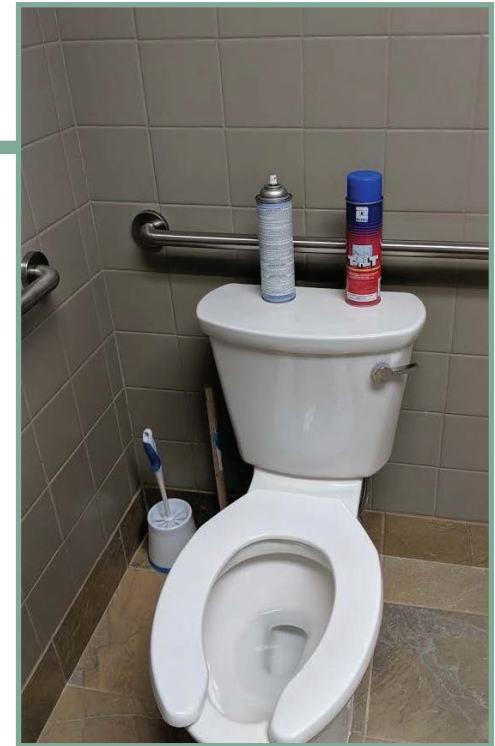
Men's Restroom (Single Compartment)

High Priority	Moderate Priority	No Low Priority
<ul style="list-style-type: none"> » Men's Restroom Door Pressures: Push Pressure: 12 pounds Pull Pressure: 10 pounds 	<ul style="list-style-type: none"> » Move cleaning supplies from the back of the toilet so the rear grab bar isn't blocked.

- » The highest grab bar is located 6" above the side grab bar. ADA Standards require a 12" clearance between the grab bar and protruding objects above. If the facility was built prior to March 15, 2012, there are no space requirements above or below bars.
- » There is no hook present. Hooks are not required, however, if installed, must be placed 15-48" high.

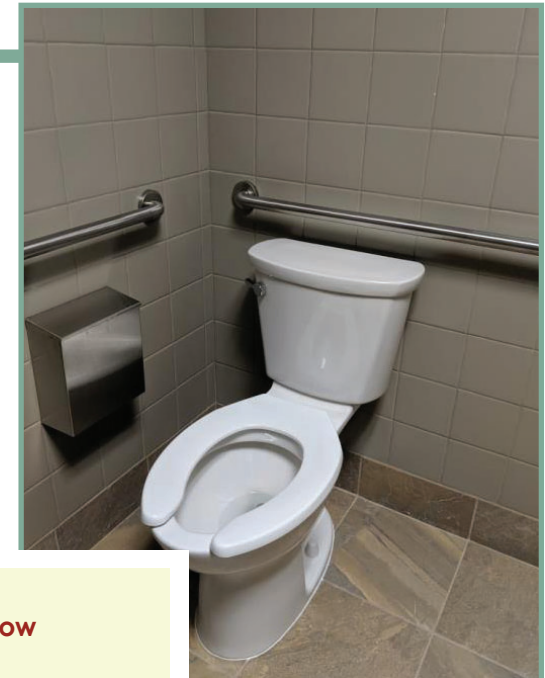
High Priority	No Moderate Priority	Low Priority
<ul style="list-style-type: none"> » If the showers are not open to the public, signage ("employees only") and a barrier need to be installed. » Women's Locker Room Door Pressures: Push Pressure: 12 pounds Pull Pressure: 9 pounds Closure Time: 2.82 seconds 		<ul style="list-style-type: none"> » The flush handle is not located on the open side of the toilet.

- » The highest grab bar is located 6" above the side grab bar. ADA Standards require a 12" clearance between the grab bar and protruding objects above. If the facility was built prior to March 15, 2012, there are no space requirements above or below bars.

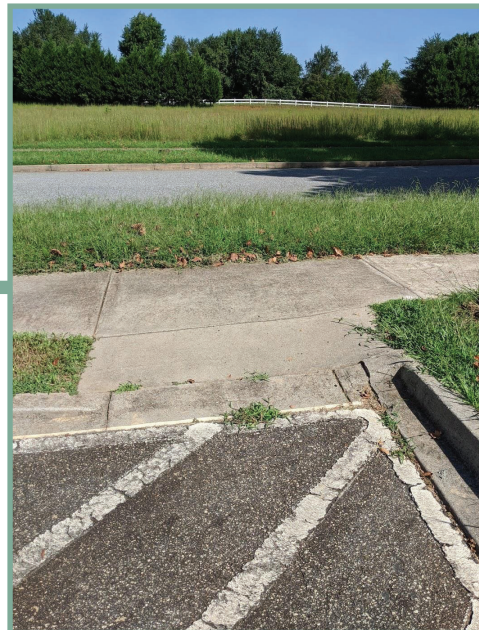
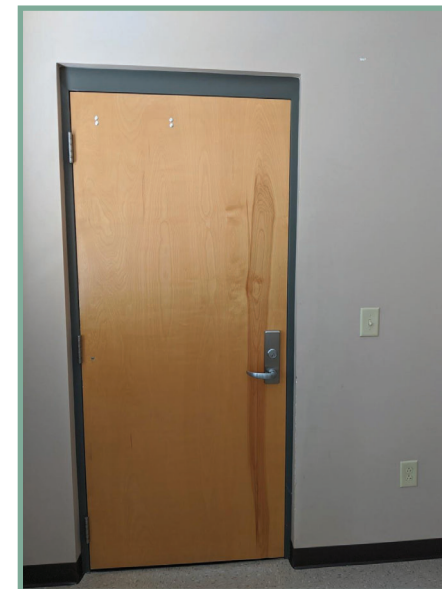
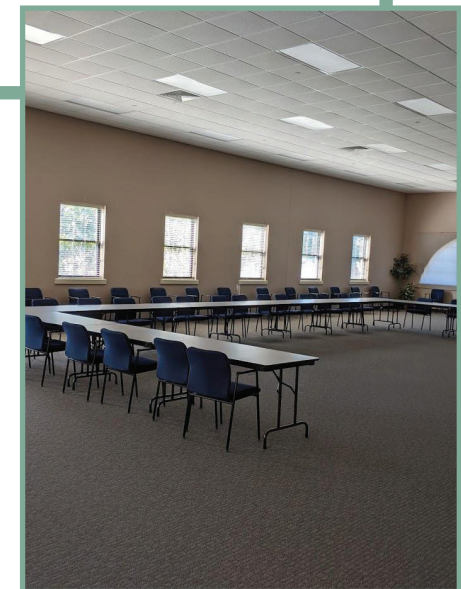
Parking Lot

No High Priority	No Moderate Priority	Low Priority
		<ul style="list-style-type: none"> » Cross slope at curb ramp connecting to accessible parking space has a cross slope of 4.3% and needs a smoother transition.

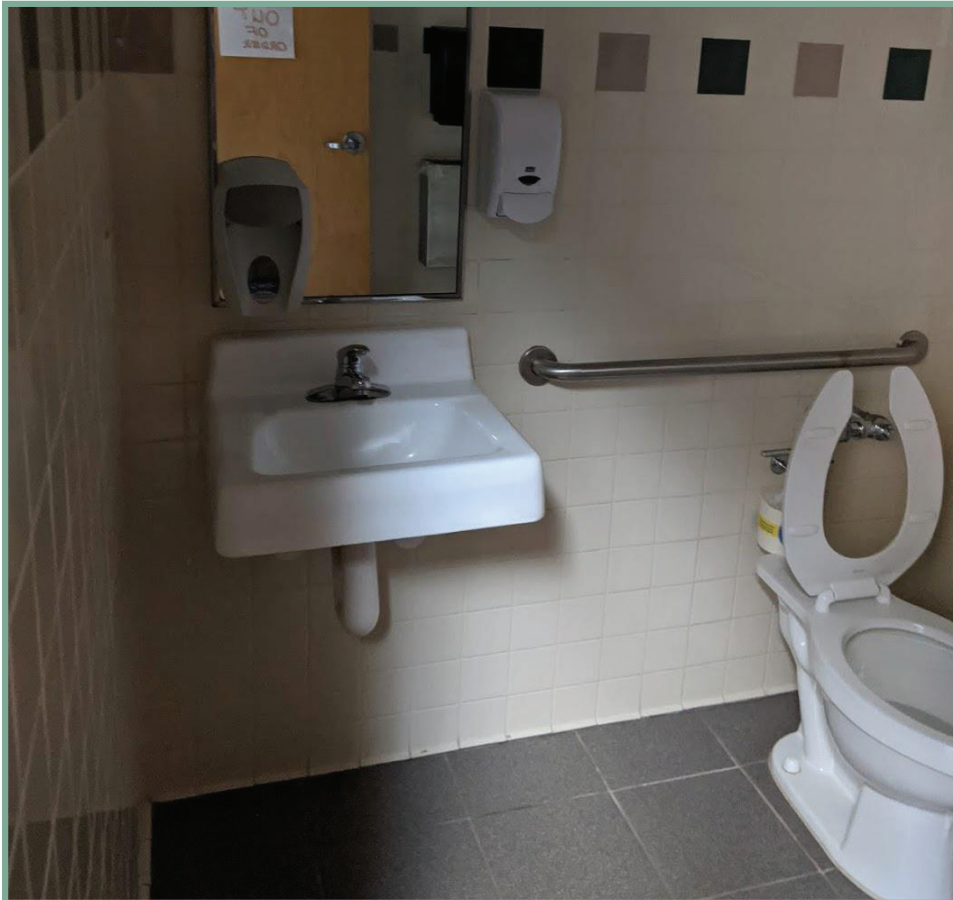
Men's Restroom

» No functioning light – safety hazard to all users.

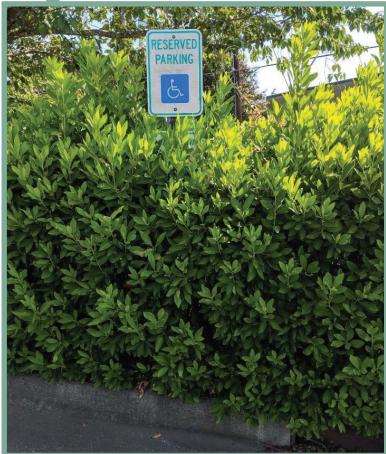
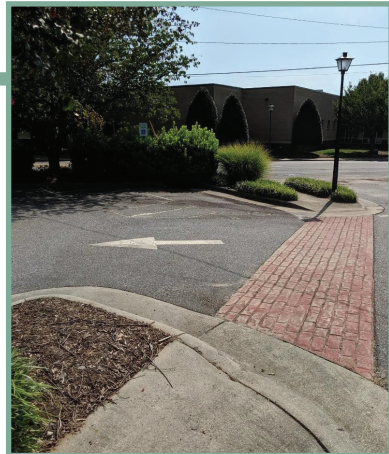
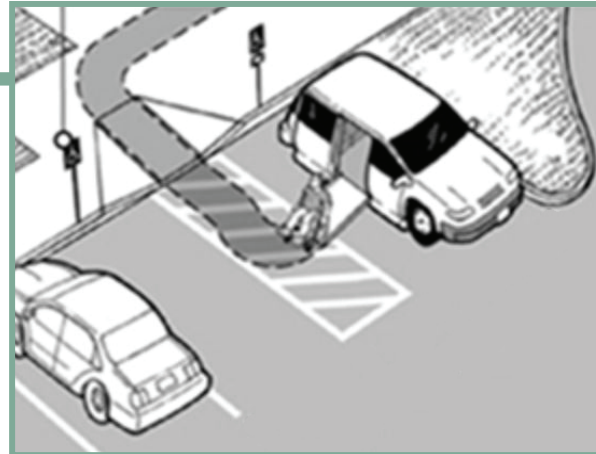
NE Alleyway Parking Lot – 109 1st Ave N

- » The cross slope at the top of the accessible space (next to the storm drain) measured 4%. The running slope of the same space measured 3.4% at the bottom of the space. All other measurements met requirements. This does not pose an immediate safety hazard.
- » The cross slope at the bottom of the 2nd accessible space measured 4.4% at the bottom of the space and 2.8% at the top. All other measurements met requirements. This does not pose an immediate safety hazard.

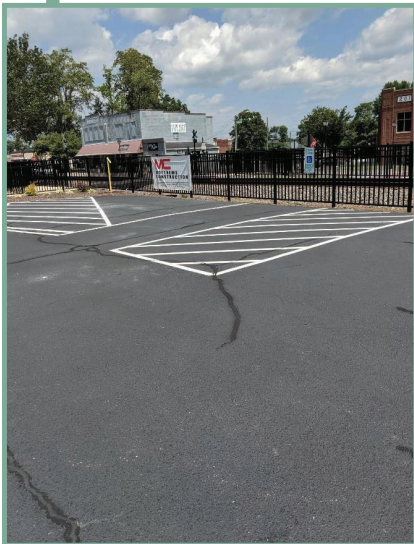
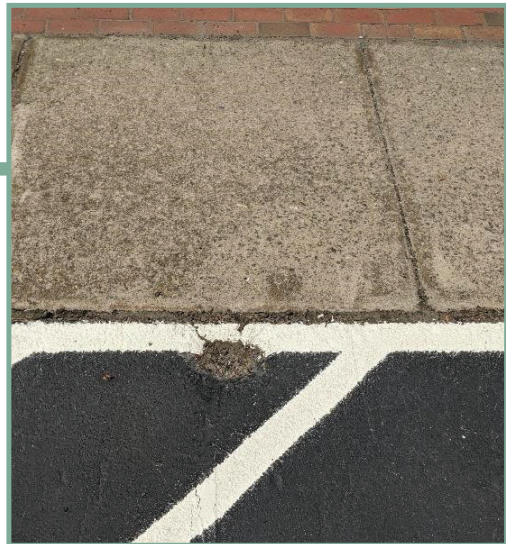
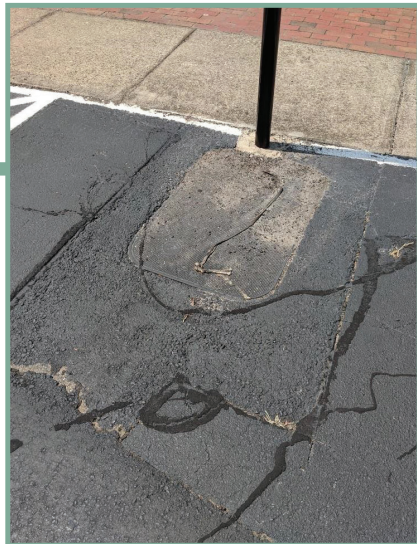
Z-Gate Parking Lot – 501 1st Ave S

<p style="text-align: center;">High Priority</p>	<p>No Moderate Priority</p>	<p style="text-align: center;">Low Priority</p>
<ul style="list-style-type: none"> » The bottom of all accessible signs must be posted at least 60" high. The current accessible space signs closest to the railroad tracks are 35-36" high. » Of the accessible spaces, at least one must be van accessible. A sign needs to be placed at least 60" high (to the bottom of the sign) reading "Van Accessible". Van spaces must be at least 11 feet wide with an access aisle of at least 5 feet wide for a total of 16 feet, or at least 8 feet wide with an access aisle at least 8 feet wide for a total of 16 feet. Currently, there is no van accessible signage; however, most accessible spaces meet van accessible space dimensions. 		<ul style="list-style-type: none"> » Fill holes in accessible spaces and aisle-ways that could be hazardous to mobility. » The running slope of the center of the space connecting to the sidewalk (closest to the utility pole) measured 3%."

<p style="text-align: center;">No High Recommendations</p>	<p style="text-align: center;">Moderate Recommendations</p> <ul style="list-style-type: none"> » The accessible space connecting to the sidewalk (closest to the charging station) is uneven and could be hazardous to mobility. Resurfacing is recommended. As shown in the picture on the bottom right, most uneven sections are where cars would be parked. This would not present an immediate safety hazard except to those traveling through an empty space. 	<p style="text-align: center;">No Low Recommendations</p>

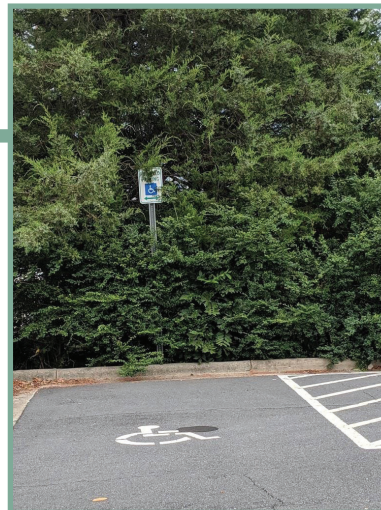
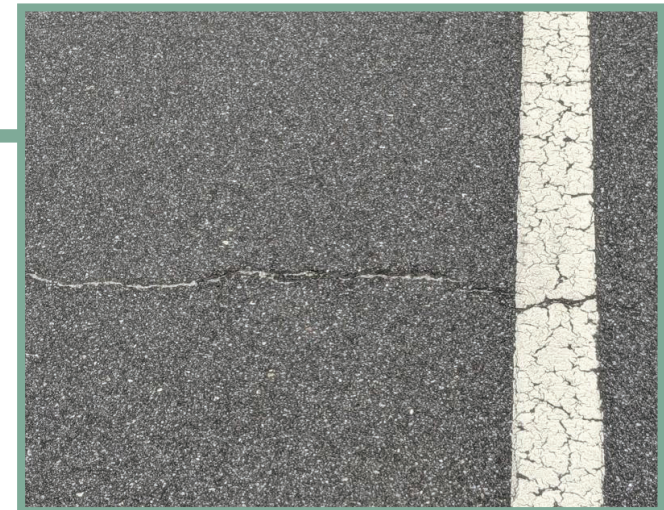
SE Alleyway Parking Lot – 122 2nd Ave SE

High Priority	Moderate Priority	Low Priority
<ul style="list-style-type: none"> » Cut vegetation for sign visibility 	<ul style="list-style-type: none"> » Adjoin access aisle (striped area next to accessible space) to a striped accessible route or follow high recommendation below: 	<ul style="list-style-type: none"> » Fill any gaps that exceed .5" – most cracks did not exceed .5" » The running slope of the accessible space closest to Wright and Associates is currently 5% when measured near the top of the space. The running slope of the accessible aisle next to the space is 4.1% when measured near the top of the aisle. All other measurements were correct. This does not pose and immediate safety hazard. » The running slope is currently 4.6% in the accessible van space closest to Pamela's Resale Shop and 3.6% in the accessible aisle. These were the only measurements that exceeded ADA standards. The middle and bottom of the space and aisle were correct.

High Recommendations	Moderate Recommendations	No Low Recommendations
<ul style="list-style-type: none"> » Recommend moving spaces closer to the accessible route. This would involve curb cuts at the access aisles. Space should be moved to connect to cemented area in center of parking lot. The space should have a curb ramp at the access aisle connecting to the sidewalk. This is only possible if there are 36" around the light poles. If moving spaces is not feasible, then ADA requires a striped aisle connecting to the accessible route. 	<ul style="list-style-type: none"> » Add pedestrian crossing and signage at road crossing adjoining to sidewalk. This is not a busy road, but this recommendation helps to identify the accessible route.
