City of Conover

ADA Transition Plan

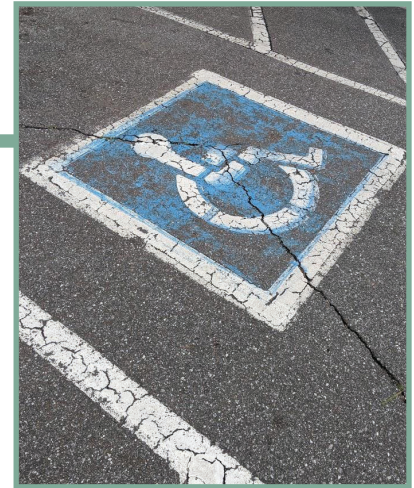
PO Parking Lot - Accessible Space 1 (Closest to Post Office)

No High Priority	Moderate Priority	Low Priority
	» Access aisle does not connect to an accessible pathway.	<ul style="list-style-type: none"> » Middle of Space: 3.6% running slope; Middle of Access Aisle: 3.2% running slope » Bottom of Space: 2.6% running slope; Bottom of Access Aisle: 4.2% running slope » Fix cracks within space and aisle.

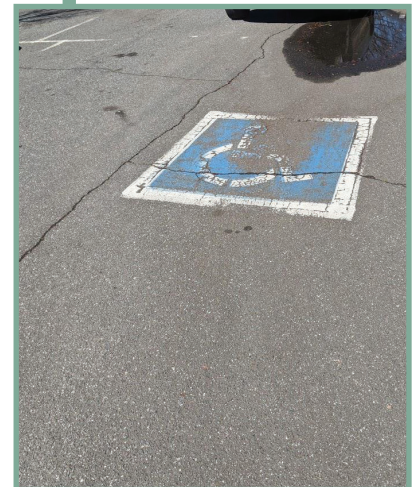
PO Parking Lot - Accessible Space 2

No High Priority	Moderate Priority	Low Priority
	» Access aisle does not connect to an accessible pathway.	<ul style="list-style-type: none"> » Top of Space: 2.9% running slope » Middle of Space: 3.5% running slope; Middle of Access Aisle: 3.1% running slope" » Bottom of Access Aisle: 2.6% running slope

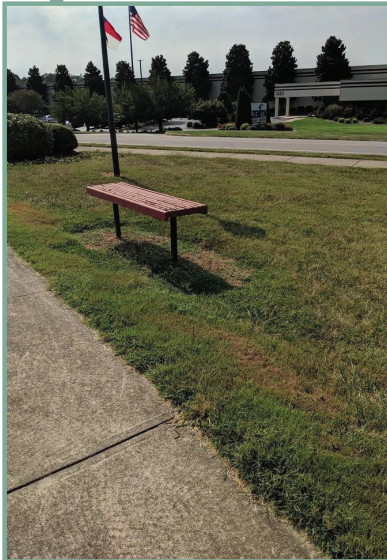
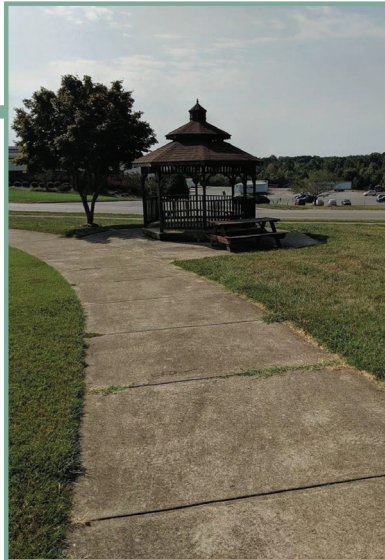
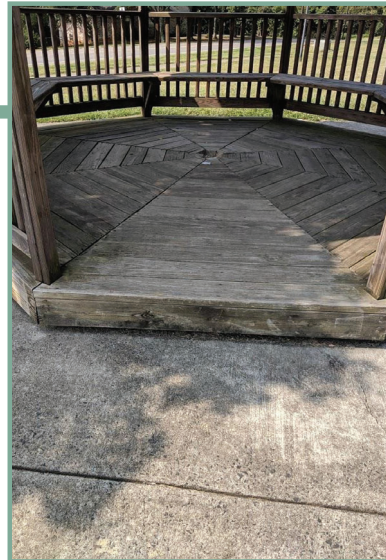
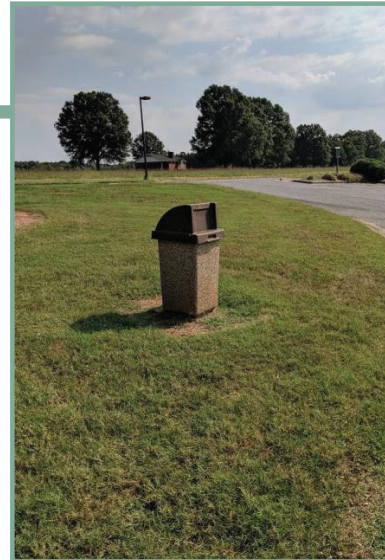
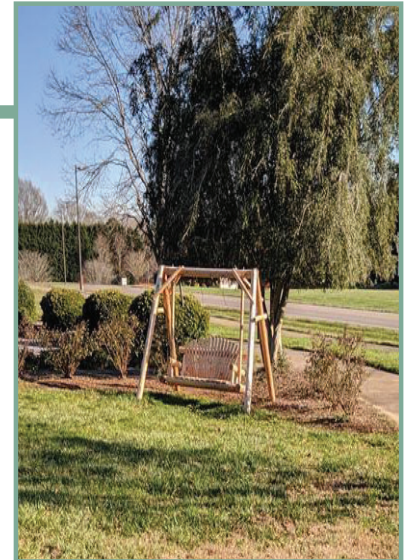
Hines Park

- » Install a shaded area comparable to the gazebo that is wheelchair accessible or a ramp into the gazebo. Please follow ramp standards in Priority 1 – Approach and Entrance. This is impassable to wheelchair users and a safety hazard.

- » Vegetation needs to be cut out of the path of travel (the tree poses a safety hazard). Trees must be trimmed as high as 7’.
- » Move the trash receptacle to an area that is wheelchair accessible.

- » The wooden swing needs to be located on an accessible pathway with 60” by 60” of clear accessible space next to the swing. Recommend a paved and level area (<2% slope in all directions)

- » Add visually contrasting reflective tape on the step up into the gazebo. This tape will also be recommended on any installed ramp.

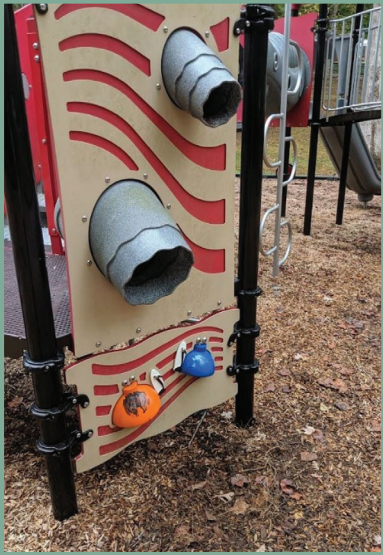
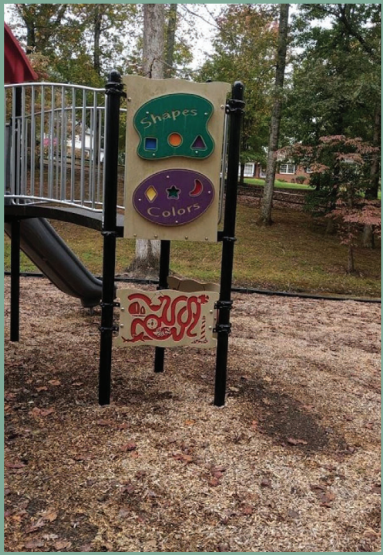
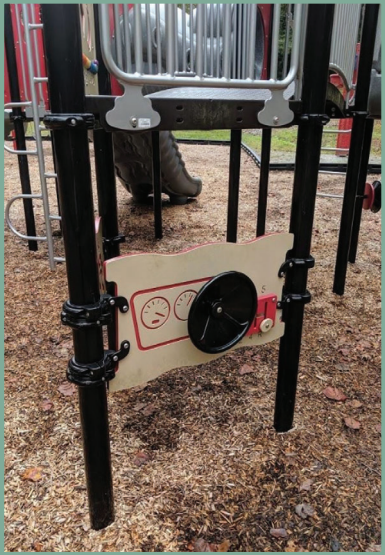
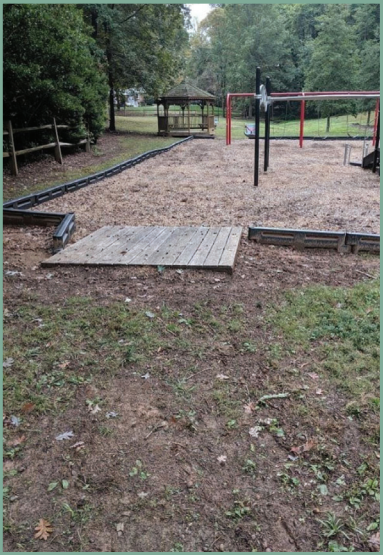
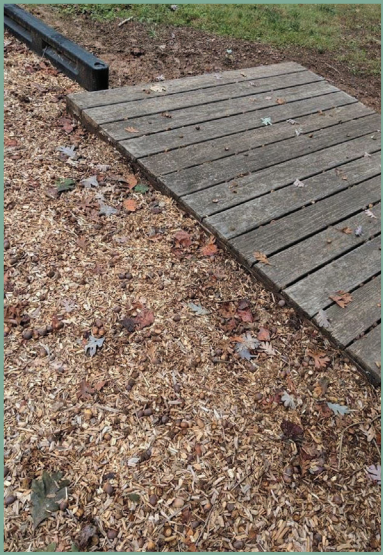
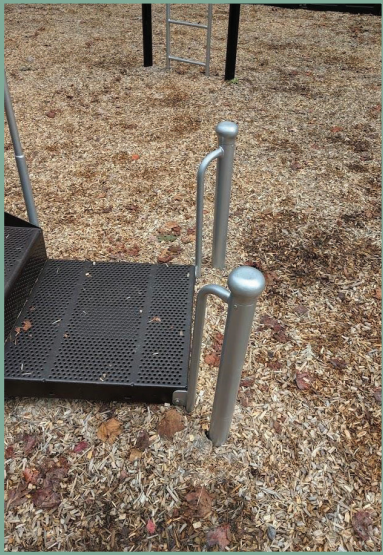
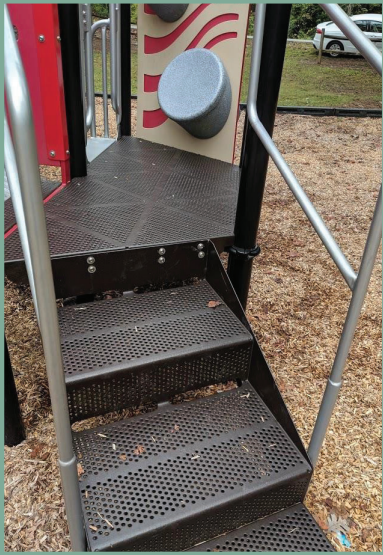
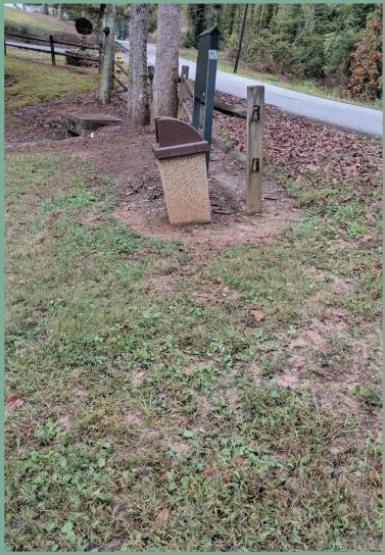
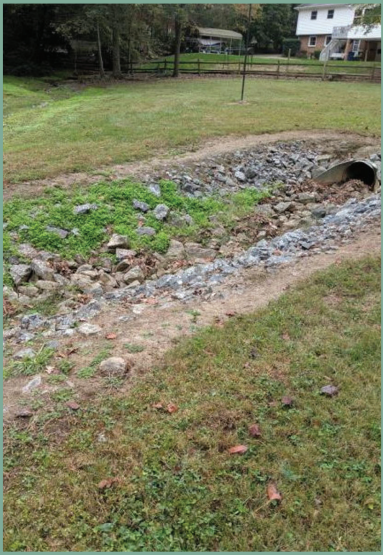
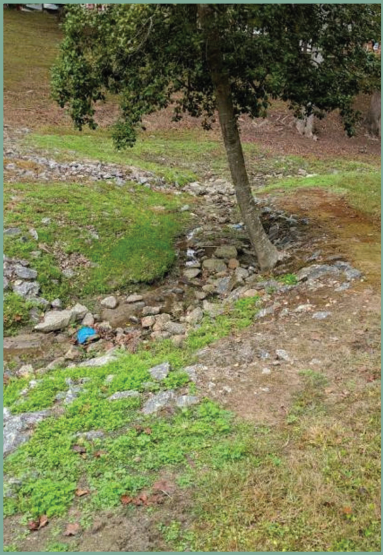
Hunsucker Park - Images Cont.

- » There should be a means for someone wheelchair bound to access the play area from 2nd Street. Accessible surface materials are included in Appendix C. The surface is currently too difficult for a person in a wheelchair to access. Since not following a roadway, accessible pathways can have a maximum running slope of 5% and a maximum cross slope of 2%. It is best practice to make pathways 5' wide.

- » Cracks in pavement and/or pathways cannot exceed 1/2”.
- » The picnic tables do not allow for knee space for wheelchair users (accessible tables have longer table tops).

- » Recommend moving the parking area entrance to the side of the parking area where the ground is more level and closer to the play area.
- » Recommend placing accessible parking spots at the bottom of the lot where the parking area is more level. An accessible pathway must connect to the accessible space access aisle.
- » Signage stating “Danger – No Public Access” and/or a barrier should be placed at the outfall next to the play area.

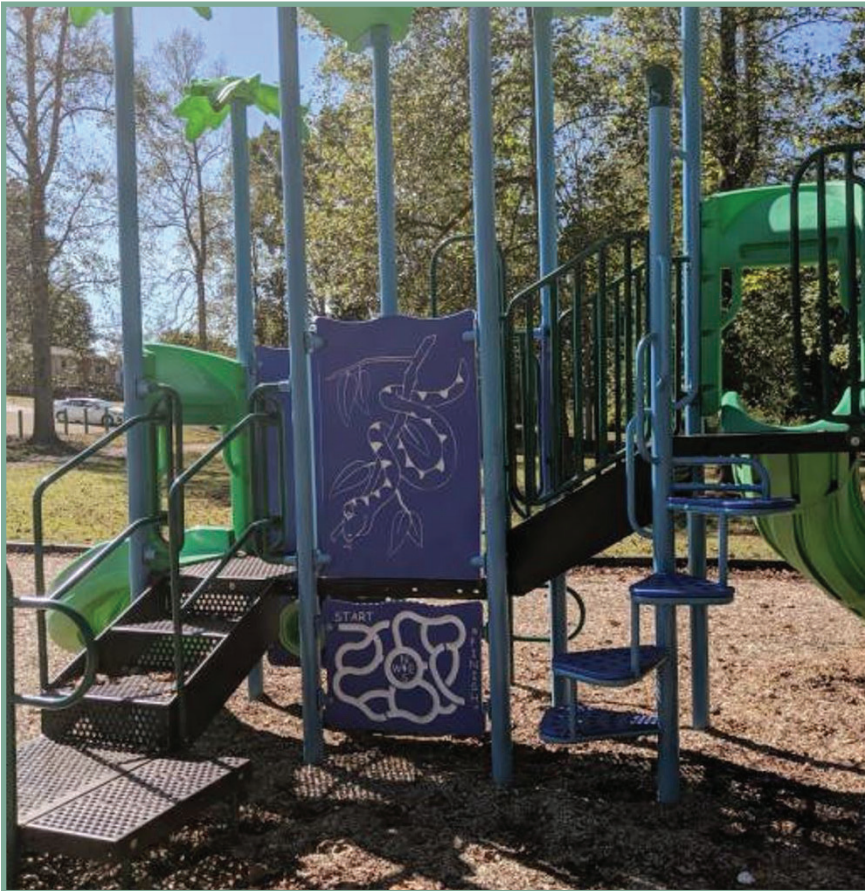
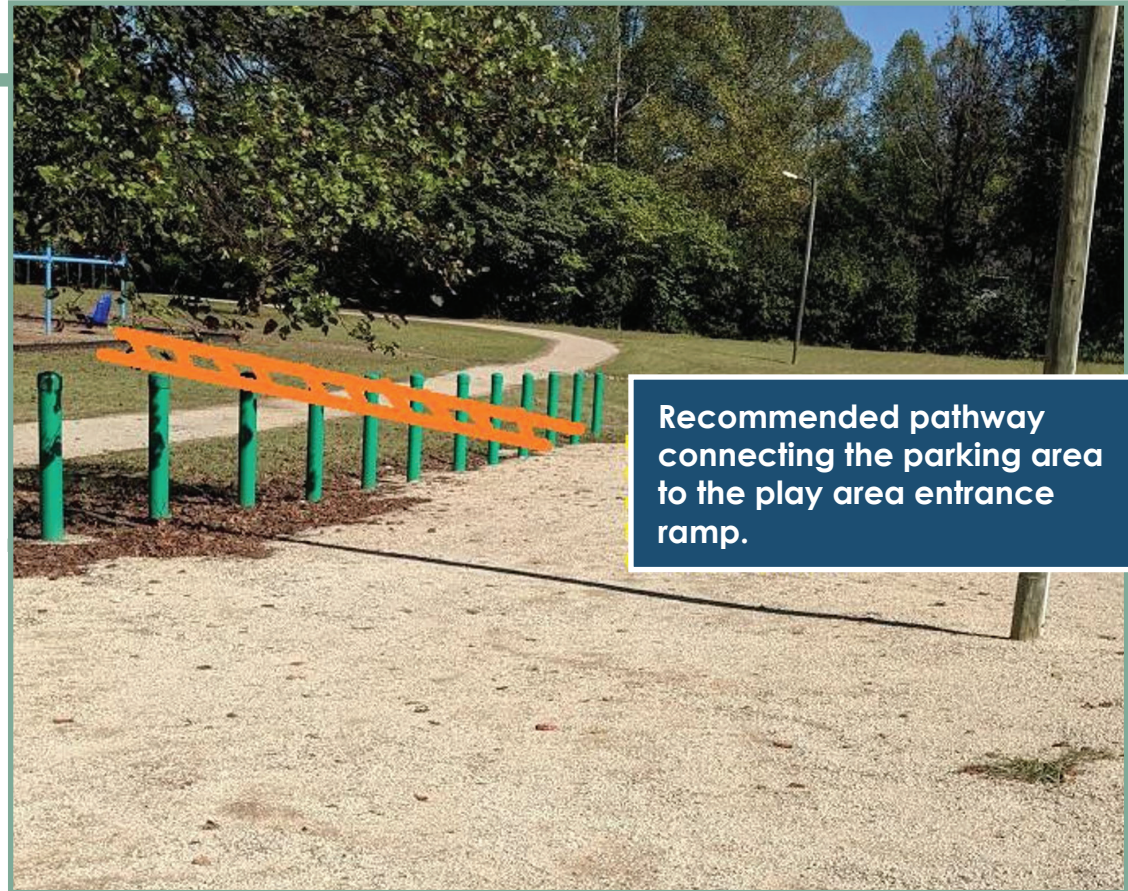
Recommended pathway connecting the parking area to the play area entrance ramp.

- » Recommend placing signage at the culvert stating “Danger – No Public Access” or a gate better separating the culvert from the play area.
 - » Currently there are no accessible play components on an accessible route. Since there is a swingset, there should be one accessible swing or comparable accessible play element.
 - » The seat should be 11-24” above the clear ground space. There should be an open circle 60” in diameter or a T-shaped space within a 60” square immediately adjacent to the accessible swing.
- ‡ Park items are not prioritized in the same manner as the previous facilities. Prioritize one entire play area at a time as opposed to making small improvements to several play areas.

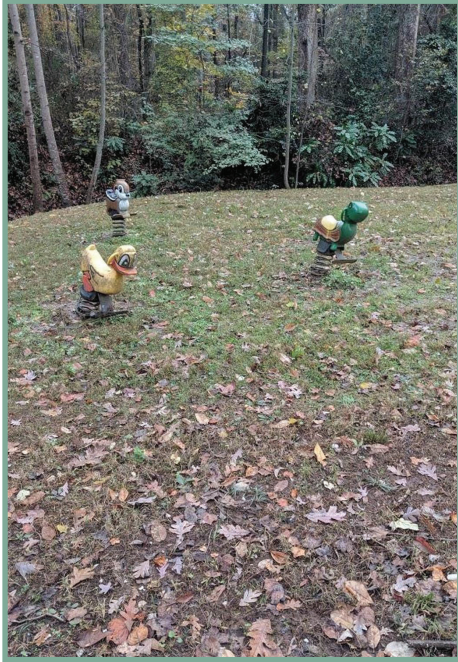
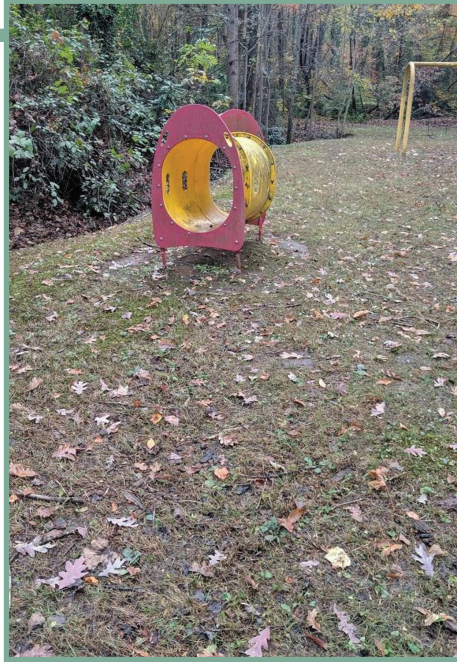
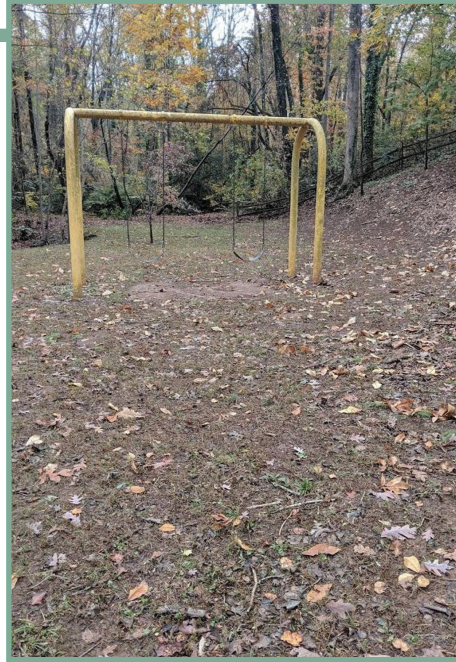
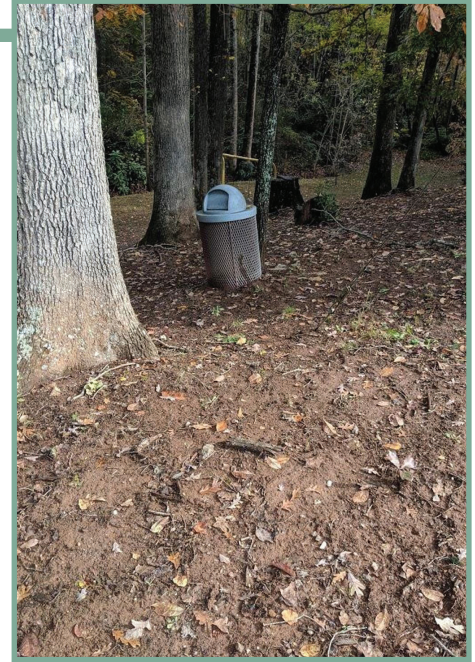
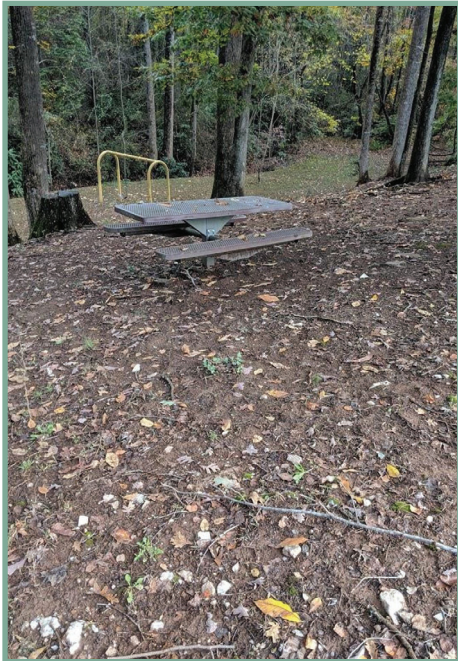
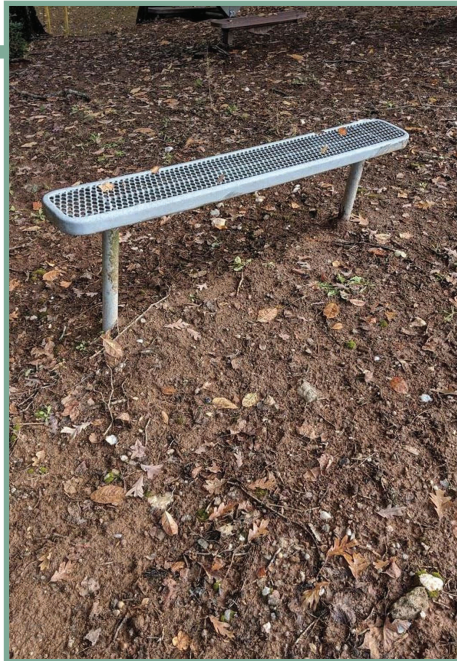
Travis Park - Cont.

- » There is no accessible route connecting the parking area to one of each ground level play element. The terrain is very steep and would exceed a 5% running slope. The current stairs are very unsafe and not accessible. If possible, recommend moving the parking area to the lower area next to the creek and connecting the lot to the road where it dead ends. There are no elements in this park accessible from the current parking area. There is no safe way for anyone to access the play components, especially those who are visually impaired or in wheelchairs.

- » Water is currently not draining properly at the bottom section of the park with all of the play elements. This creates a hazardous surface for all users, but is impassable for individuals with disabilities.

- » The entry point or seat to all play elements must be 11-24" from the clear ground space. The rockers do not comply in their current condition.

- » The slope of the stairway is very steep. The steps should be replaced. The new stairway could be improved with handrails, steps with a better gripping surface, and tape at the edge of each step for individuals with visual impairments. This would still not improve access for persons in wheelchairs. An accessible pathway is necessary per ADA Standards.
- » The play elements are very dated and could be hazardous. Recommend replacing play elements that could present a safety threat.
- » Recommend a sign next to the streambed stating "Danger - No Public Access" and/or a barrier.

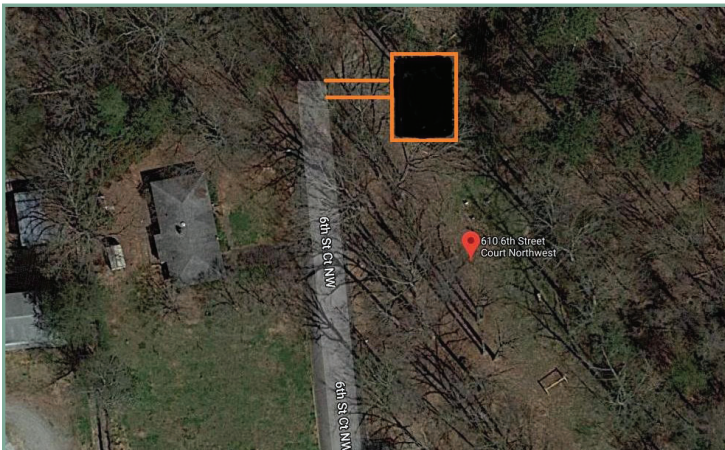
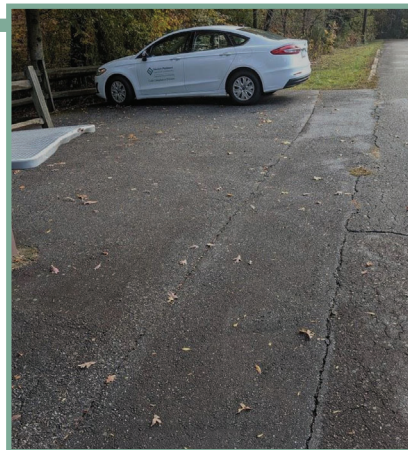
- » There is no designated accessible space at the bottom access to the park (next to the City Park sign)
- » The space to the left of the sign meets the proper size dimensions and slope requirements of a van or standard accessible space – signage should be added

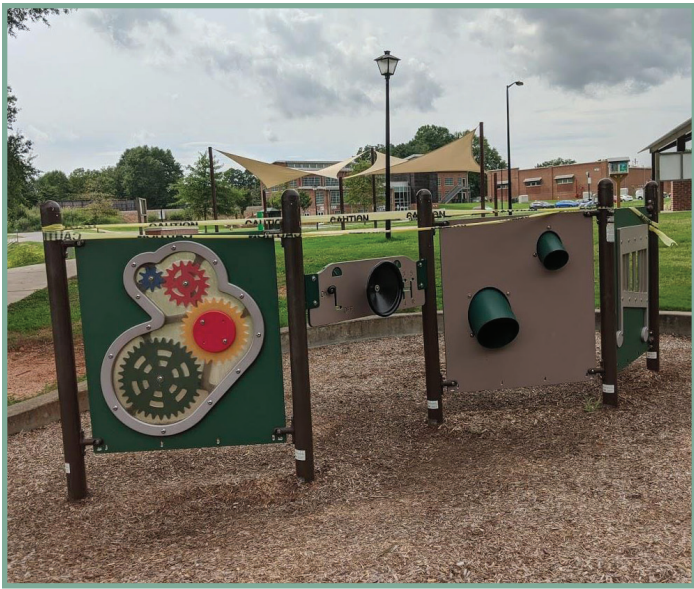
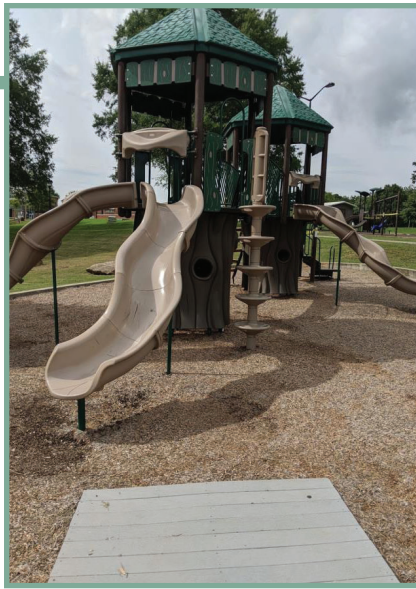
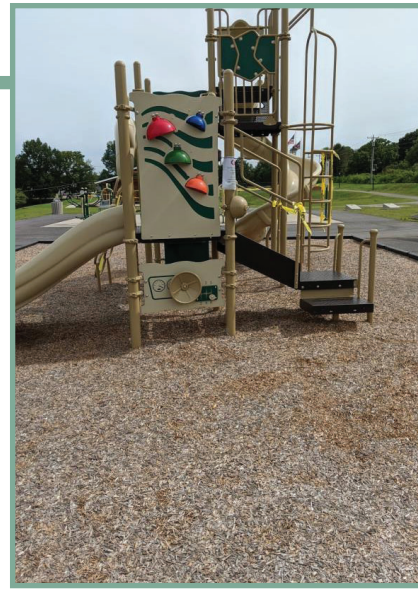
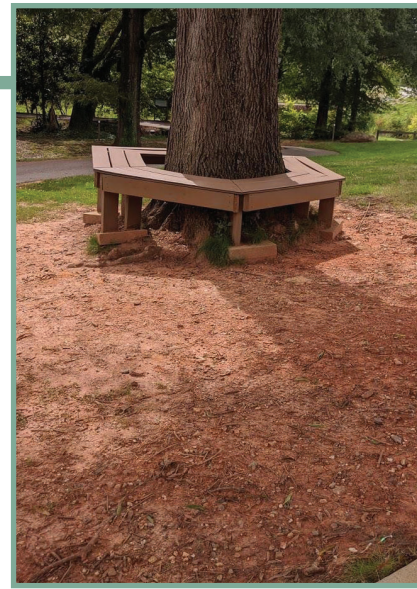
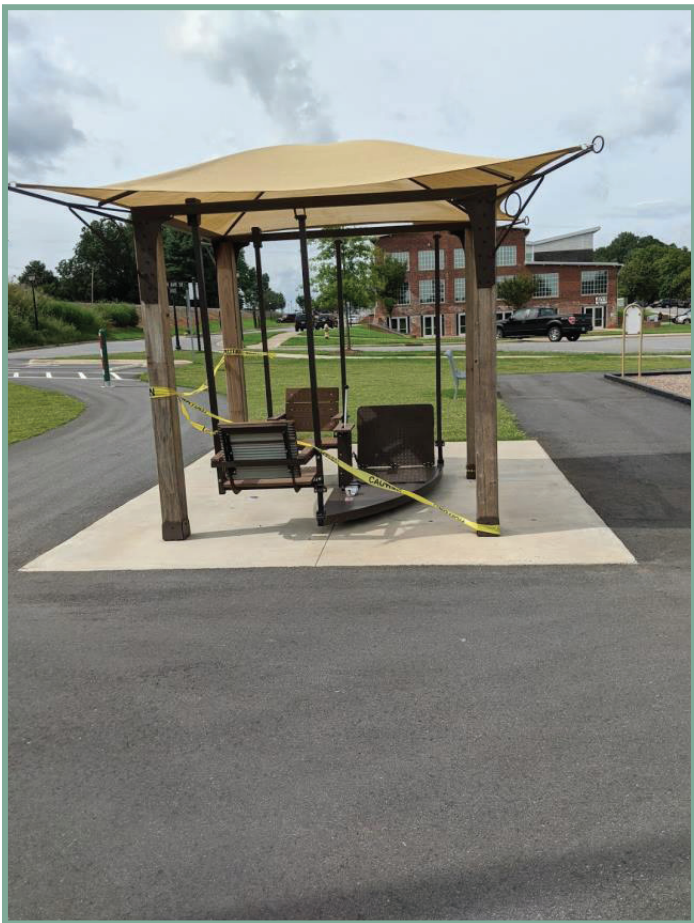
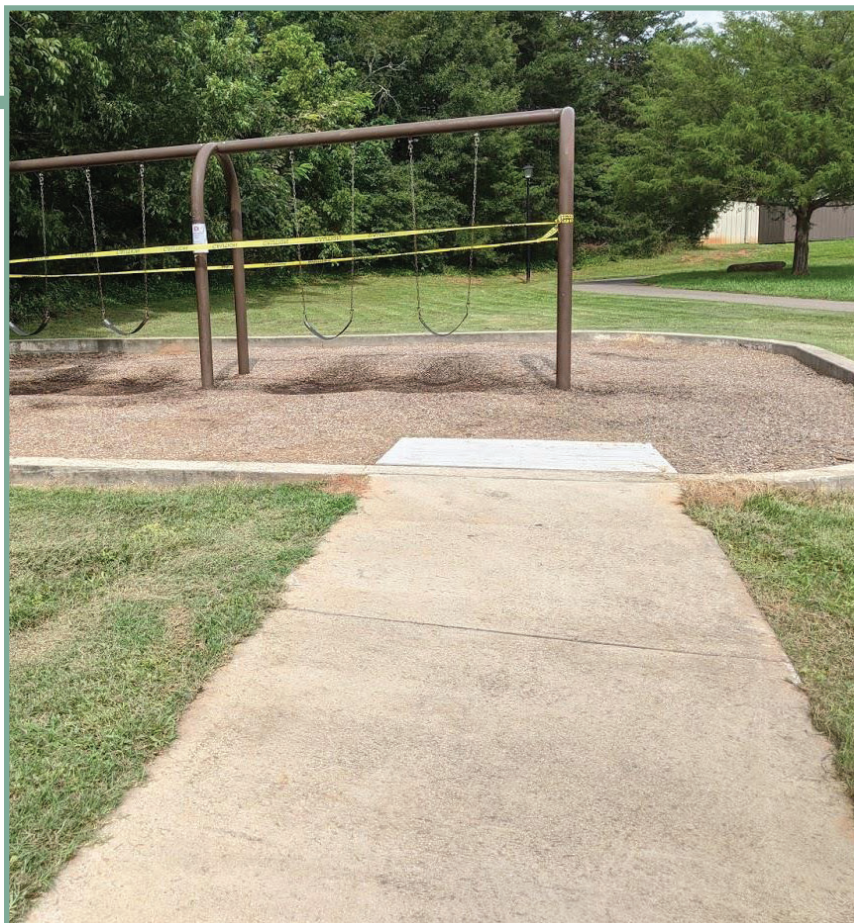
- » No accessible route within 2 of the 3 play areas
- » Mulched surface is too difficult for mobility. Mulch should be replaced with an accessible surface along accessible pathways and next to accessible play elements. Please note that while surfaces such as cement are accessible, they can also pose as a safety hazard in play areas if located too close to elevated and some ground level components.

- » There should be a better transition from the asphalt path to the bridge. There is more than a 1/2" vertical discontinuity creating a mobility hazard.

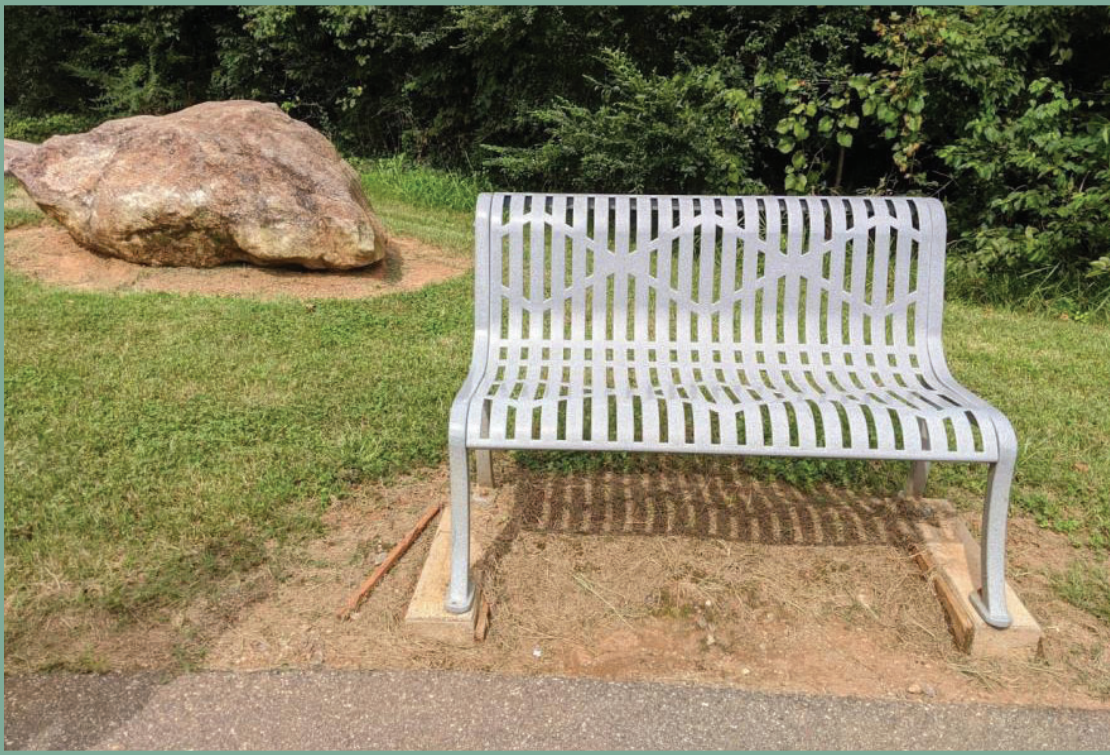
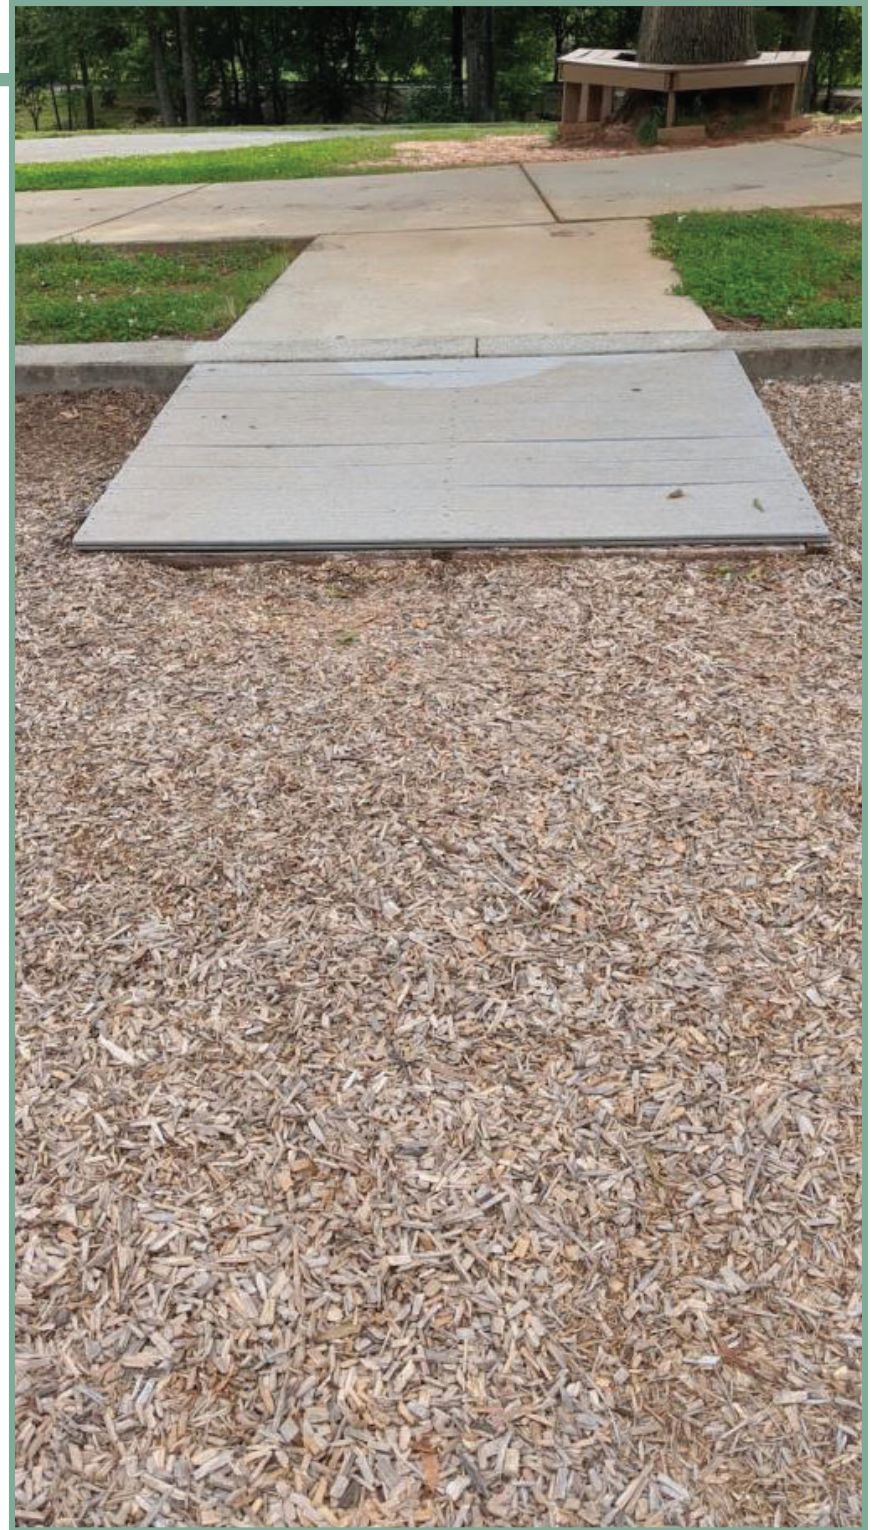
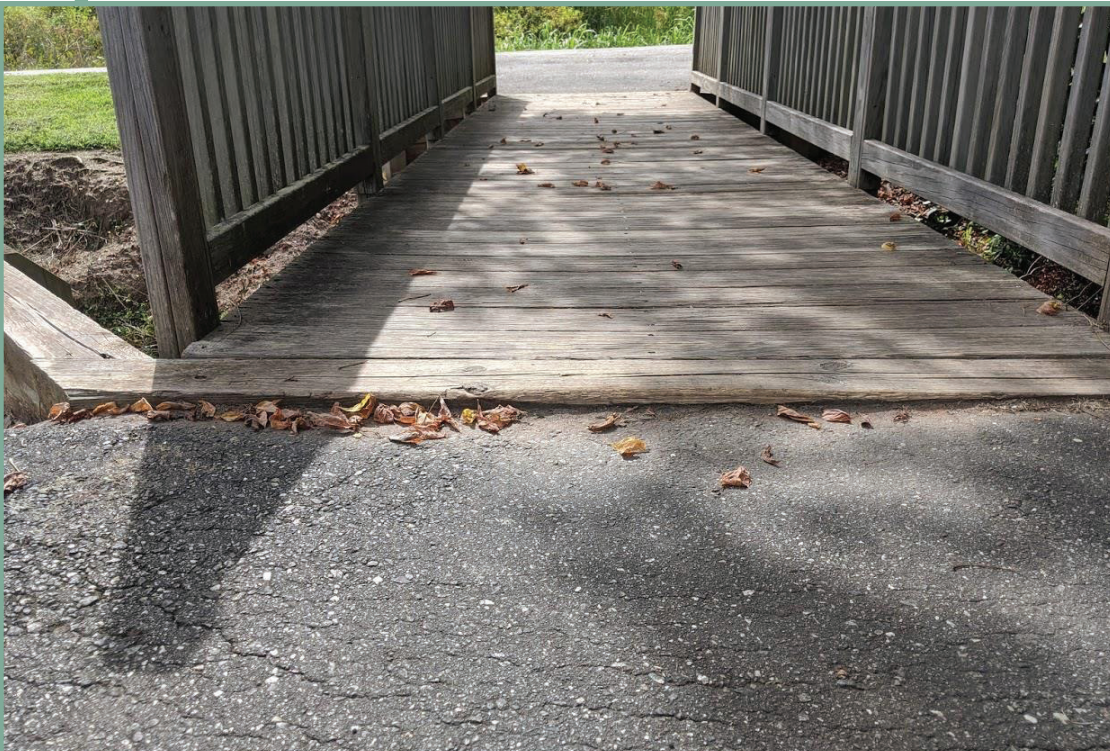
- » Access to one entrance of the park is obstructed due to non-compliant surface blocking the gate.
- » There is no accessible route connecting accessible play elements to the entrance of the park.

- » Mulched and gravel surface is too difficult for mobility. Mulch should be replaced with an accessible surface along accessible pathways and next to accessible play elements. Please note that while surfaces such as cement are accessible, they can also pose as a safety hazard in play areas if located too close to elevated and some ground components.

- » Recommend installing an ADA accessible swing as the accessible ground play element.
- » Accessible path should extend to benches overlooking the play area. There is a paved existing resting area between the benches where the accessible path could connect.

- » Recommend replacing some of the more dated play elements.
- » The basketball court is currently not accessible to all users due to the surface between the park gate and the court. This could easily be linked to the entrance of the park.

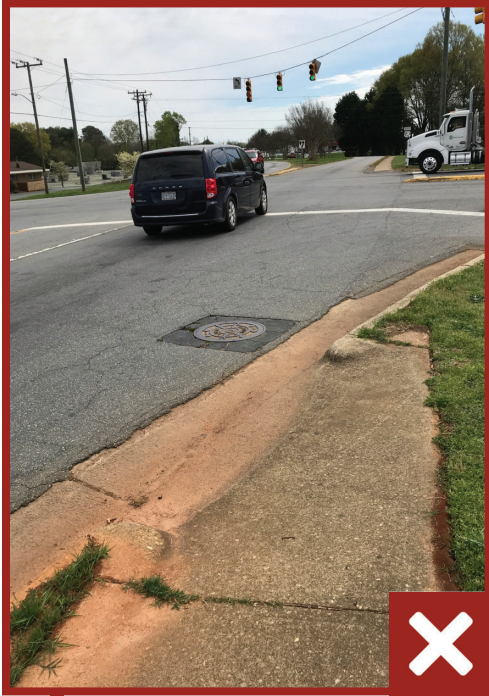
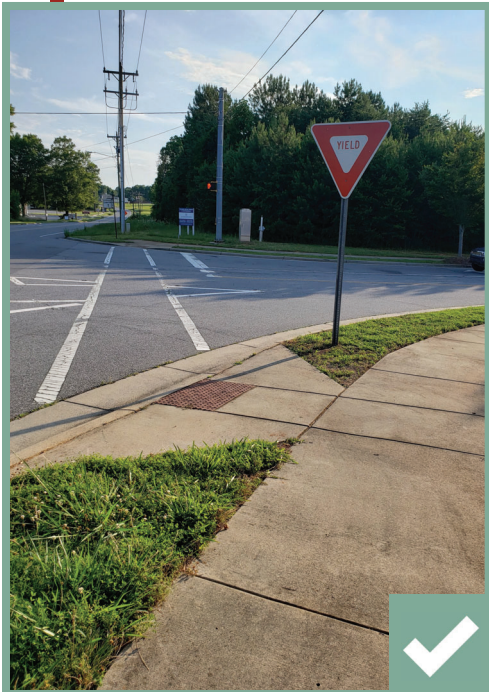
Curb Ramps

- » No detectable warning – detectable warnings, or truncated dome mats, are what warns visually impaired individuals that they are about to enter a roadway with vehicular traffic. These mats must visually contrast with the surrounding pavement and be placed at the back of the curb, right before the gutter. There are exceptions where back of curb is not always feasible, however, detectable warnings must be present when entering roadways. Detectable warnings must cover the entire depressed segment of curb and must be 24 inches wide. There should be a smooth surface around detectable warnings so that mats are more easily noticed. Detectable warnings are not necessary at residential driveway cuts. They are recommended at busy commercial driveway cuts.

- » The depressed curb must be at least 48 inches wide to allow for wheelchair accessibility.
- » If one curb ramp serves two adjoining crosswalks at two adjoining streets, there must be a space 48 inches wide and 48 inches deep that is outside of vehicle travel lanes and within the crosswalks. This space must be as level as possible. This is known as a diagonal curb ramp. While diagonal curb ramps are allowed, they are not recommended. New construction is advised against using diagonal curb ramps.

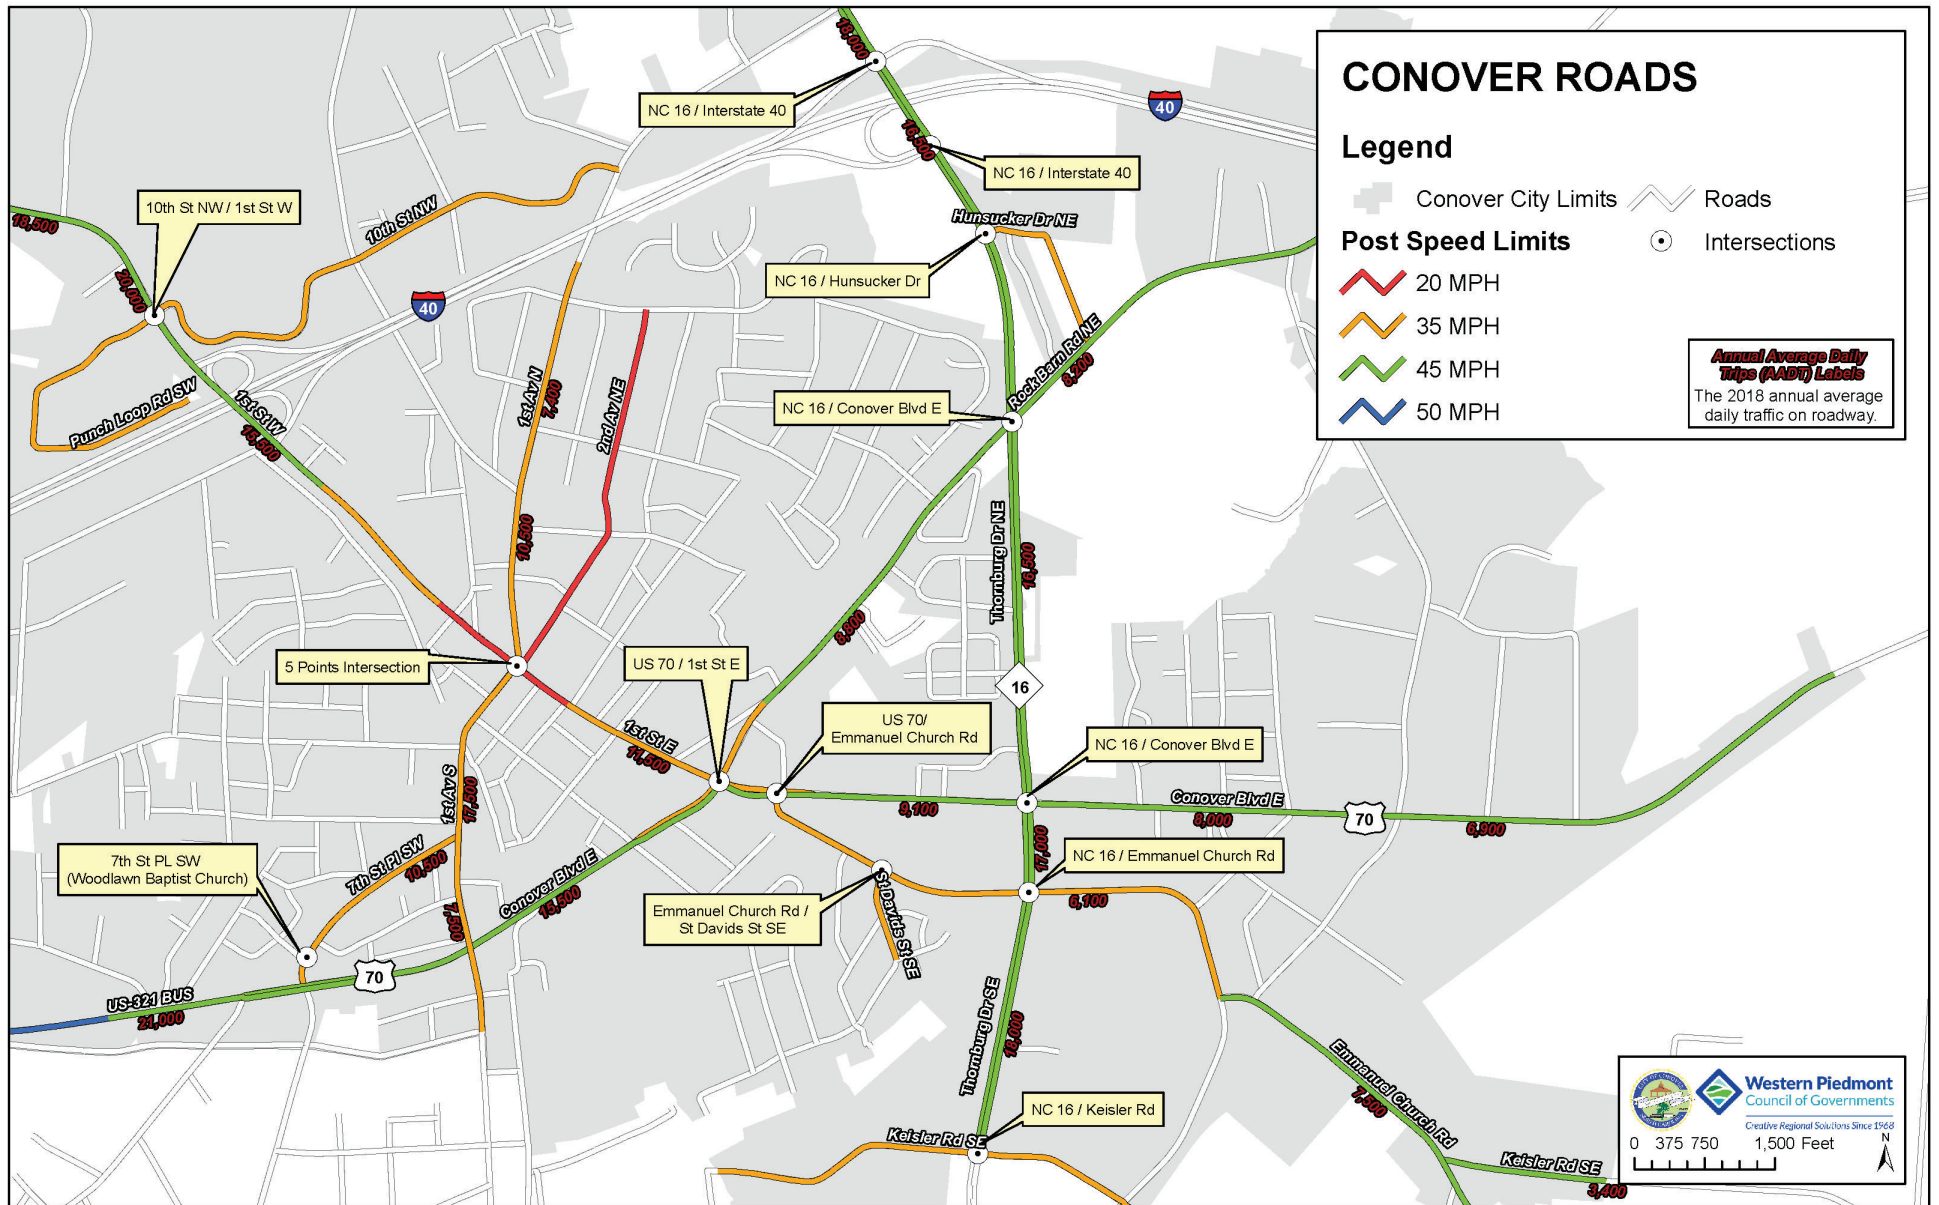
The map on page 137 displays available AADT counts as well as posted speed limits. The points call out specific problematic areas noted previously in the Pedestrian Right of Way section. The highest traffic volumes and highest speeds are along NC 16. The pedestrian facilities are compliant along this route; however, intersections lack a sense of pedestrian safety. 1st Ave South has a lower speed limit of 35; however, AADT counts are as high as 17,500. This is problematic at the intersection of 4th St Southwest

and 1st Ave South, 5 Points intersection, as well as the midblock crossing downtown. 7th St Place Southwest has a speed limit of 35 and an AADT count of 10,500. The high traffic counts and speed limits of US 70 make the midblock crossing on 7th St Place Southwest hazardous without proper warnings to motorists. The intersection of 10th St Northwest and 1st St West has a speed limit of 45 mph as well as an AADT of 20,000. An improved crossing at 1st St West is necessary for pedestrian safety. Please see suggested safety and ADA improvements in the Pedestrian Right of Way section.

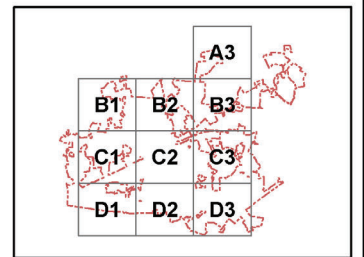
GRID Index: D3

The following maps display a magnified grid version of Conover's proposed SRN, Conover facilities, and pedestrian crashes. While many pedestrian crashes fell outside of the proposed SRN, several occurred within the SRN at identified problematic areas noted in the pedestrian right of way section. Each factor within the SRN should be analyzed in coordination with ADA standards to reduce pedestrian crashes.
