City of Conover

ADA Transition Plan

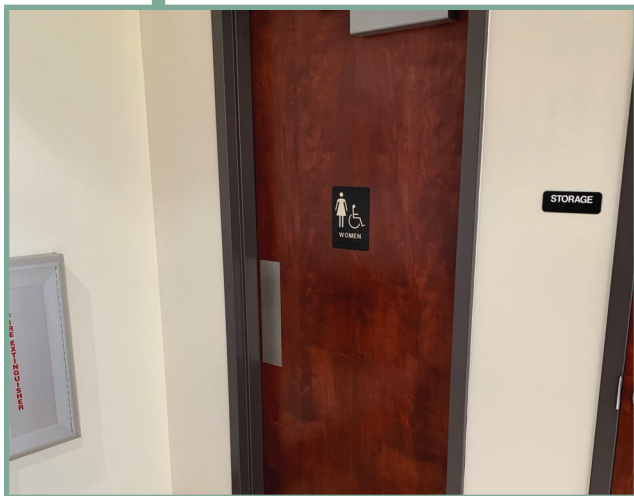
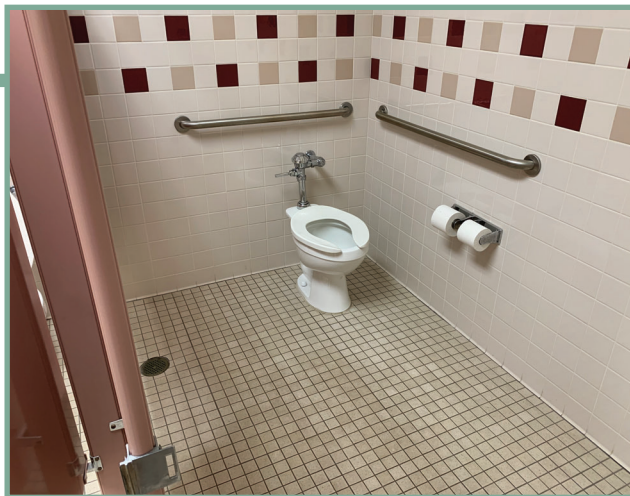
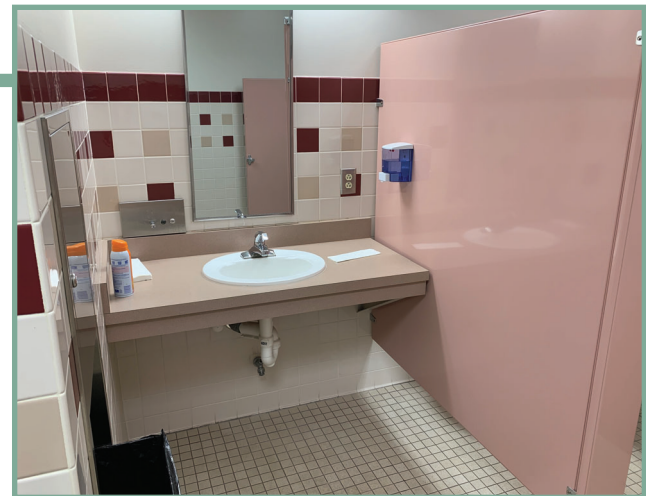
Men's Restroom - at the Council Chambers

High Priority	Moderate Priority	Low Priority
<ul style="list-style-type: none"> » Push pressure of restroom entry door: 7 pounds » Closure time of restroom entry door: 3.29 seconds 	<ul style="list-style-type: none"> » Restroom sign is located on the door. Restroom signs must be on latch side of the door. 	<ul style="list-style-type: none"> » Operable portion of towel dispenser should be less than 44" above floor currently 46" » Operable portion of soap dispenser (on left) should be mounted less than 44" above floor – currently 47" » Side grab bar in accessible stall should be located 12" from rear wall and extend 54" from rear wall » Accessible stall doors should be self-closing » Currently, door pulls only on one side. Install handle 34-48" above floor

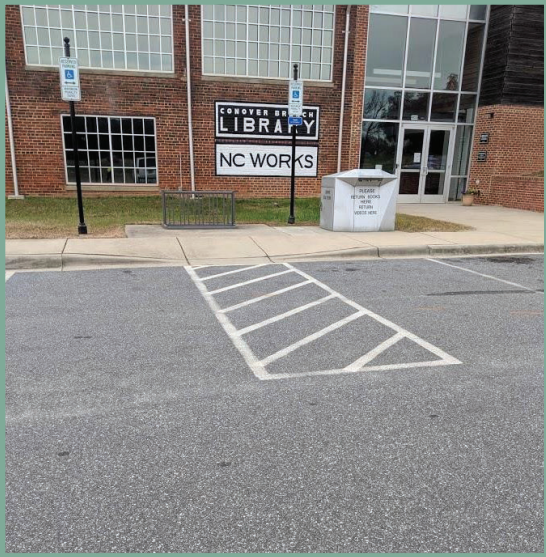
Spaces in Front of Drop-off

- » There should be an accessible parallel space at the front of Conover Station as close to the ramp as possible. A curb ramp should be installed that connects to the space in the picture at the bottom right (please see curb ramp measurements in application).
- » There is currently not an accessible space that meets the proper dimensions of an accessible van space at the Library Dropoff. A van accessible space must be at least 11 feet wide with an access aisle at least 5 feet wide OR at least 8 feet wide with an access aisle at least 8 feet wide. There must be at least one accessible van space (can be the same space as the regular accessible space). Van sign mounted 60" above the ground is required.

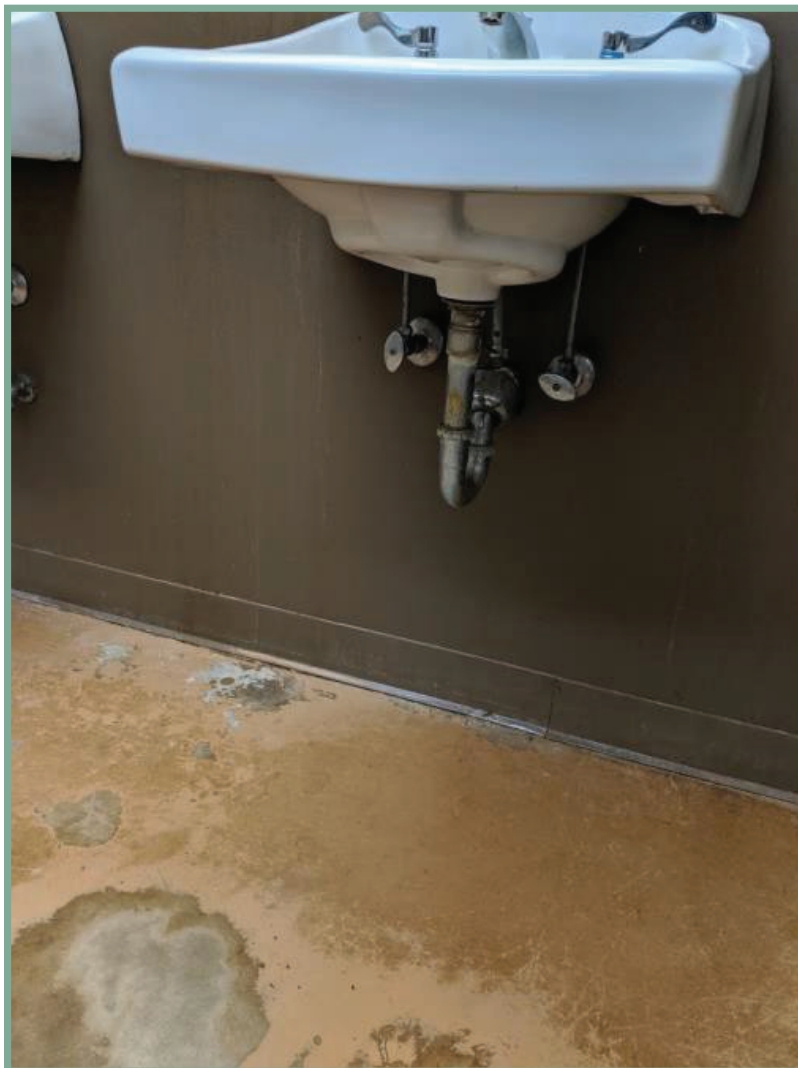
- » When soap dispensers are not located over sinks, they can be no higher than 48". The current soap dispenser is 51"s high.
- » ADA Standards require the stall door to be self-closing.

- » 2010 ADA Standards require a 12" clearance between the grab bar and protruding objects above. There are 7.5" between the side bar and the toilet paper dispenser above the side bar. If the facility was built prior to 2012, there are no space requirements above or below bars.
- » Door pulls on stalls (both sides) are recommended but not required if the facility was constructed prior to 3/15/12.

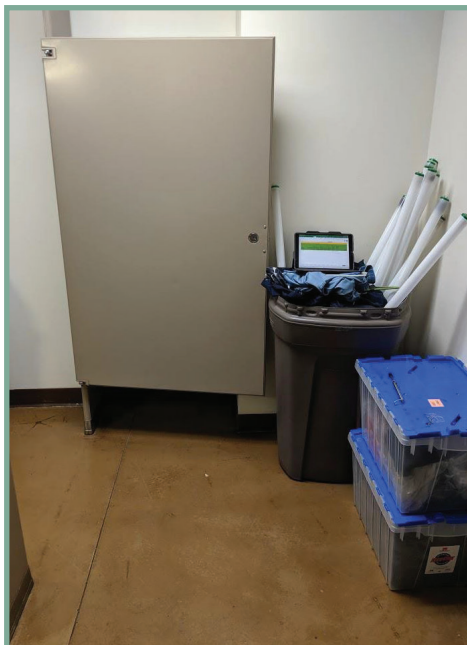
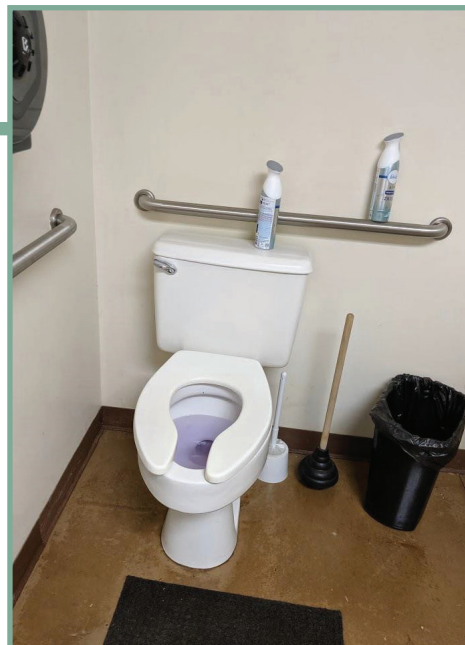
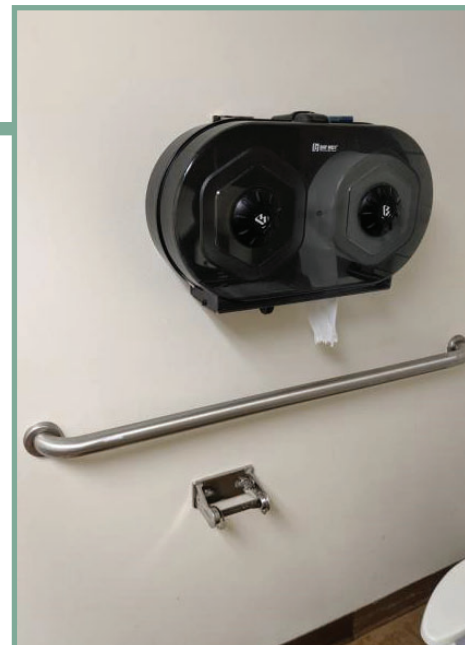
- » The stall door/circulation path cannot be fully accessed due to obstructions. Recommend moving the obstructions for wheelchair access.
- » **Door Pressures**
Push Pressure: 9 pounds
Pull Pressure: 8 pounds
Closure Time: 2.81 seconds
- » Coat hooks are not required, however, if present, must be 15-48" high. The current coat hook is 65" high and could be hazardous to safety.

- » 2010 ADA Standards require a 12" clearance between the grab bar and protruding objects above. There are 9" between the side bar and the toilet paper dispenser above the side bar. If the facility was built prior to 2012, there are no space requirements above or below bars.
- » Door pulls on stalls (both sides) are recommended but not required if the facility was constructed prior to 3/15/12.

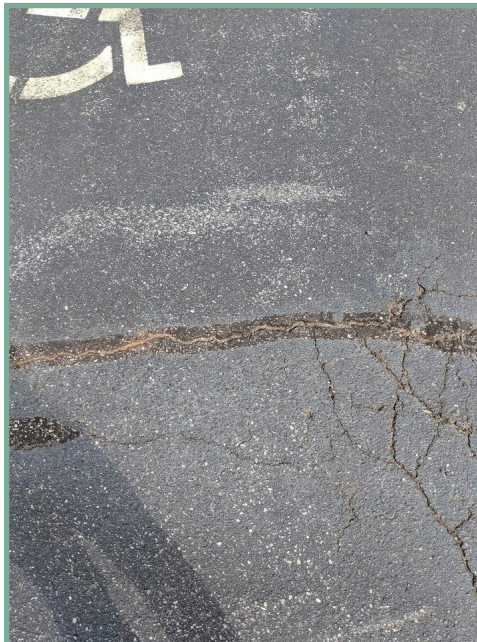
- » Access aisles are supposed to connect to the accessible route. Recommend switching spaces and access aisles so they connect to the curb ramp.
- » The accessible spaces are not signed for van parking but are the proper dimensions for an accessible van space. One space must have accessible van signage. Van sign mounted 60" above ground is required.
- » There should be a smoother transition for the curb ramp leading from the spaces to Public Works. The standards for curb ramps leading from parking lots to facilities differ slightly from curb ramps within the right-of-way. Please see Priority 1 – Approach and Entrance standards 1.19 – 1.24 for proper curb ramp standards.

- » Seal any cracks exceeding 1/2". There were no notable ones that were obvious safety hazards.
 - » The top and middle of the access aisle closest to Public Work's main entry exceed a 2% cross slope. Top cross slope: 2.9%, Middle cross slope: 3.1% All other measurements meet proper dimensions.
 - » Space closest to break room:
Cross slope at top of space: 2.8%
Cross slope at top of aisle: 2.8%
Cross slope at middle of space: 2.7%
Cross slope at middle of aisle: 2.8%
- All other measurements meet proper dimensions. The listed ones are not far out of compliance.

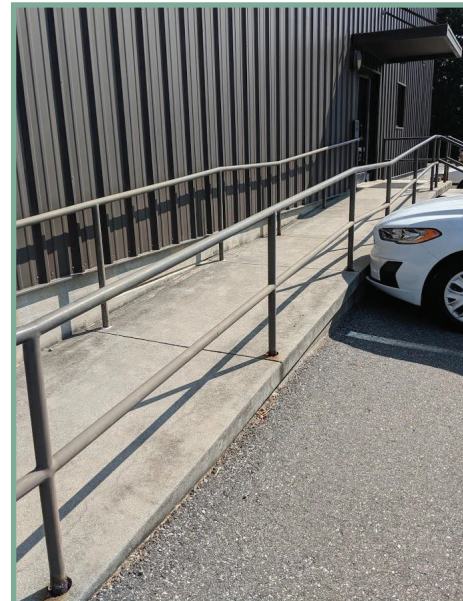
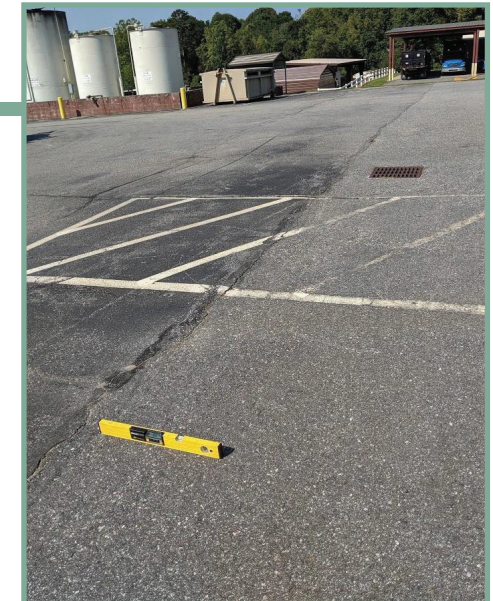
Low Priority (Fleet Maintenance Accessible Parking Space)

- » Fill in all pavement cracks that exceed 1/2". This does not present immediate safety hazard.
- » The running slope at the top of the accessible space measures 3%. The running slope in the middle of the space measures 3.3%. All other measurements are within range and does not pose an immediate safety hazard.
- » The running slope in the middle of the accessible aisle measures 3.4%. The running slope at the bottom of the accessible aisle measures 3.1%. All other measurements are within range and do not pose an immediate safety hazard

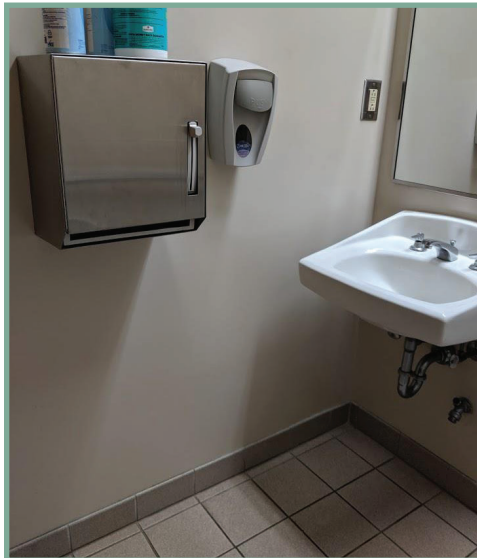
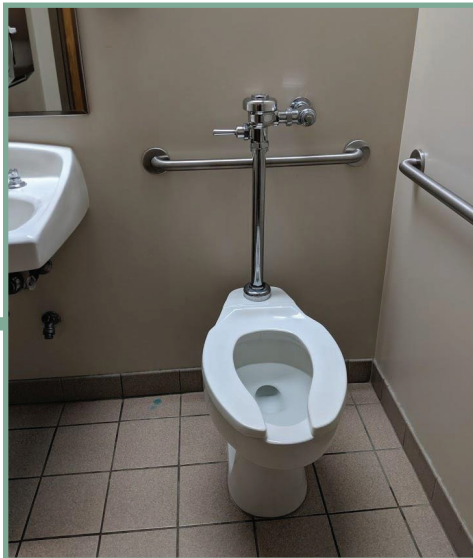
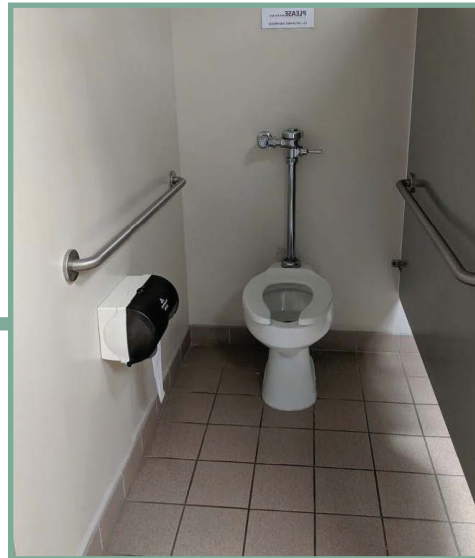
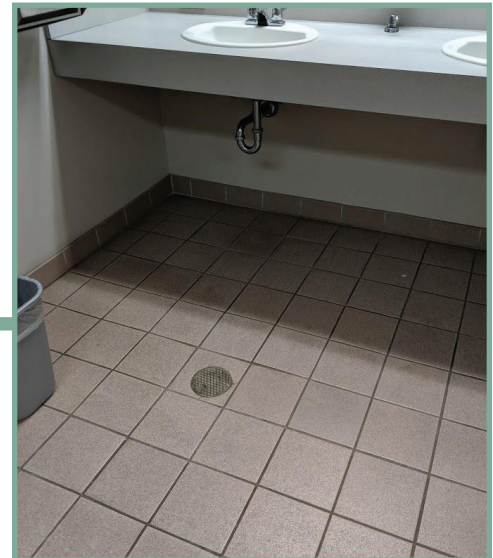
- » No coat hook present, however, if installed, needs to be between 15-48" above the floor.
- » The rear grab bar is 25" long due to space restrictions. ADA Standards require a rear grab bar 36" long.
- » ADA Standards require that the toilet paper dispenser be installed 7-9" from the front of the toilet to the centerline of the dispenser. The dispenser is currently 16" from the toilet to the center of the dispenser.
- » Operable portion of light switch 50" high – in the future, install operable parts no higher than 48" above the floor.

Note: The restrooms in the back (at the Multi-Purpose Room) should not be open to the public. There is accessible signage present, however the restrooms do not meet ADA Standards. Recommend signage either discouraging public use or stating "accessible restroom in lobby." There are no high, moderate, or low recommendations.

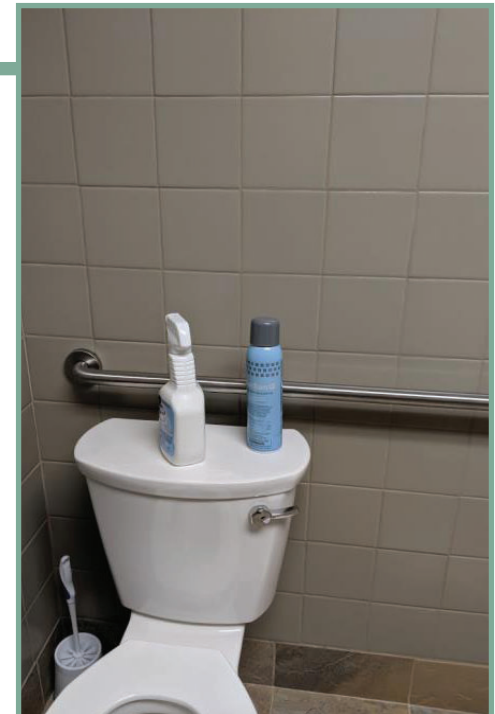
Men's Restroom (Single Compartment)

High Priority	Moderate Priority	No Low Priority
<ul style="list-style-type: none"> » Men's Restroom Door Pressures: Push Pressure: 12 pounds Pull Pressure: 10 pounds 	<ul style="list-style-type: none"> » Move cleaning supplies from the back of the toilet so the rear grab bar isn't blocked.

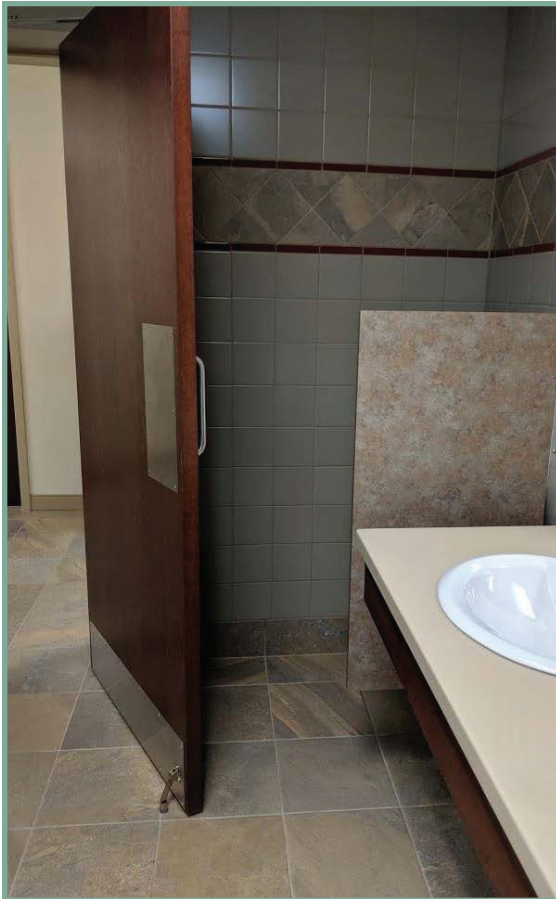
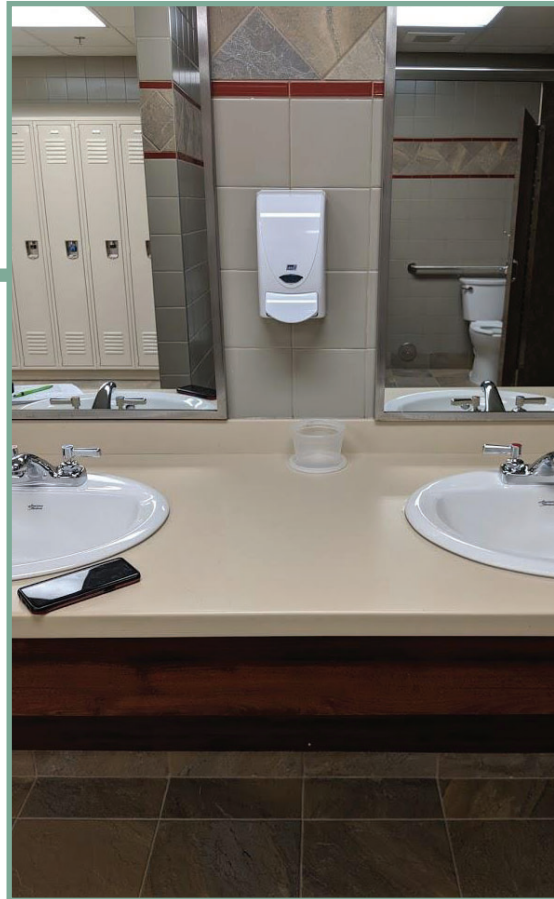
- » Urinal location could be hazardous (in very close proximity to the door).

- » The highest grab bar is located 6" above the side grab bar. ADA Standards require a 12" clearance between the grab bar and protruding objects above. If the facility was built prior to March 15, 2012, there are no space requirements above or below bars.

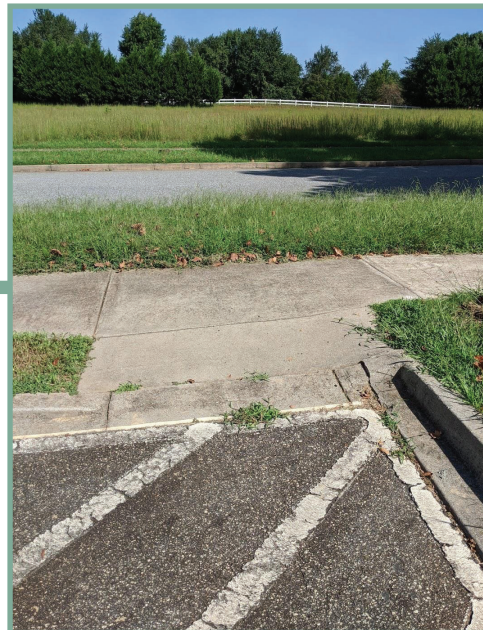
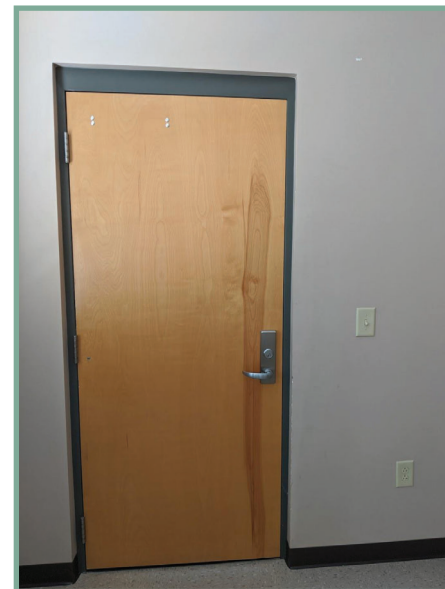
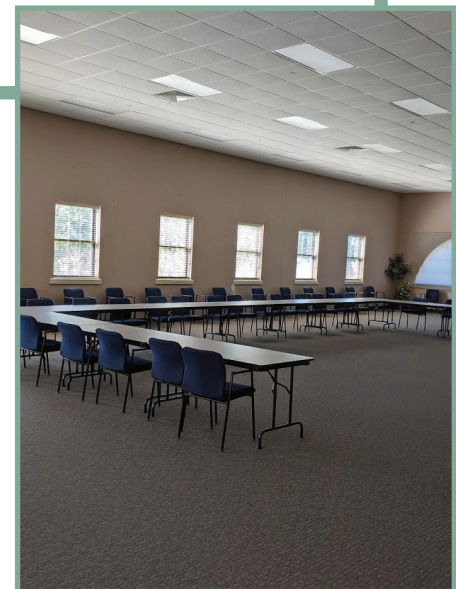
Parking Lot

No High Priority	No Moderate Priority	<p data-bbox="310 1219 516 1256">Low Priority</p> <ul style="list-style-type: none"> » Cross slope at curb ramp connecting to accessible parking space has a cross slope of 4.3% and needs a smoother transition.
------------------	----------------------	---

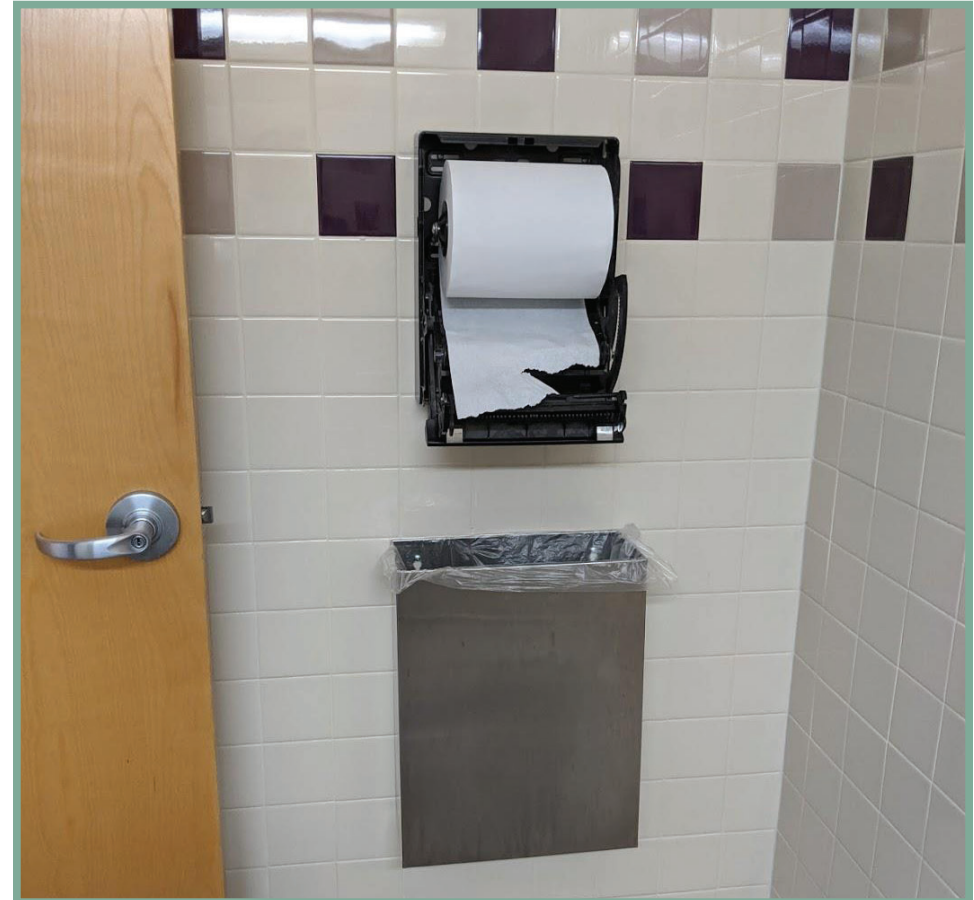
Women's Restroom

» Hand towel dispenser needs to be repaired for all users – ADA Standards do not allow for motions that involve tight grasping, pinching, or twisting of the wrist.

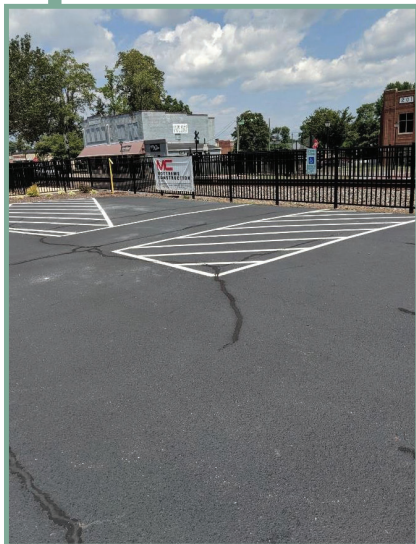
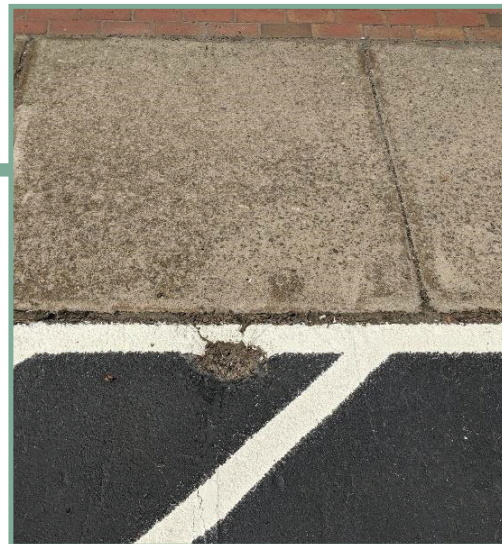
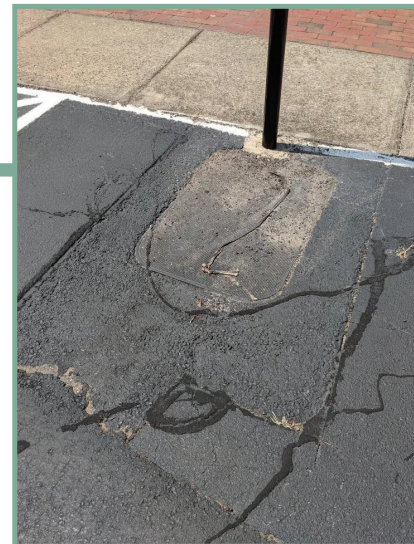
Z-Gate Parking Lot – 501 1st Ave S

- » Fill holes in accessible spaces and aisle-ways that could be hazardous to mobility.
- » The running slope of the center of the space connecting to the sidewalk (closest to the utility pole) measured 3%."

- » The accessible space connecting to the sidewalk (closest to the charging station) is uneven and could be hazardous to mobility. Resurfacing is recommended. As shown in the picture on the bottom right, most uneven sections are where cars would be parked. This would not present an immediate safety hazard except to those traveling through an empty space.

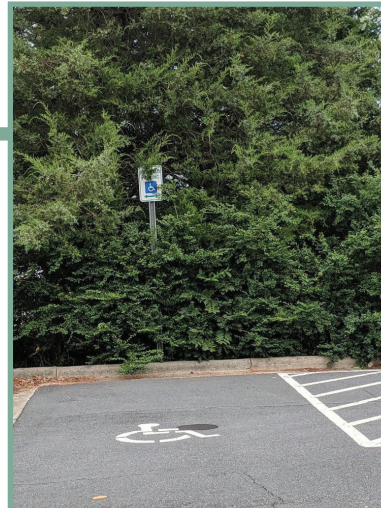
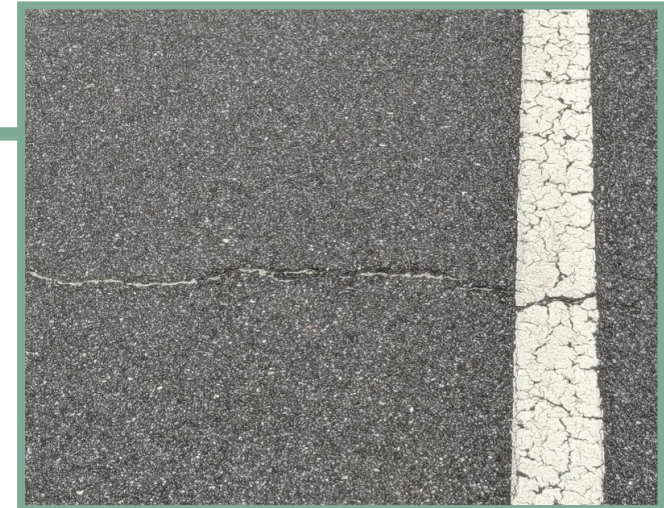
SE Alleyway Parking Lot – 122 2nd Ave SE

High Priority	Moderate Priority	Low Priority
<ul style="list-style-type: none"> » Cut vegetation for sign visibility 	<ul style="list-style-type: none"> » Adjoin access aisle (striped area next to accessible space) to a striped accessible route or follow high recommendation below: 	<ul style="list-style-type: none"> » Fill any gaps that exceed .5" – most cracks did not exceed .5" » The running slope of the accessible space closest to Wright and Associates is currently 5% when measured near the top of the space. The running slope of the accessible aisle next to the space is 4.1% when measured near the top of the aisle. All other measurements were correct. This does not pose and immediate safety hazard. » The running slope is currently 4.6% in the accessible van space closest to Pamela's Resale Shop and 3.6% in the accessible aisle. These were the only measurements that exceeded ADA standards. The middle and bottom of the space and aisle were correct.

High Recommendations	Moderate Recommendations	No Low Recommendations
<ul style="list-style-type: none"> » Recommend moving spaces closer to the accessible route. This would involve curb cuts at the access aisles. Space should be moved to connect to cemented area in center of parking lot. The space should have a curb ramp at the access aisle connecting to the sidewalk. This is only possible if there are 36" around the light poles. If moving spaces is not feasible, then ADA requires a striped aisle connecting to the accessible route. 	<ul style="list-style-type: none"> » Add pedestrian crossing and signage at road crossing adjoining to sidewalk. This is not a busy road, but this recommendation helps to identify the accessible route.

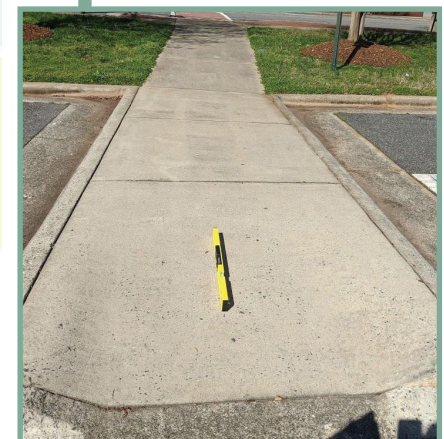
PO Parking Lot - Accessible Space 1 (Closest to Post Office)

No High Priority	Moderate Priority	Low Priority
	» Access aisle does not connect to an accessible pathway.	<ul style="list-style-type: none"> » Middle of Space: 3.6% running slope; Middle of Access Aisle: 3.2% running slope » Bottom of Space: 2.6% running slope; Bottom of Access Aisle: 4.2% running slope » Fix cracks within space and aisle.

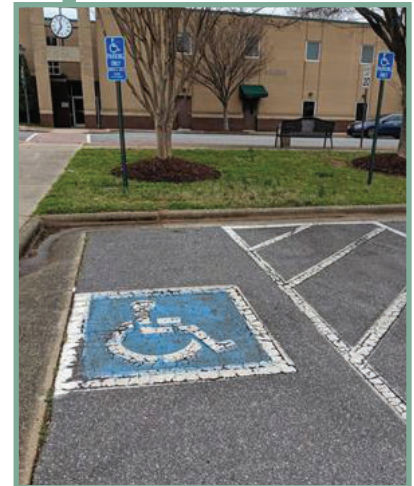
PO Parking Lot - Accessible Space 2

No High Priority	Moderate Priority	Low Priority
	» Access aisle does not connect to an accessible pathway.	<ul style="list-style-type: none"> » Top of Space: 2.9% running slope » Middle of Space: 3.5% running slope; Middle of Access Aisle: 3.1% running slope" » Bottom of Access Aisle: 2.6% running slope

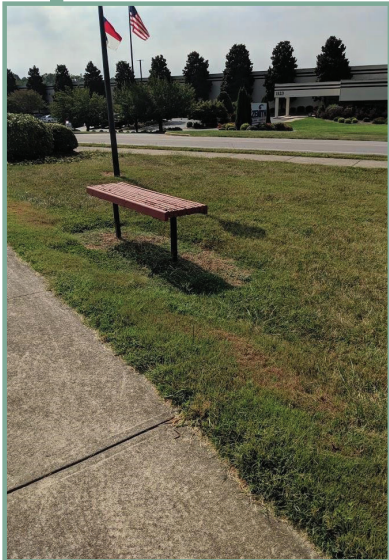
Hines Park

- » Install a shaded area comparable to the gazebo that is wheelchair accessible or a ramp into the gazebo. Please follow ramp standards in Priority 1 – Approach and Entrance. This is impassable to wheelchair users and a safety hazard.

- » Vegetation needs to be cut out of the path of travel (the tree poses a safety hazard). Trees must be trimmed as high as 7’.
- » Move the trash receptacle to an area that is wheelchair accessible.

- » The wooden swing needs to be located on an accessible pathway with 60” by 60” of clear accessible space next to the swing. Recommend a paved and level area (<2% slope in all directions)

- » Add visually contrasting reflective tape on the step up into the gazebo. This tape will also be recommended on any installed ramp.

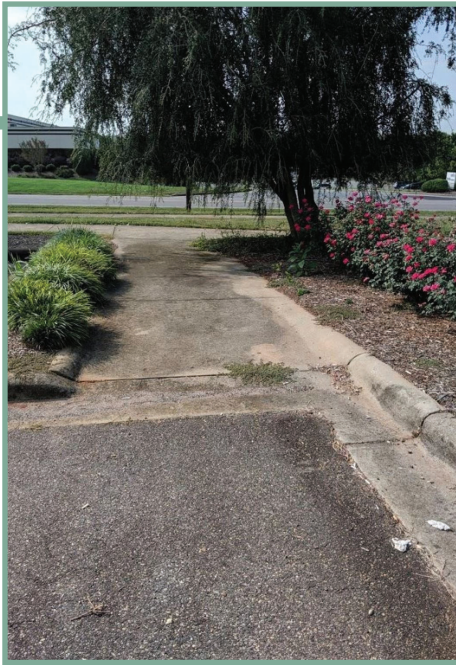
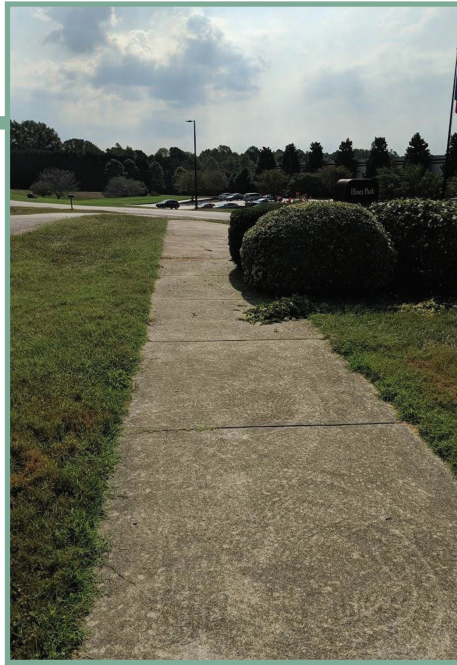
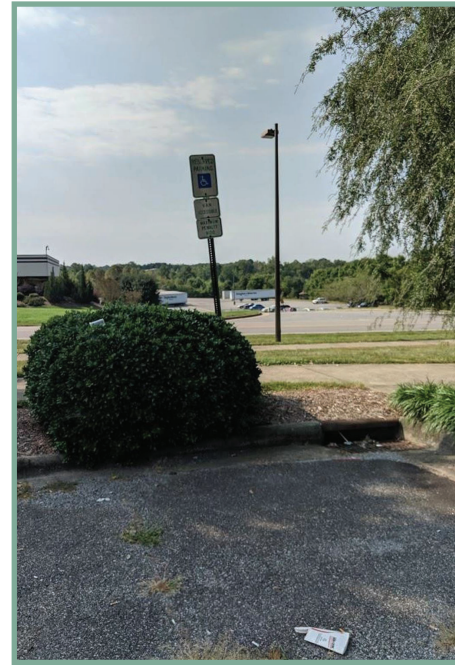
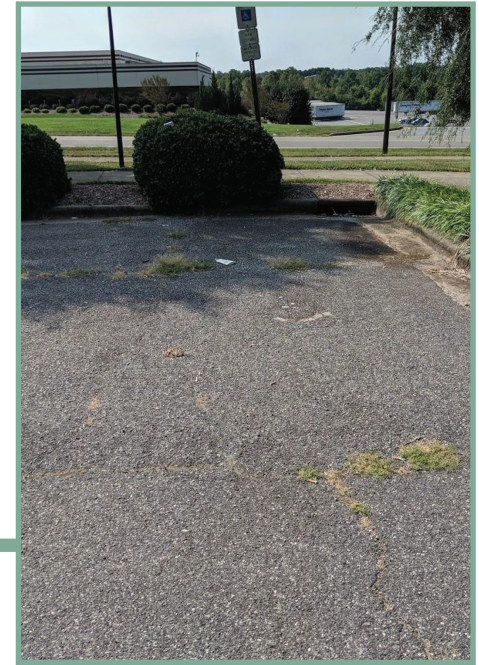
Hines Park - Parking Lot

- » The lot needs to be resurfaced. The accessible spaces are uneven and present mobility hazards.
- » The lot needs to be restriped. There are no visible lines/access aisle for an accessible space. The accessible space should have the dimensions and signage for a van accessible space. Please follow the standards in Priority 1 – Approach and Entrance in Appendix B.
- » Middle of accessible space running slope: 3.1%
- » Bottom of accessible space running slope: 4%
- » Bottom of accessible space cross slope: 2.7%
- » Bottom of accessible aisle cross slope: 3.6%
- » Bottom of accessible aisle running slope: 3.7%

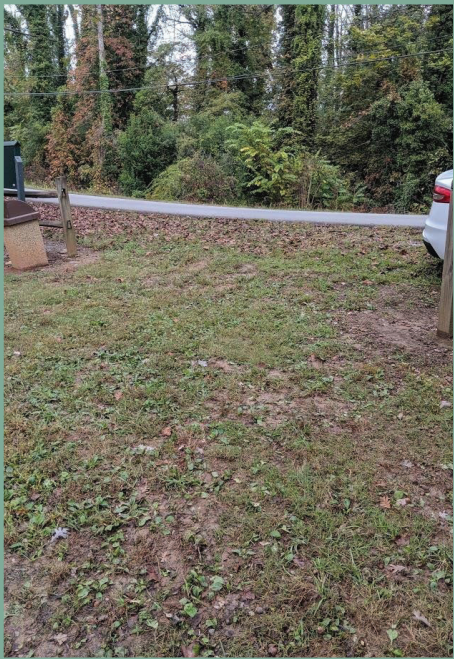
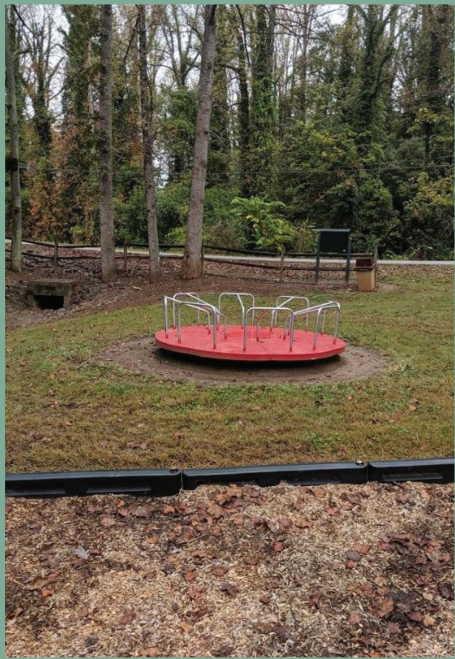
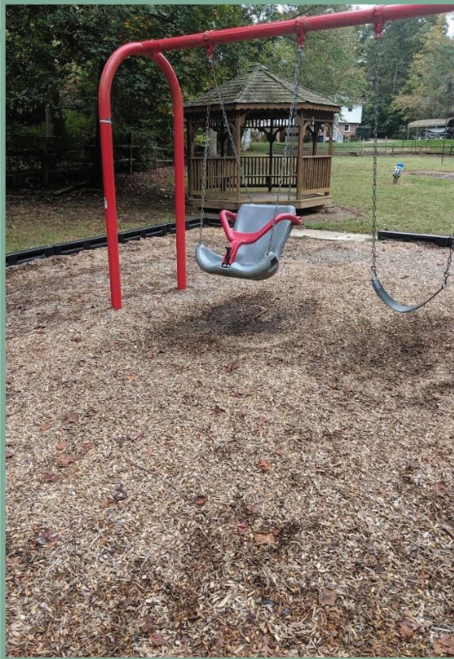
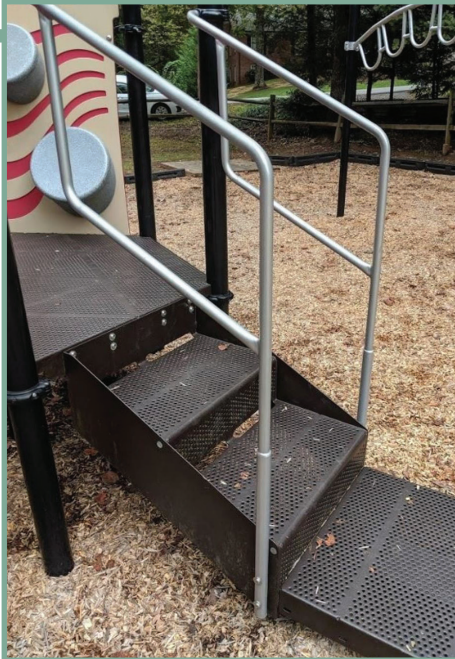
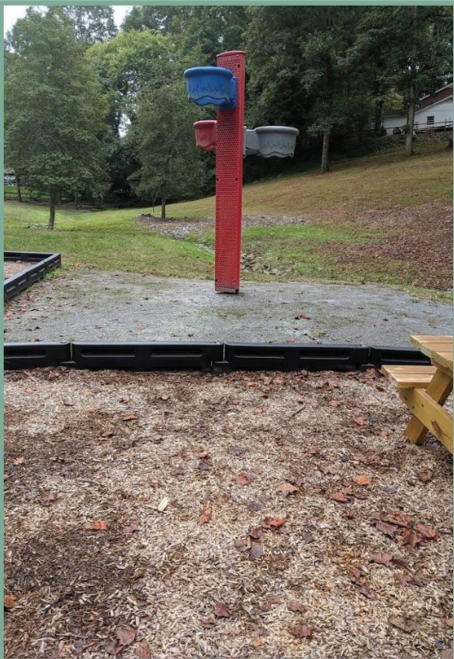
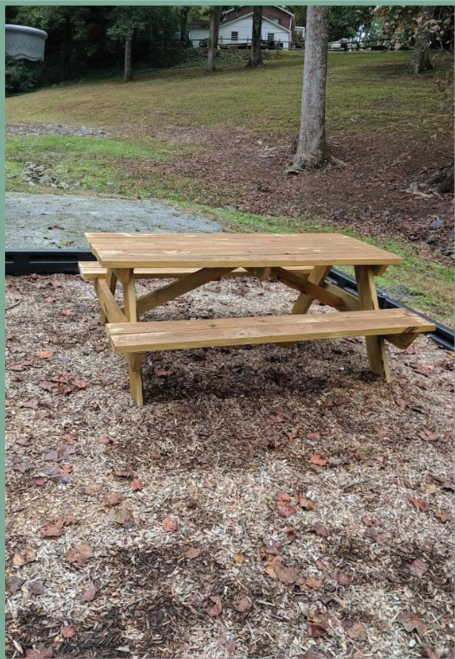
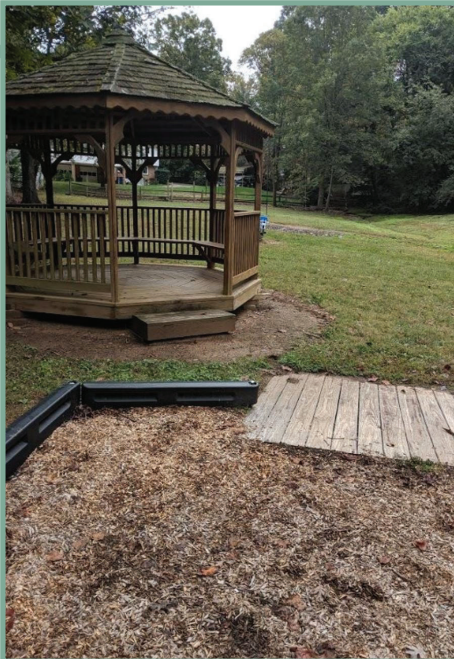
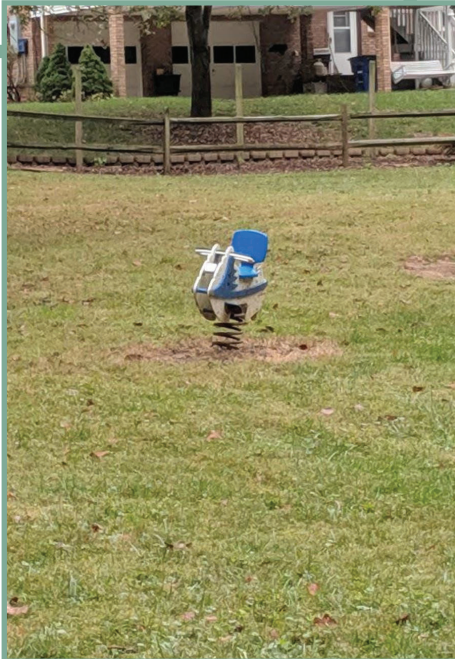
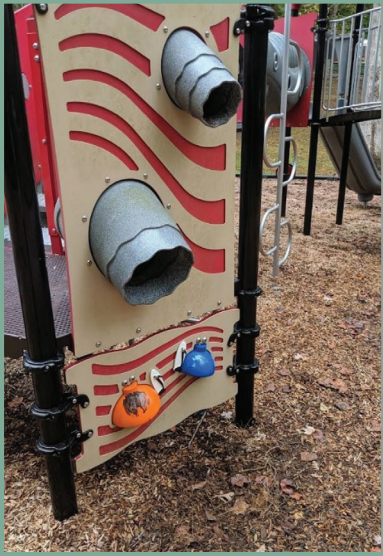
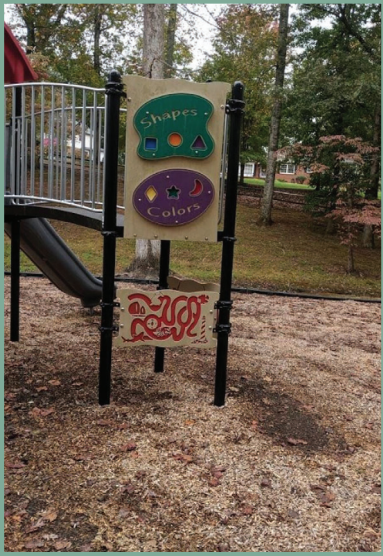
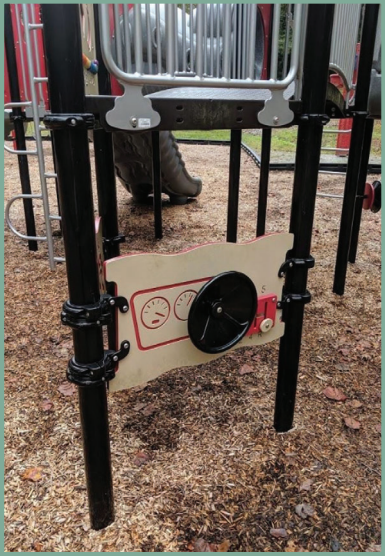
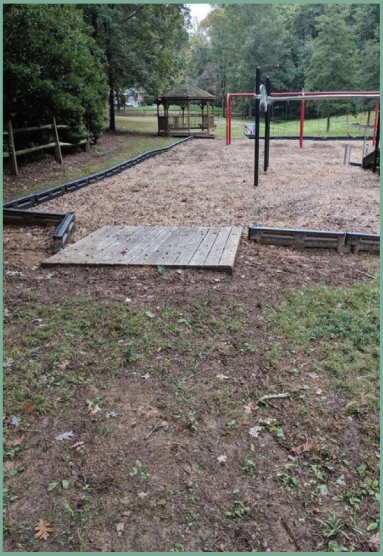
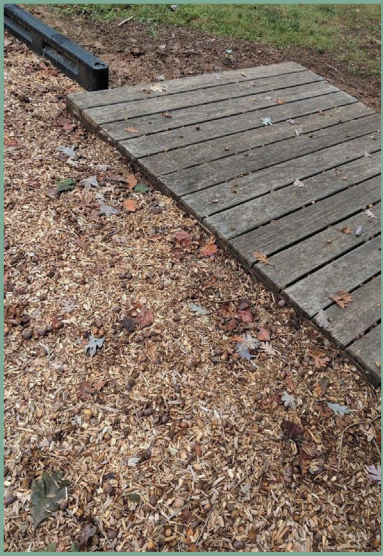
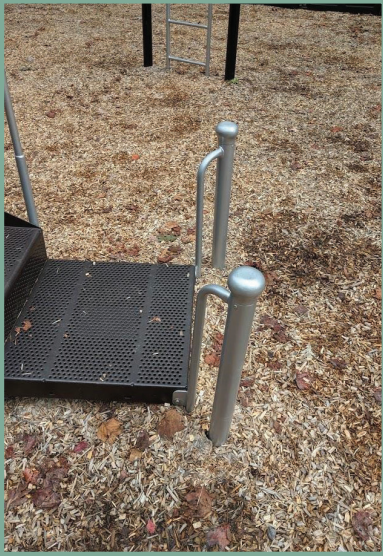
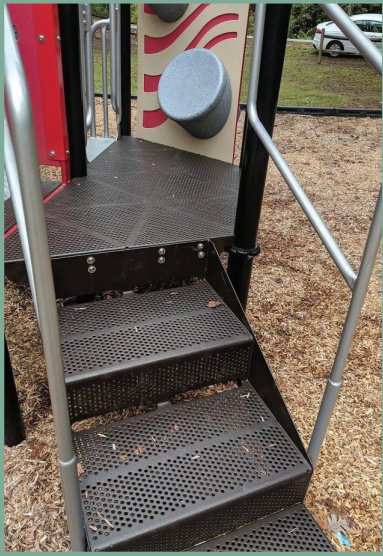
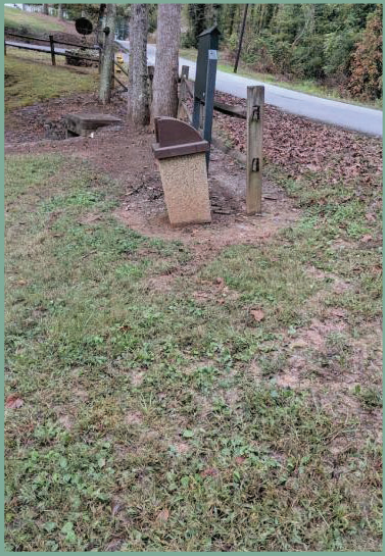
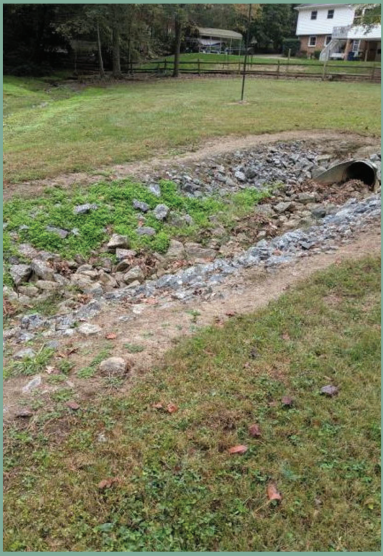
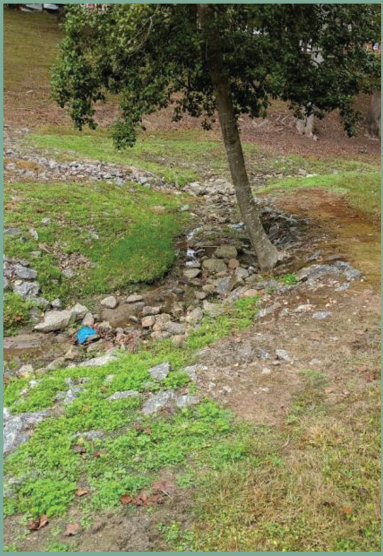
Hunsucker Park - Images

- » There should be a means for someone wheelchair bound to access the play area from 2nd Street. Accessible surface materials are included in Appendix C. The surface is currently too difficult for a person in a wheelchair to access. Since not following a roadway, accessible pathways can have a maximum running slope of 5% and a maximum cross slope of 2%. It is best practice to make pathways 5' wide.

- » Cracks in pavement and/or pathways cannot exceed 1/2”.
- » The picnic tables do not allow for knee space for wheelchair users (accessible tables have longer table tops).

- » Recommend moving the parking area entrance to the side of the parking area where the ground is more level and closer to the play area.
- » Recommend placing accessible parking spots at the bottom of the lot where the parking area is more level. An accessible pathway must connect to the accessible space access aisle.
- » Signage stating “Danger – No Public Access” and/or a barrier should be placed at the outfall next to the play area.
