City of Conover

ADA Transition Plan

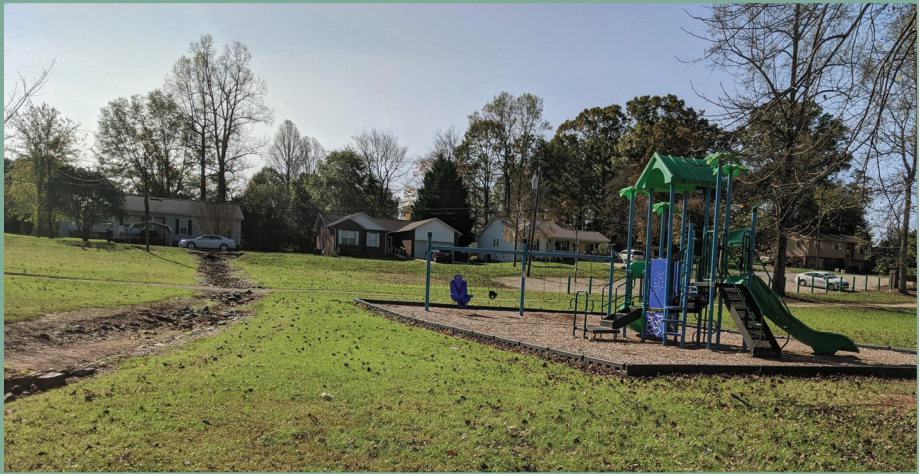
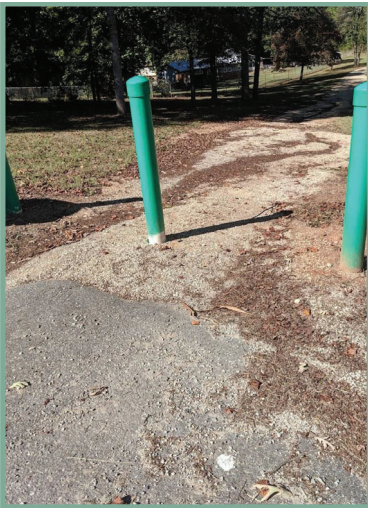
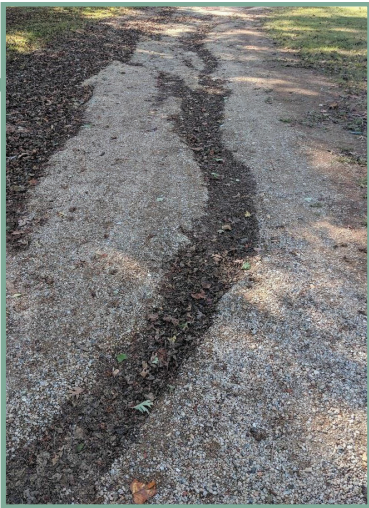
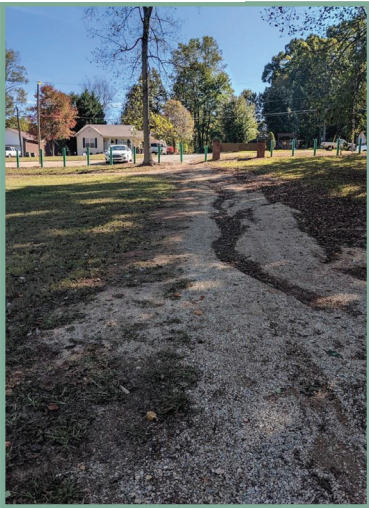
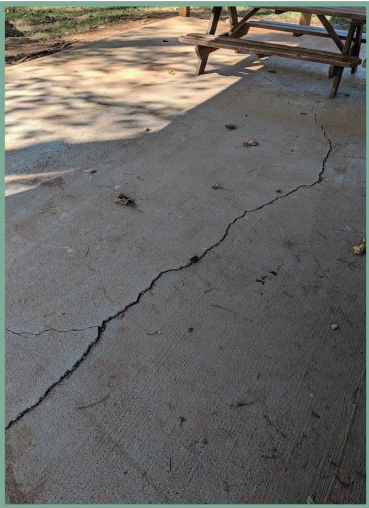
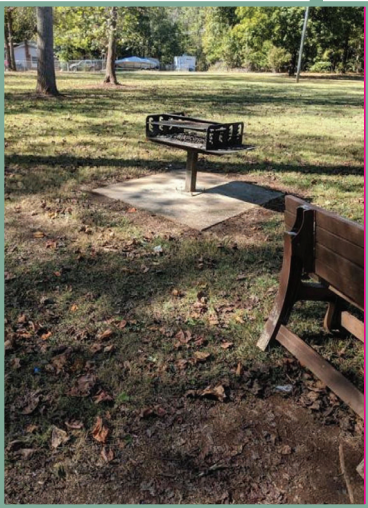
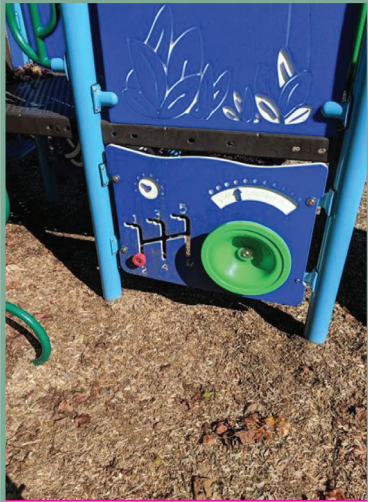
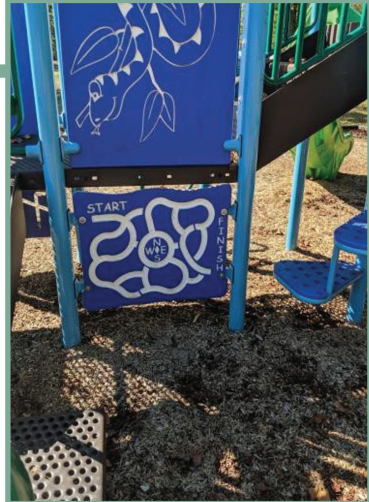
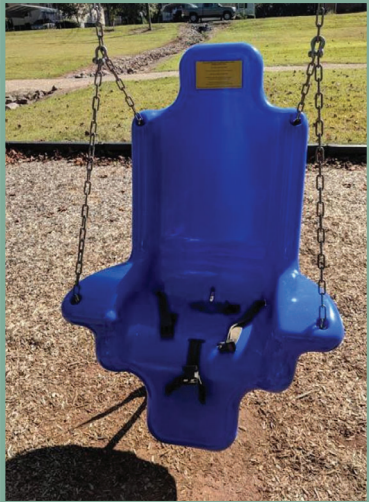
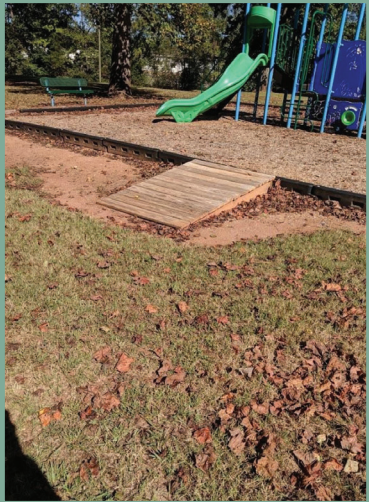
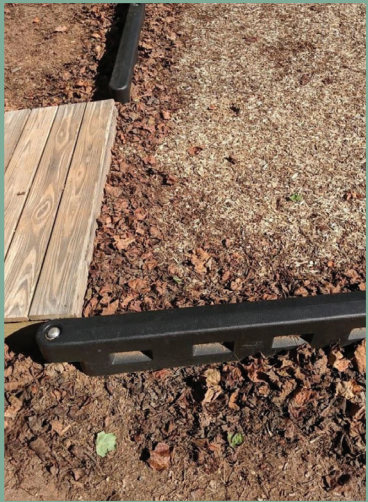
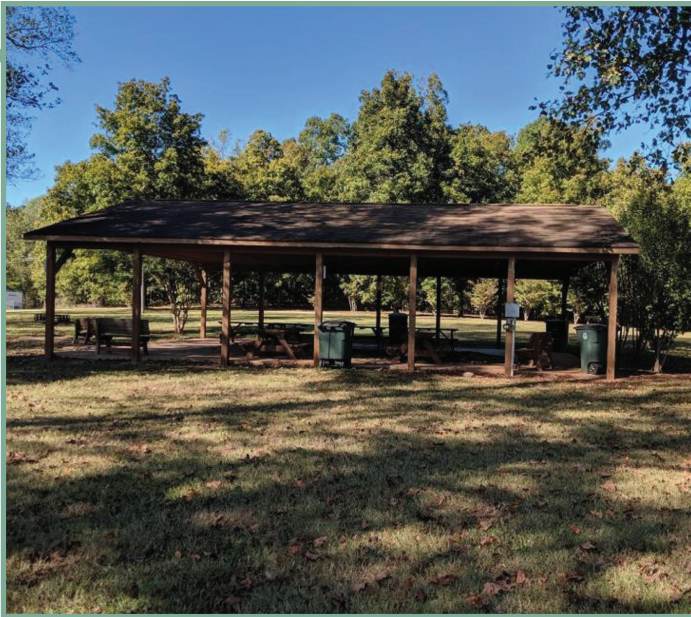
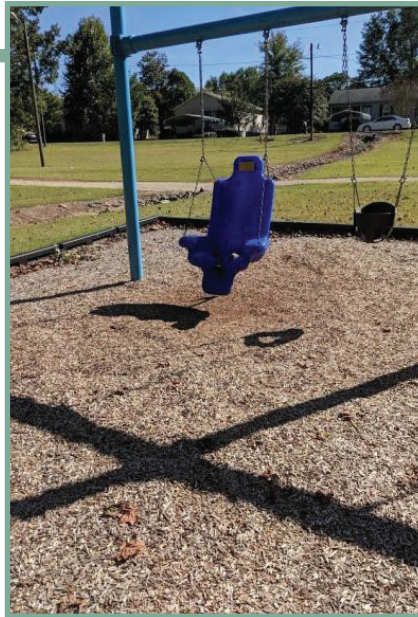
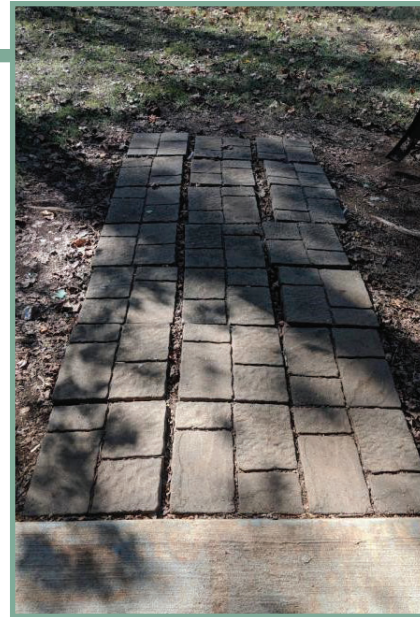
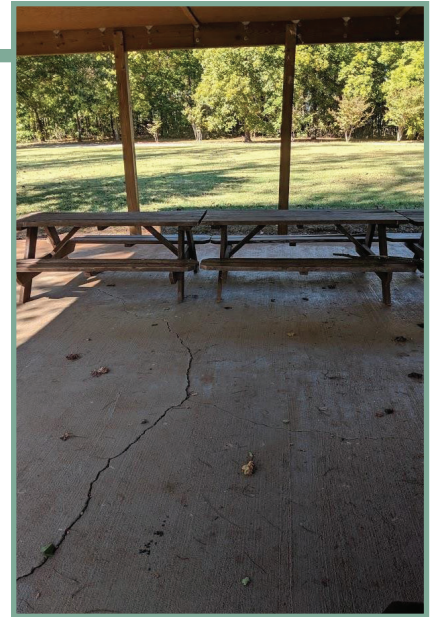
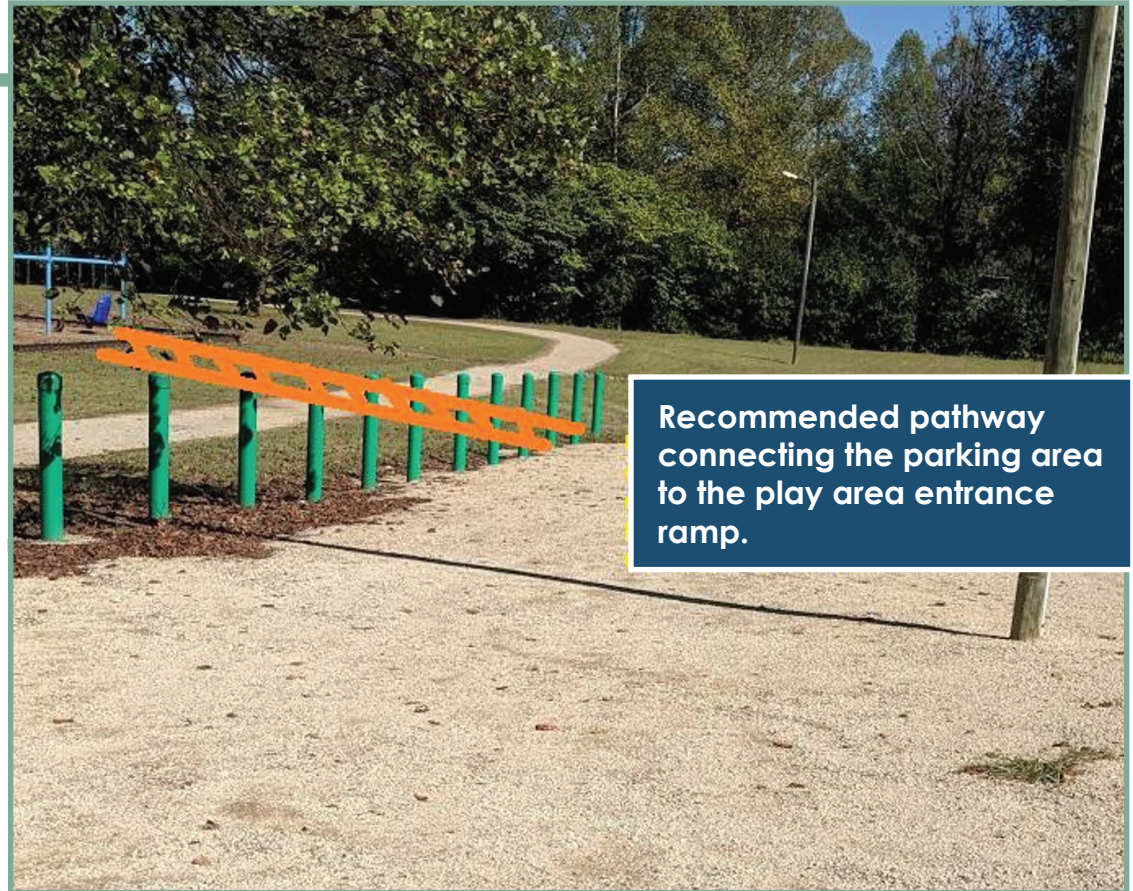
- » The surface is currently too difficult for a person in a wheelchair to access and requires an accessible path. Since not following a roadway, accessible pathways can have a maximum running slope of 5% and a maximum cross slope of 2%. It is best practice to make pathways 5' wide.

- » Recommend placing signage at the culvert stating “Danger – No Public Access” or a gate better separating the culvert from the play area.
 - » Currently there are no accessible play components on an accessible route. Since there is a swingset, there should be one accessible swing or comparable accessible play element.
 - » The seat should be 11-24” above the clear ground space. There should be an open circle 60” in diameter or a T-shaped space within a 60” square immediately adjacent to the accessible swing.
- ‡ Park items are not prioritized in the same manner as the previous facilities. Prioritize one entire play area at a time as opposed to making small improvements to several play areas.

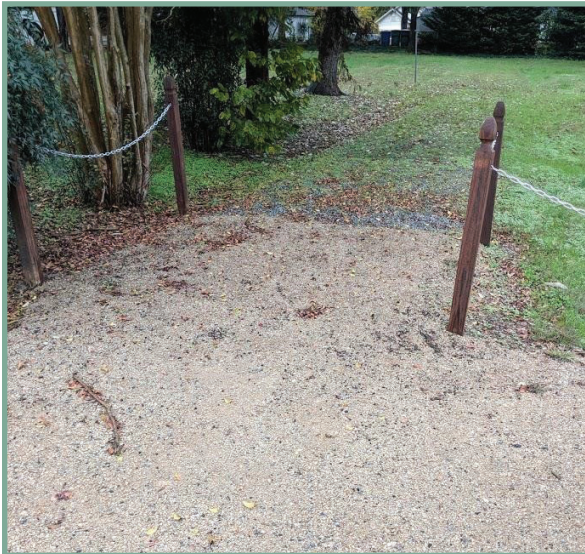
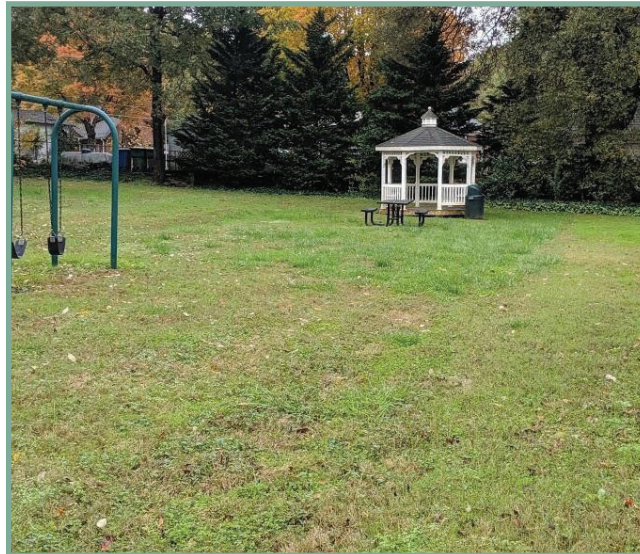
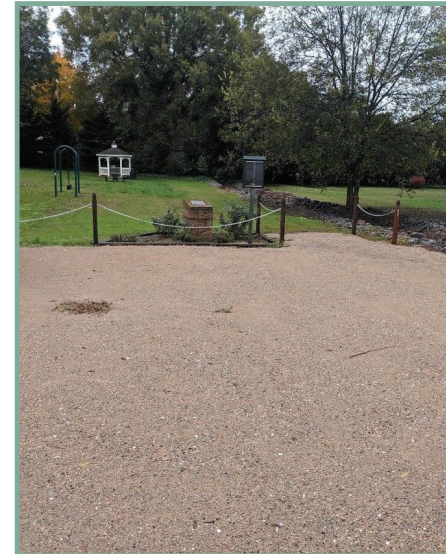
- » There is no accessible route connecting the parking area to one of each ground level play element. The terrain is very steep and would exceed a 5% running slope. The current stairs are very unsafe and not accessible. If possible, recommend moving the parking area to the lower area next to the creek and connecting the lot to the road where it dead ends. There are no elements in this park accessible from the current parking area. There is no safe way for anyone to access the play components, especially those who are visually impaired or in wheelchairs.

- » Water is currently not draining properly at the bottom section of the park with all of the play elements. This creates a hazardous surface for all users, but is impassable for individuals with disabilities.

- » The entry point or seat to all play elements must be 11-24" from the clear ground space. The rockers do not comply in their current condition.

- » The slope of the stairway is very steep. The steps should be replaced. The new stairway could be improved with handrails, steps with a better gripping surface, and tape at the edge of each step for individuals with visual impairments. This would still not improve access for persons in wheelchairs. An accessible pathway is necessary per ADA Standards.
- » The play elements are very dated and could be hazardous. Recommend replacing play elements that could present a safety threat.
- » Recommend a sign next to the streambed stating "Danger - No Public Access" and/or a barrier.

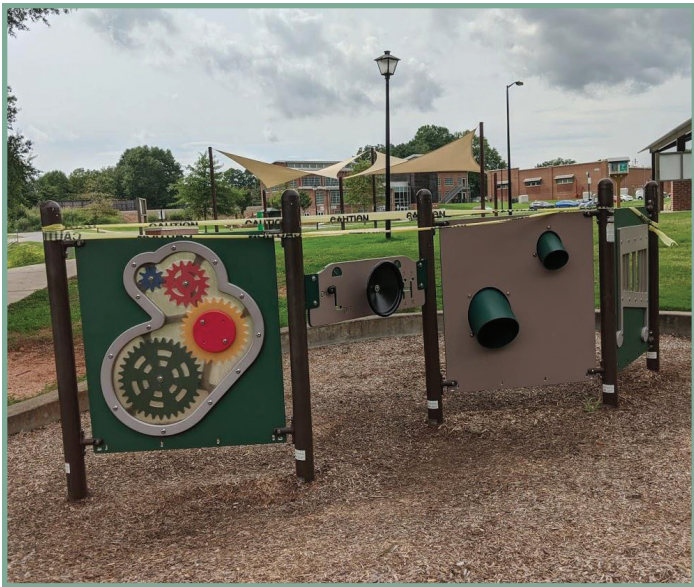
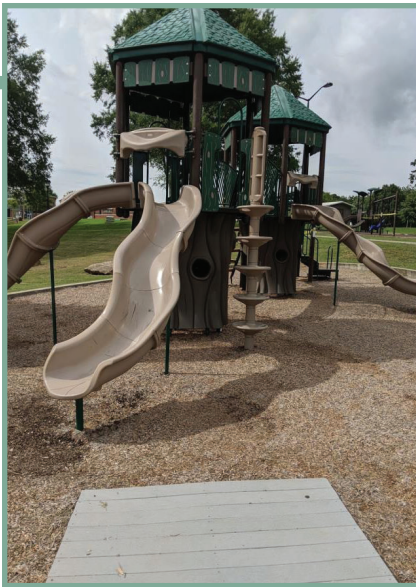
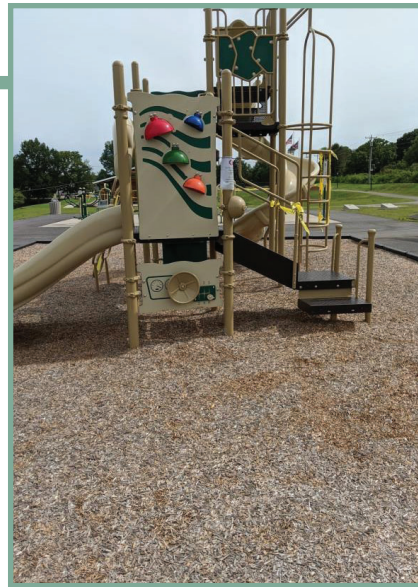
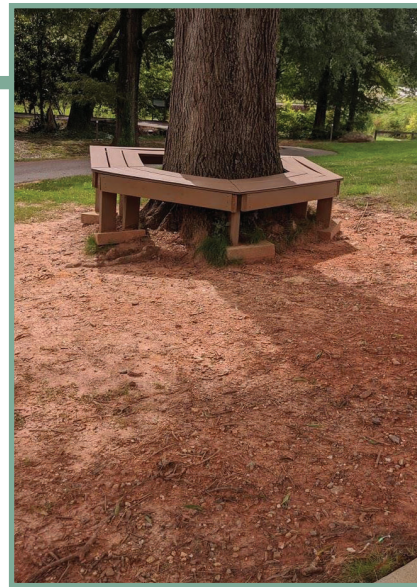
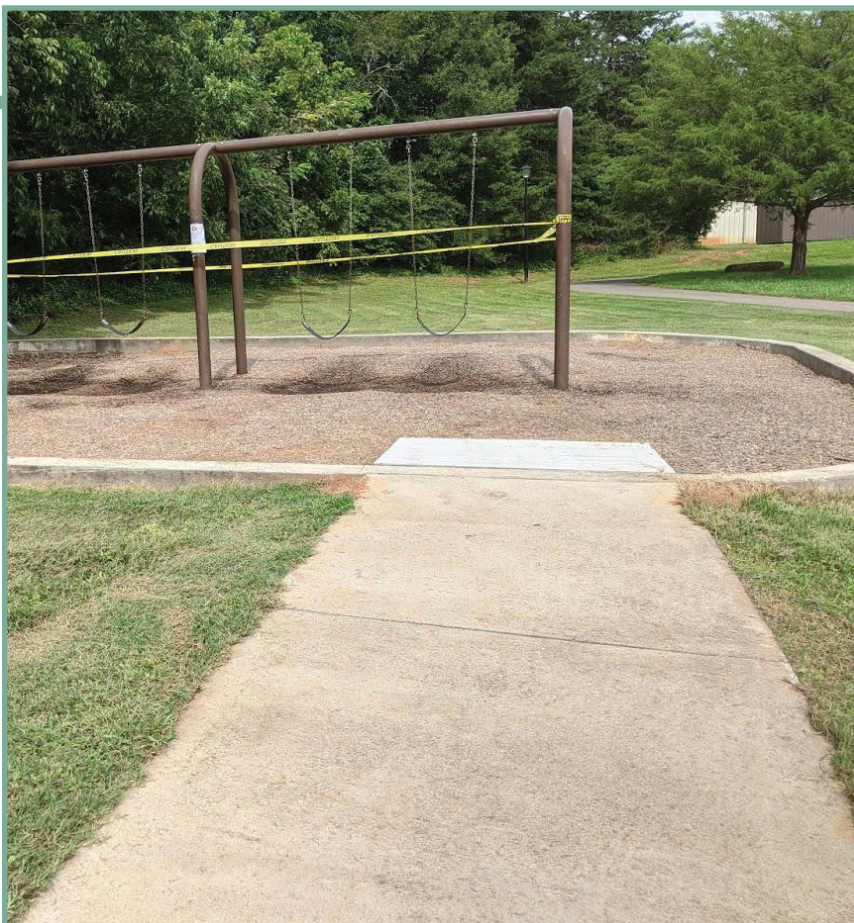
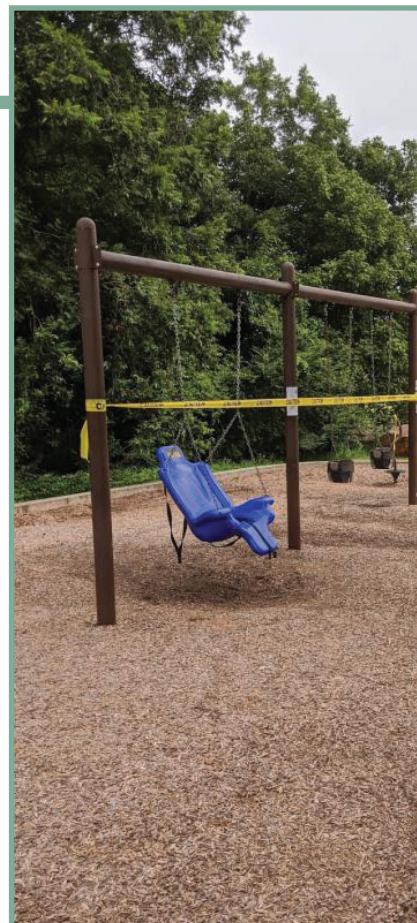
- » There is no designated accessible space at the bottom access to the park (next to the City Park sign)
- » The space to the left of the sign meets the proper size dimensions and slope requirements of a van or standard accessible space – signage should be added

- » No accessible route within 2 of the 3 play areas
- » Mulched surface is too difficult for mobility. Mulch should be replaced with an accessible surface along accessible pathways and next to accessible play elements. Please note that while surfaces such as cement are accessible, they can also pose as a safety hazard in play areas if located too close to elevated and some ground level components.

- » There should be a better transition from the asphalt path to the bridge. There is more than a 1/2" vertical discontinuity creating a mobility hazard.

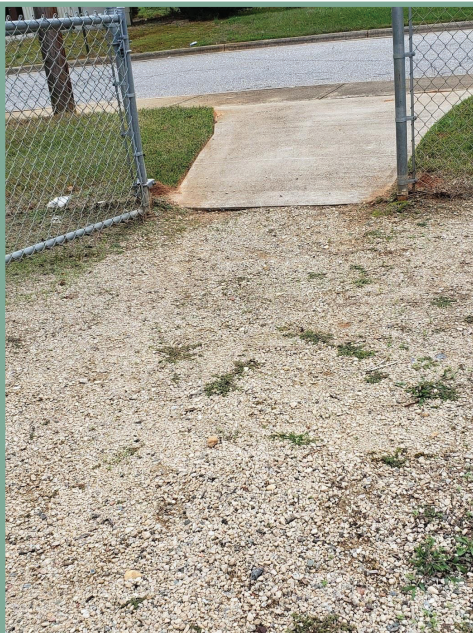
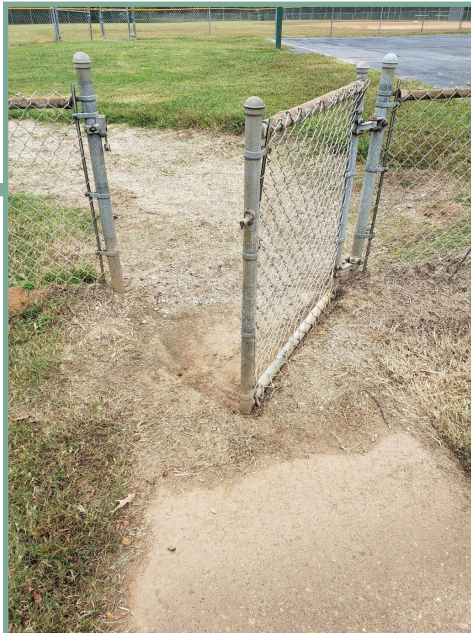
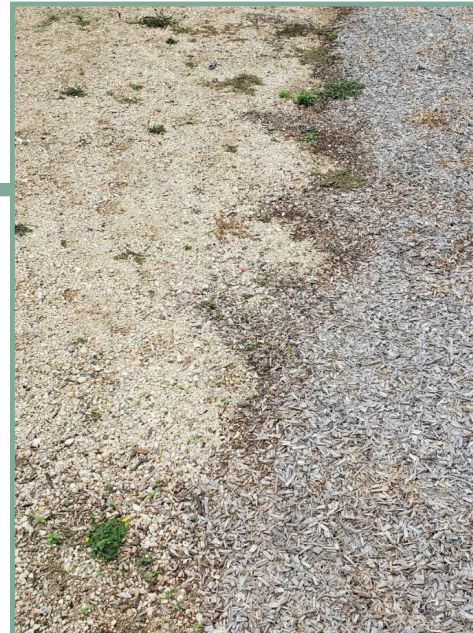
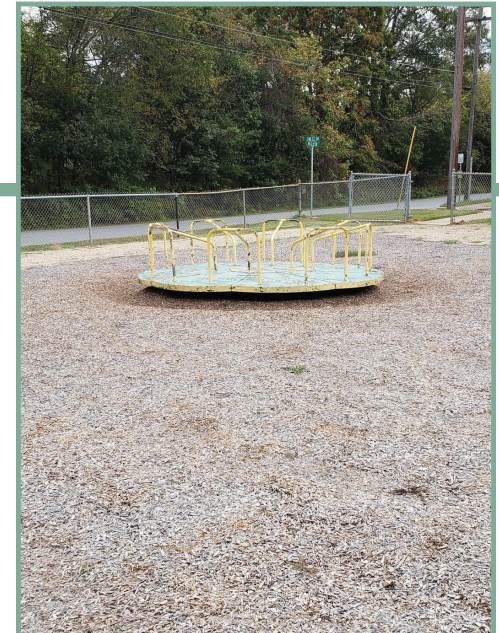
- » Access to one entrance of the park is obstructed due to non-compliant surface blocking the gate.
- » There is no accessible route connecting accessible play elements to the entrance of the park.

- » Mulched and gravel surface is too difficult for mobility. Mulch should be replaced with an accessible surface along accessible pathways and next to accessible play elements. Please note that while surfaces such as cement are accessible, they can also pose as a safety hazard in play areas if located too close to elevated and some ground components.

- » Recommend installing an ADA accessible swing as the accessible ground play element.
- » Accessible path should extend to benches overlooking the play area. There is a paved existing resting area between the benches where the accessible path could connect.

- » Recommend replacing some of the more dated play elements.
- » The basketball court is currently not accessible to all users due to the surface between the park gate and the court. This could easily be linked to the entrance of the park.

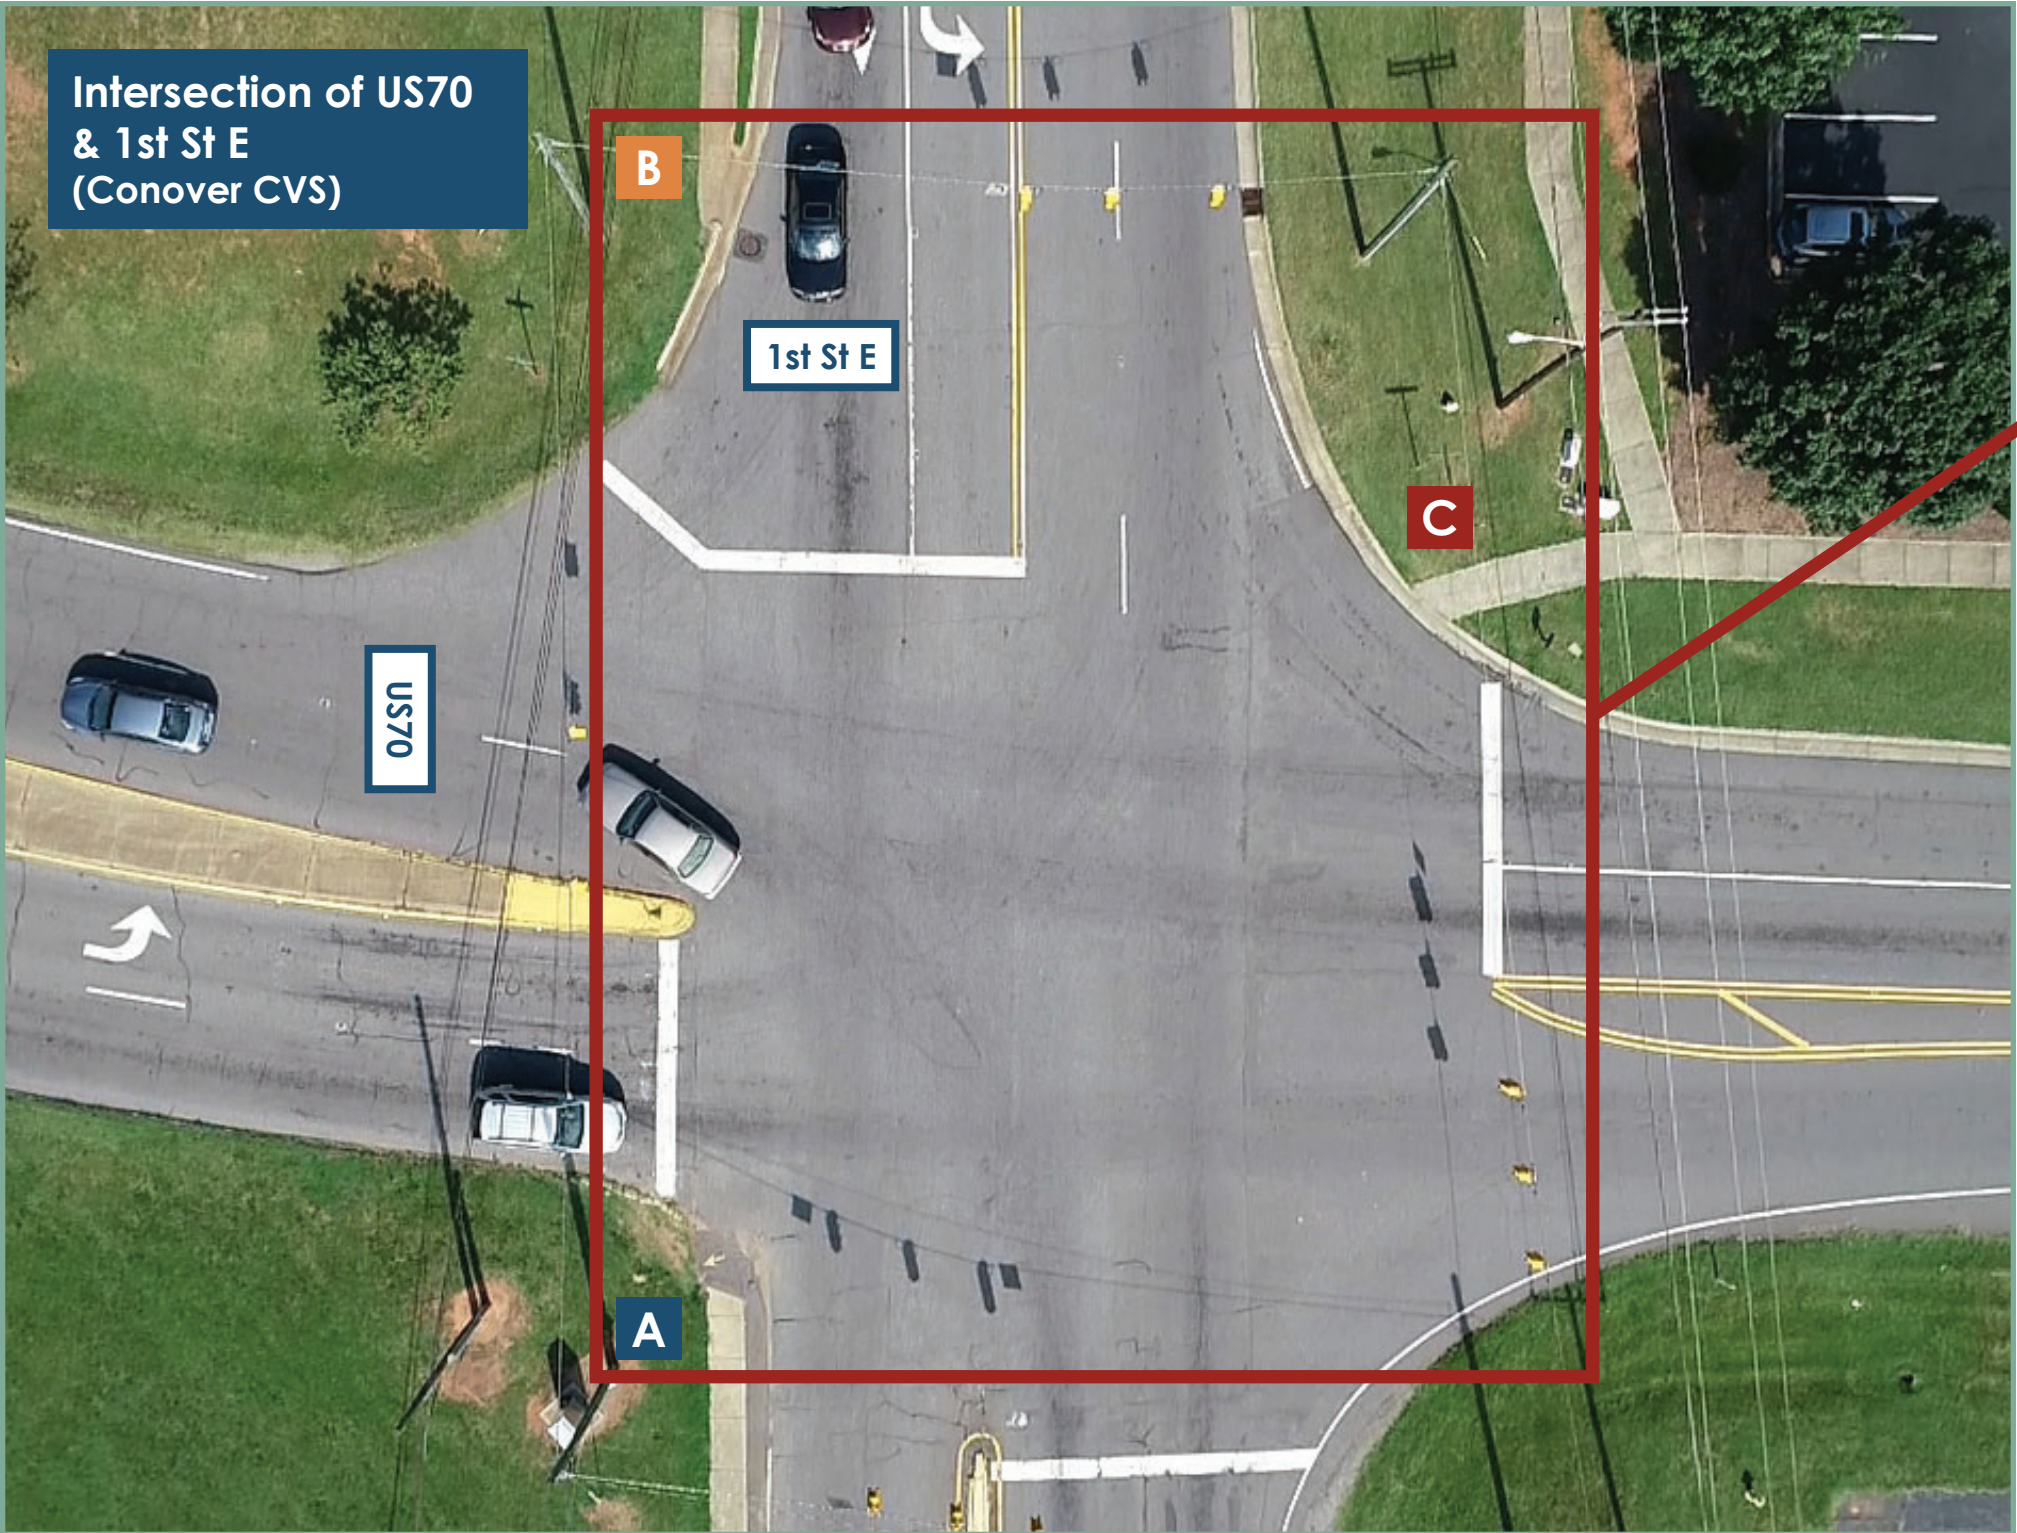
**Intersection of US70
& 1st St E
(Conover CVS)**

- » NW quadrant extend sidewalk up to intersection
- » Stop bar moved back 4 feet behind the designated crossing
- » NW quadrant curb ramp has detectable warning at the curb ramp
- » NW quadrant curb ramp aligns with curb ramp on NE quadrant
- » NW quadrant has additional curb ramp to align with curb ramp in SW quadrant – additional curb ramp should also have a detectable warning
- » Recommend marking crosswalks – crosswalks are needed where sidewalk is on either side of road/intersection. If crosswalks are marked at signalized intersections, NCDOT requests pedestrian signals.

- » NE quadrant curb ramp aligns with NW quad curb ramp and has detectable warning (only need one curb ramp here since sidewalk is only on NW side)
- » SW quadrant has curb ramp with detectable warning
- » SW and NW quadrant ramps align with 4 feet of space between vehicle stop bar and crosswalk
- » If feasible, a pedestrian refuge island is recommended where the traffic median is currently. Refuge islands wider than 6 feet need detectable warnings on either side of the crossing. If an island is not feasible, the current median and stop bar should be reduced to allow for proper pedestrian crossing. Evaluate green times for traffic signals to ensure all pedestrians have sufficient crossing time

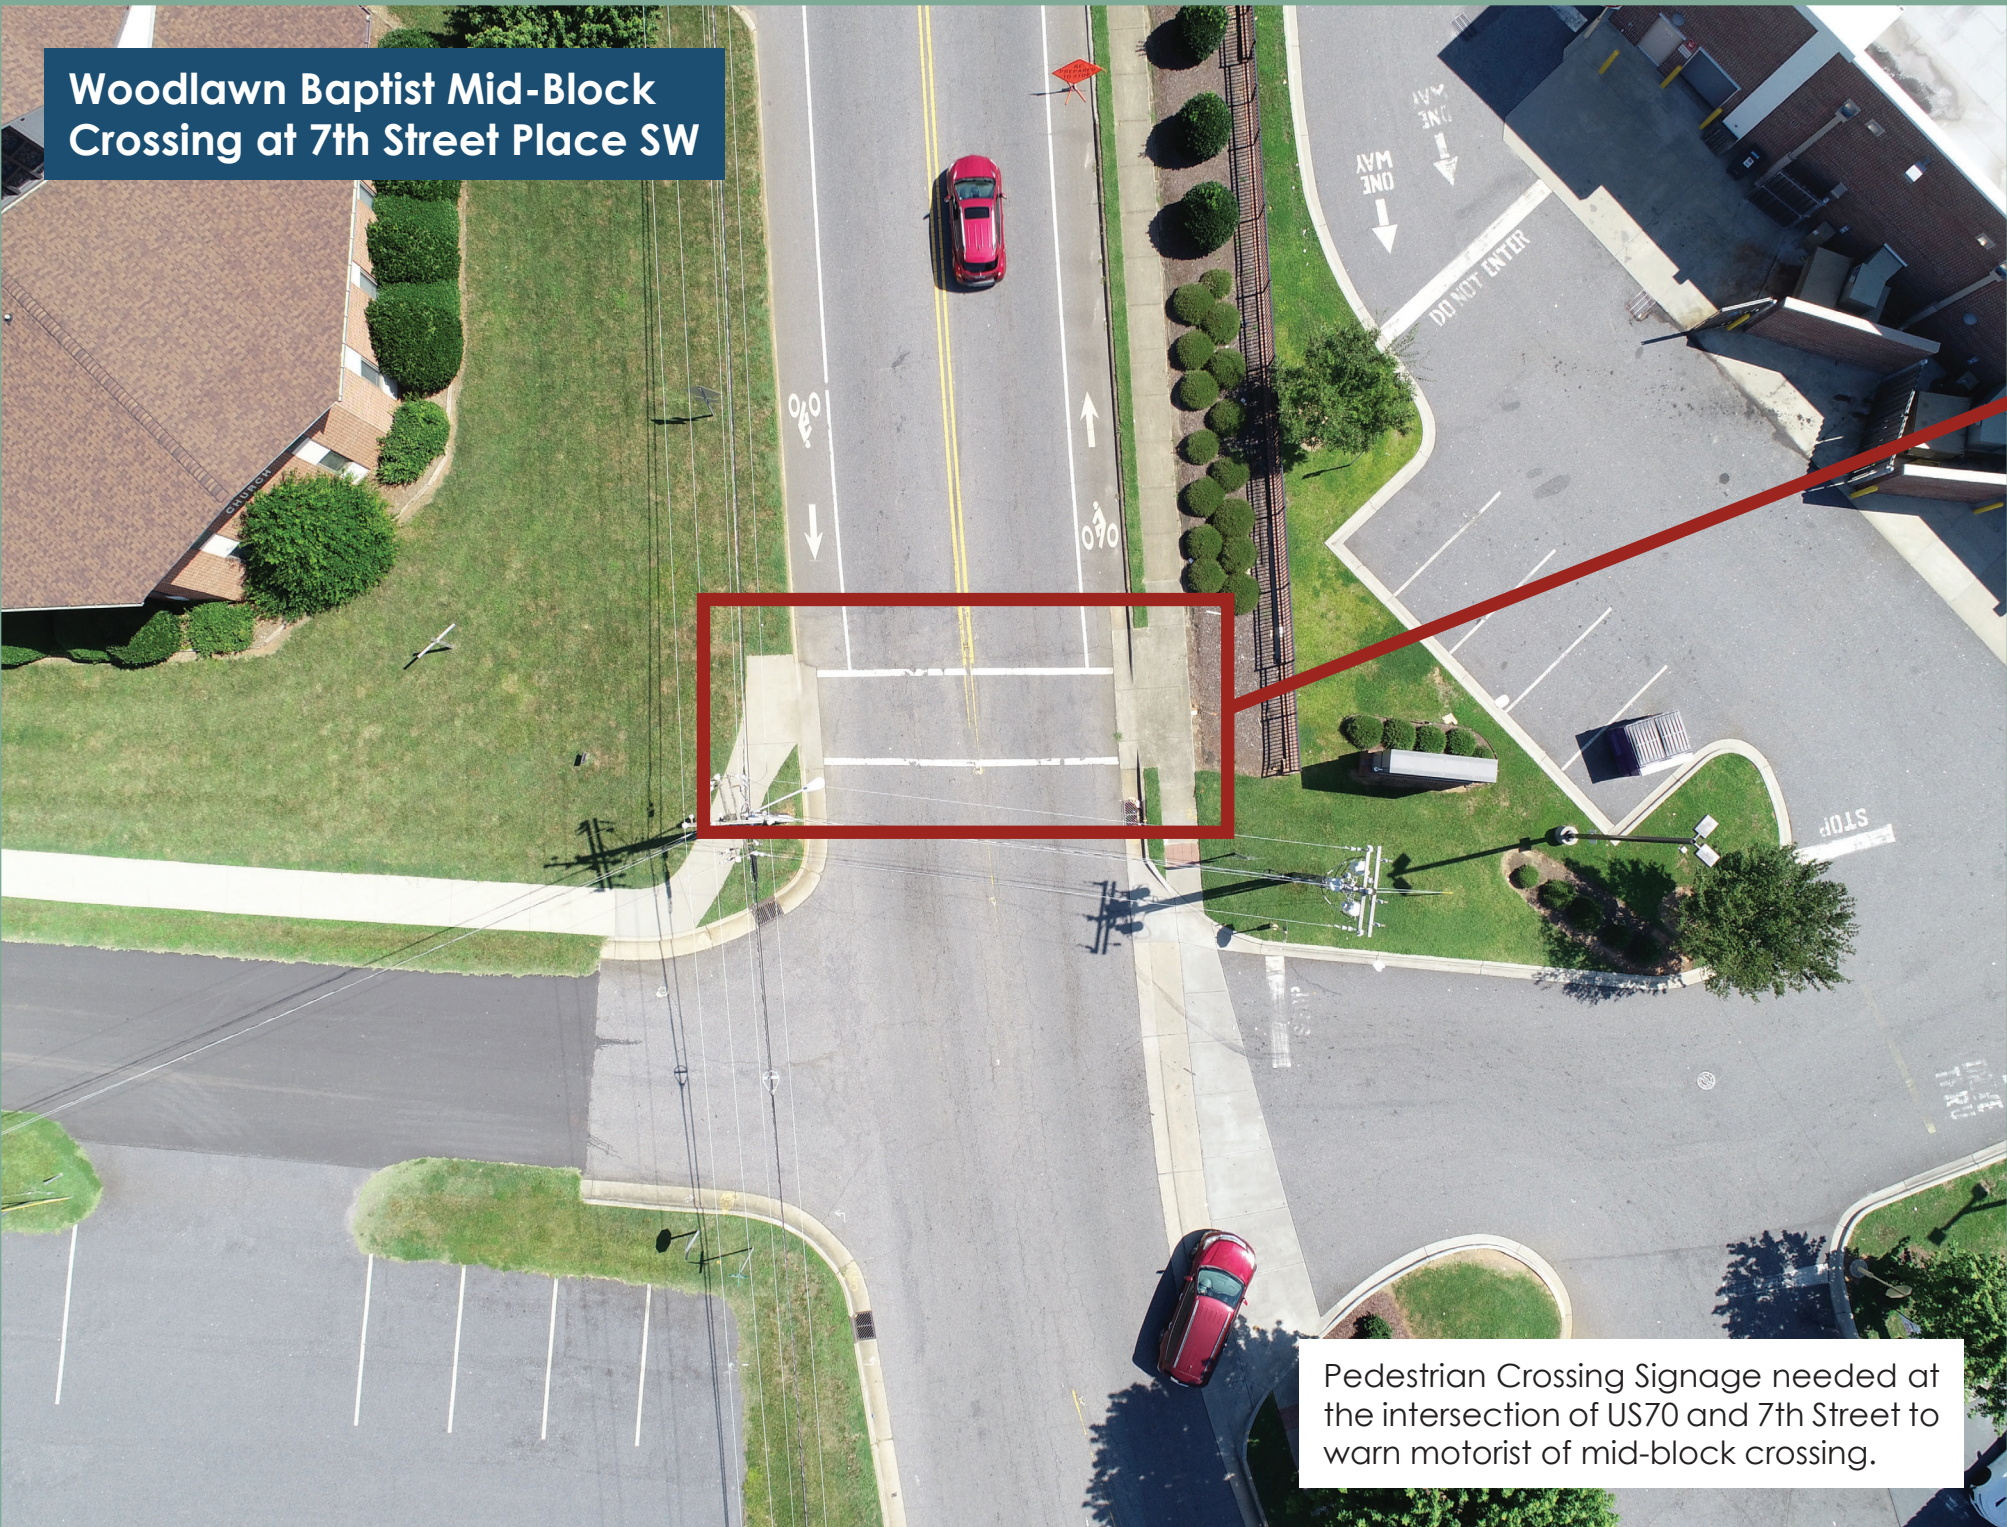
Woodlawn Baptist Mid-Block Crossing at 7th Street Place SW

Pedestrian Crossing Signage needed at the intersection of US70 and 7th Street to warn motorists of mid-block crossing.

- » Detectable warnings present on either side of crosswalk
- » Extend curb ramps out to inside edge of the bike lanes to shorten the walking distance for pedestrians
- » High visual crosswalk to improve visibility
- » Advanced signage at intersection of US 70 warning motorists of midblock crossing
- » Rapid flashing beacon recommended
